# Shin Shin Apparels Ltd. (9615)

27.MAY.2014

# Identified Priority 1 Concerns

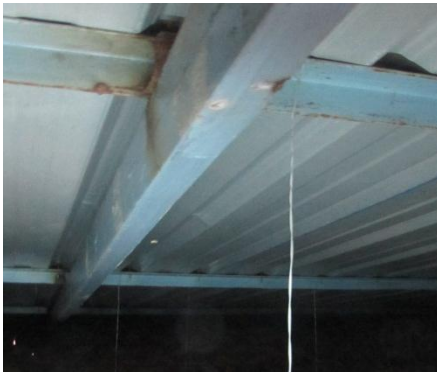
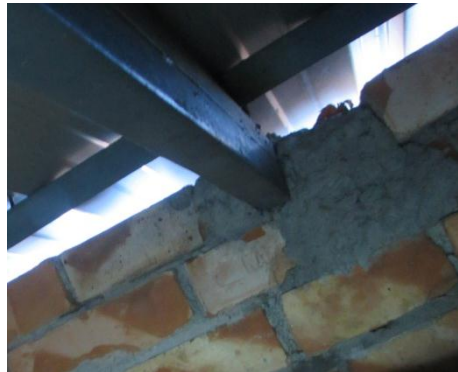
# Overall Stability System

The steel truss and beams is not longitudinally braced and the steel connection needs to be reviewed and repaired properly according to the proper design.

We require that these items be investigated in a Detail Engineering Assessment
