# M.A.C.K Shirts Ltd (9649)

## Basic Apparels Ltd (9791)

Plot #135-138, Abdullahpur, Uttara  
(+23.880716N, +90.401497E)

06.April.2014

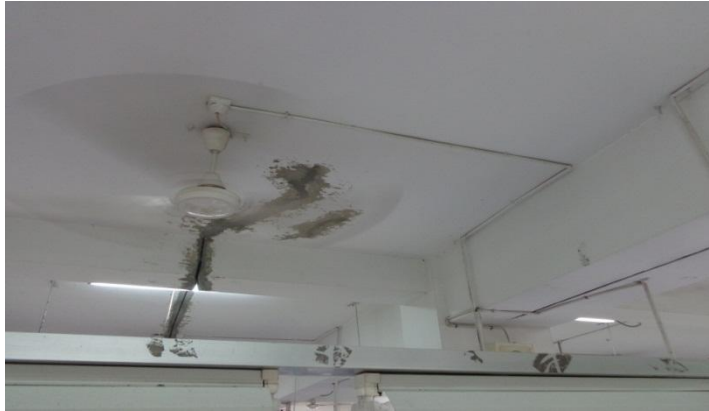
Capacity of the roof slab with regards to the quantity of water tanks in small area. These should be spread out ensure that the load is not carried out by same structural elements

**Multiple water tanks on the roof**
