Nine 2 Nine Intimates Ltd

35/A –B, Kalurghat Heavy Industrial Area ,Chittagong 4208 , Bangladesh
(22.390795, 91.872791)

18 June 2017

Observations

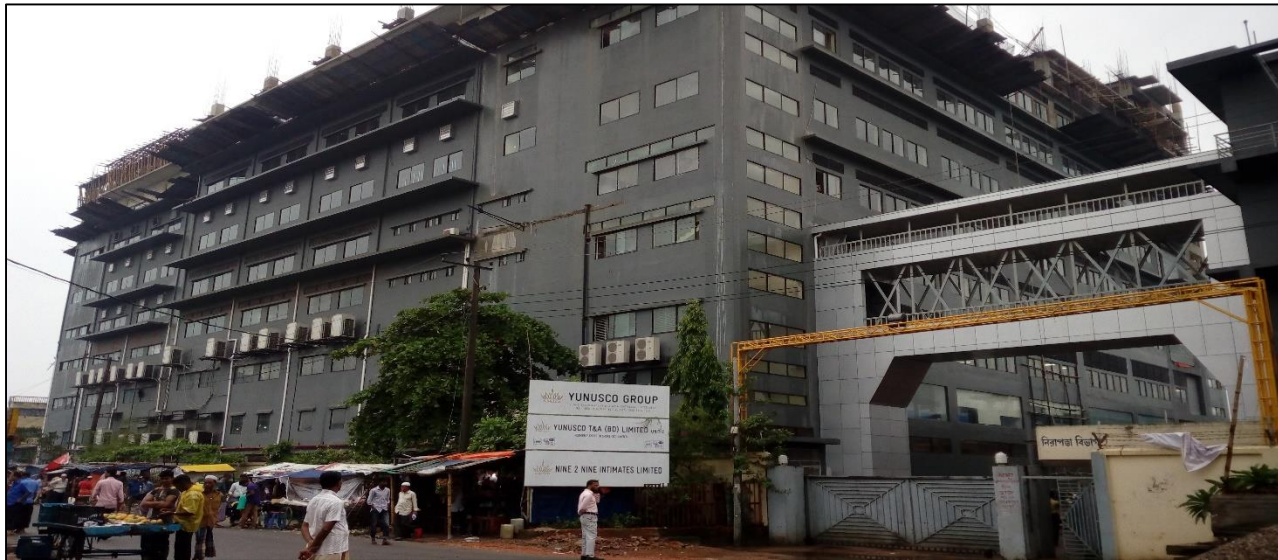
Foundation of main Building exceeds normal design limit

According to the design report Factor Of Safety of some of the foundations are found less than the recommended $FOS=2.5$ as per BNBC (marked below). It creates concern of the capacity of the pile foundation. Building engineer is required to check the capacity of the foundation system as part of the Engineering Assessment.

Item No.	Observation	Recommended Action Plan	Recommended Timeline
1	Foundation of main Building exceeds normal design limit	Check the foundation capacity as part of Engineering Assessment capacity as per BNBC.	6-weeks
2	Foundation of main Building exceeds normal design limit	Produce and actively manage a loading plan for all floor plates within the factory giving consideration to floor capacity.	6-weeks
3	Foundation of main Building exceeds normal design limit	Apply remedial action where necessary.	6-months
4	Foundation of main Building exceeds normal design limit	Follow the load plans and make sure that the workers understand the loading requirements.	6-months
5	Inconsistency in the as built drawings of the Generator building	Factory Engineer is to investigate the footing type and Check the adequacy of the existing footing.	6-weeks
6	Inconsistency in the as built drawings of the Generator building	Produce Accurate as built drawings of the Generator Building as part of Engineering assessment.	6-weeks
