# SQ Birichina Ltd Unit 2

SQ Station, Jamirdia, Bhaluka, Mymensingh  
(24.283 N, 90.392 E)  
19 October 2015

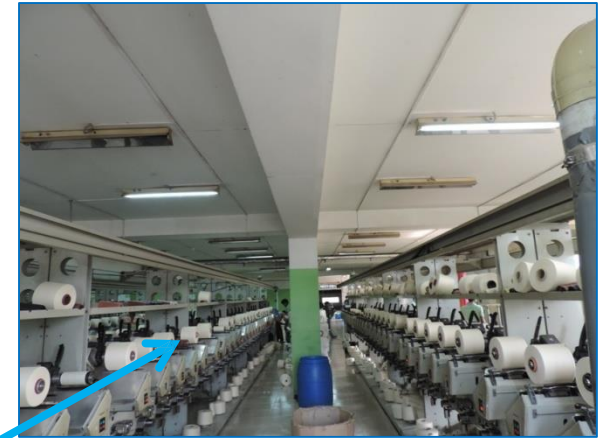
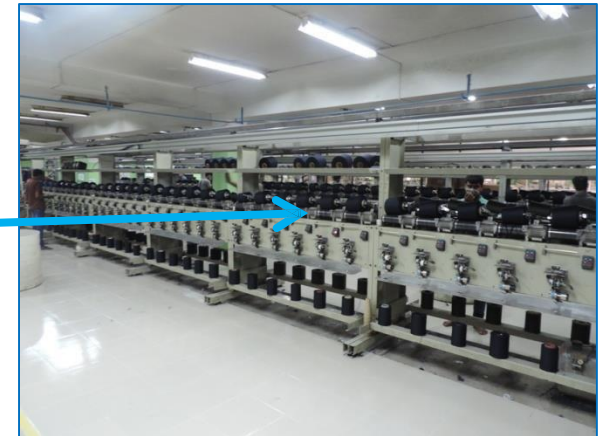
# Heavy floor load

Heavy machinery on the 1<sup>st</sup> floor

| Item No. | Observation | Recommended Action Plan | Recommended Timeline |
|---|---|---|---|
| 12 | Machinery on the 1st floor. Heavy floor load | Building engineer to check the capacity of the floor slab to carry the machinery and storage on 1st floor level as part of the DEA noted at Item 1 above. | 6-weeks |
| 13 | Machinery on the 1st floor. Heavy floor load | Carry out any load reduction and maintain restriction based on recommendations made by the Building Engineer. | 6-months |

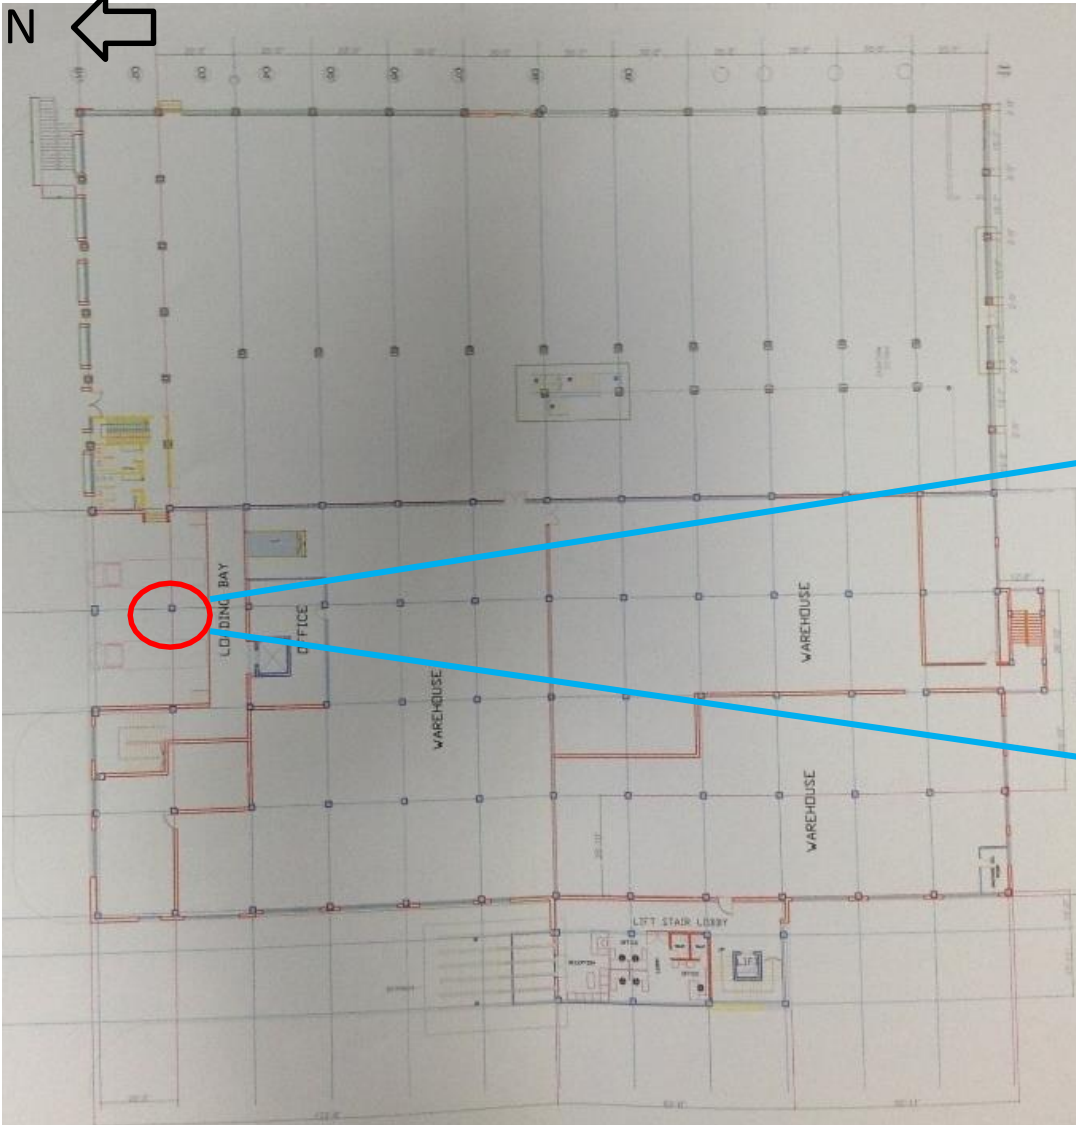
# **Column in loading bay unprotected from truck impact**
