# SF Sweaters Ltd. Building – 2

P.O. Salna Bazar, Gazipur, South Salina (Opposite of ABC Complex)

17<sup>th</sup> May 2017

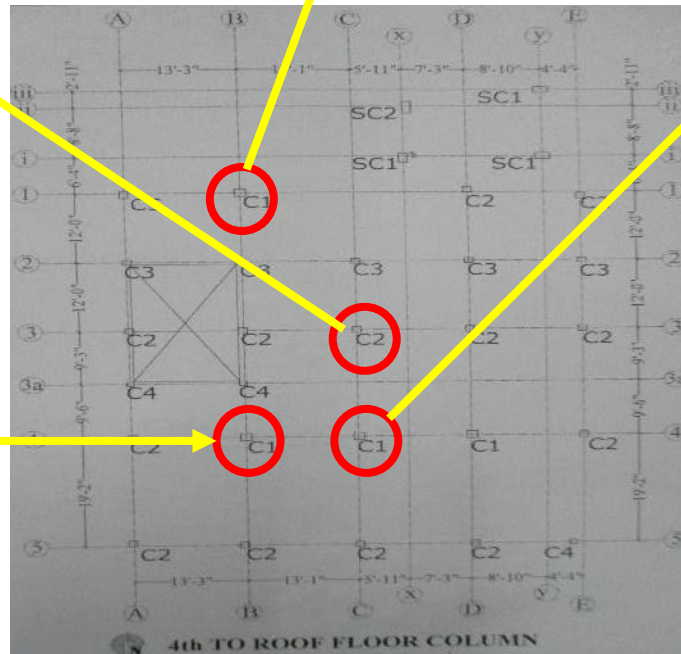
C1: 2- 16mm+5-20mm+2- 16mm on roof

### COLUMN SCHEDULE:

Building Engineer required to update As-Built drawings incorporate the verified number of reinforcement in columns.

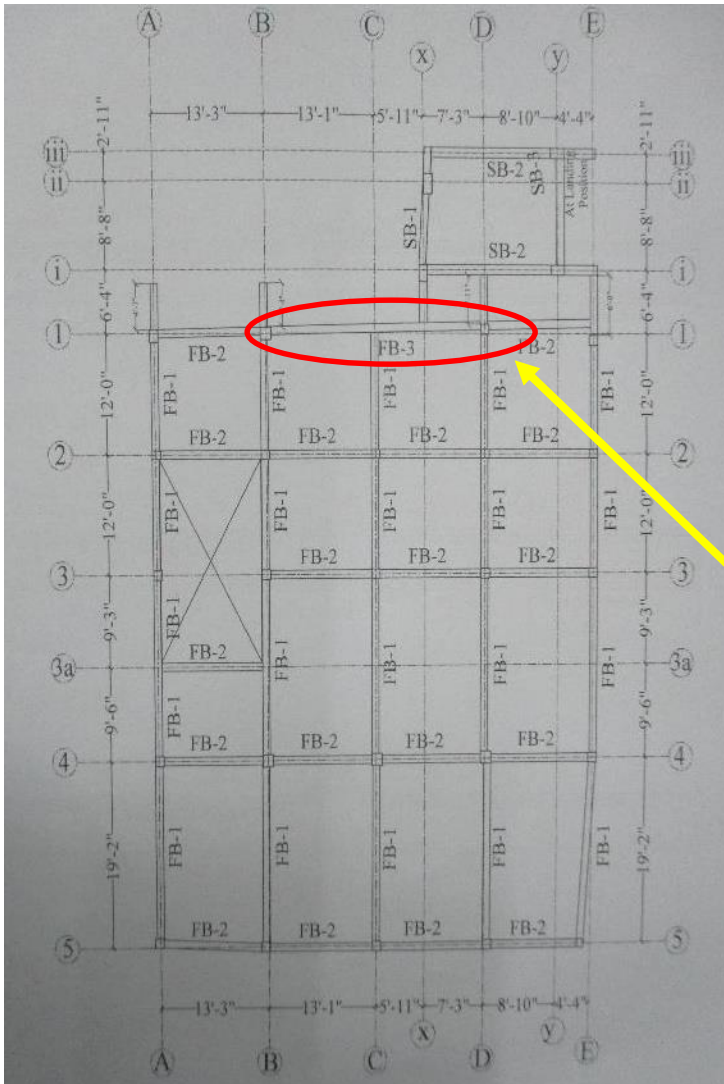
Typical Beam Layout Plan

**Observation: Discrepancy observed between drawings and site observation**

| Item No. | Observation | Recommended Action Plan | Recommended Timeline |
|---|---|---|---|
| 3 | (Building-2)<br>Discrepancy observed between As-Built drawing and actual condition | Building engineer to survey the whole building and produce as-built documentation reflecting the as constructed condition | 6-weeks |

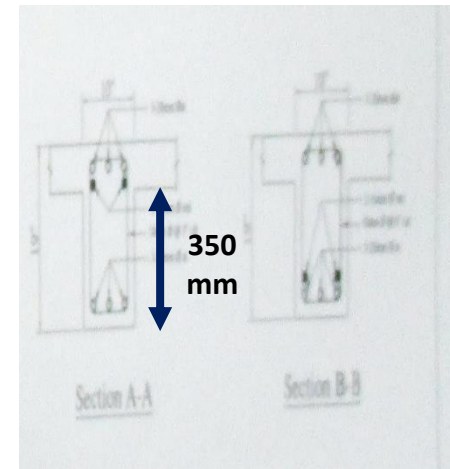
Cross section of FB-  
3 Beam

Down stand of beam  
observed 475mm instead  
of 350mm
