# Romo Fashion Today Ltd. (9373)

Vannera Road, Mouchak, Kaliakoir, Gazipur

31.05.2014

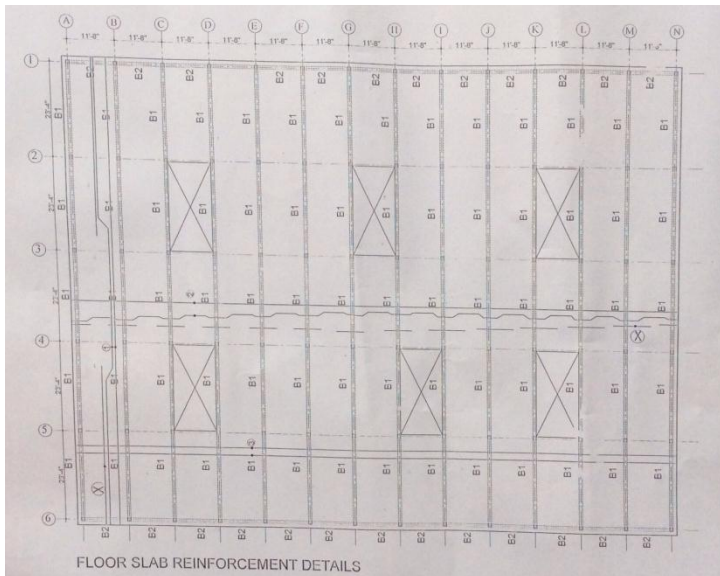
in the Factory Building, we believe that the intent of the original structural design was to use the main grid line beams to provide some form of lateral stability via moment frame action. However, the grid line beams only exist in one direction (north to south). In the other direction (east to west) there are no beams.

We require that the lateral support system is investigated as part of a Engineering Assessment.
