# P.M. Knittex (Pvt) Ltd. (9944)

Chowdhurry Bari, Godhnail, Narayangonj.

01.June.2014

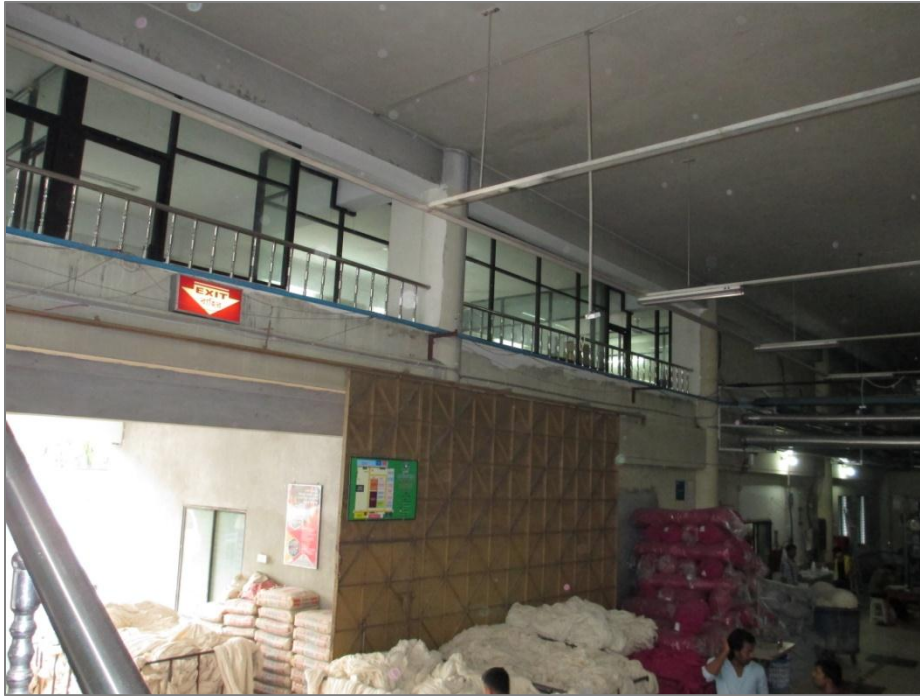
- Building #1 – Mezzanine between the ground floor and the 1st floor. No documents available.
- Buildings #1 & #2 – Floor loading should be controlled.
- Building #1 - No documents were provided for the dining structure on the roof
- Knitting, Generator, Chemical storage and waste storage sheds are poorly constructed and no drawings were available.

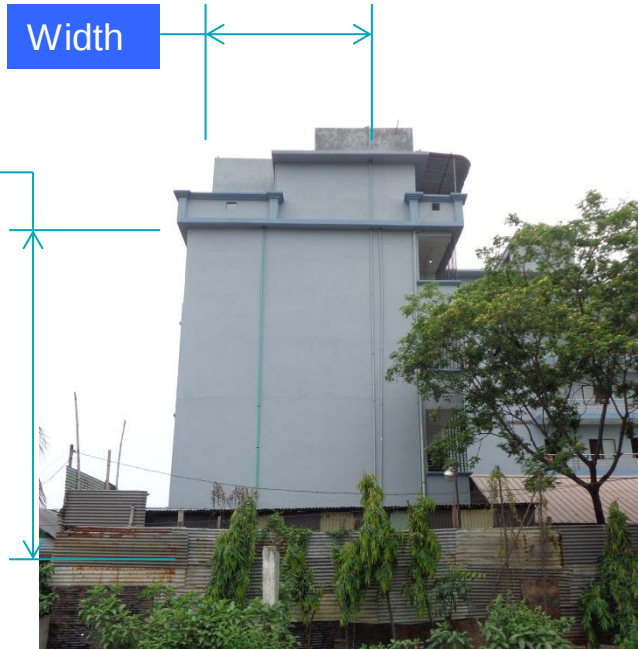
## Building Extents – Building #1

We believe that the intent of the original structural design was to use the main grid line beams to provide some form of lateral stability via moment frame action.

However, for Building #2, the width of the building compared to the height gives us cause for concern and we require the lateral support system to be investigated as part of a Detailed Engineering Assessment.
