# Magpie Composite Textile Ltd. (9804)

02.JUN.2014

# Identified Priority 1 Concerns

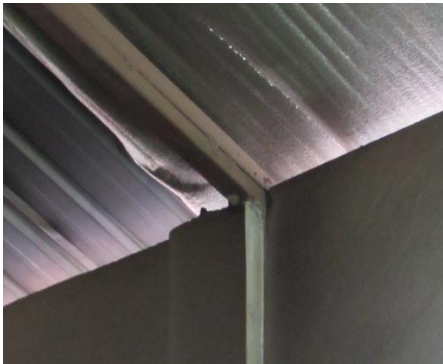
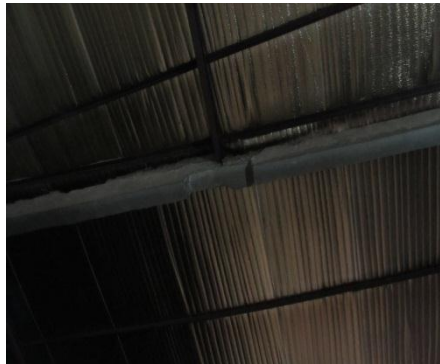
The steel beams of the roof are very small with very simple connections and appear to be corroded and have excessive deflections.

We require that these items be investigated in a Detailed Engineering Assessment.
