Sams Fashion (10011)

Sams Socks

Keowa Pashim Khanda (Koroitola), Mawna, Sreepur, Gazipur

02.JUNE.2014

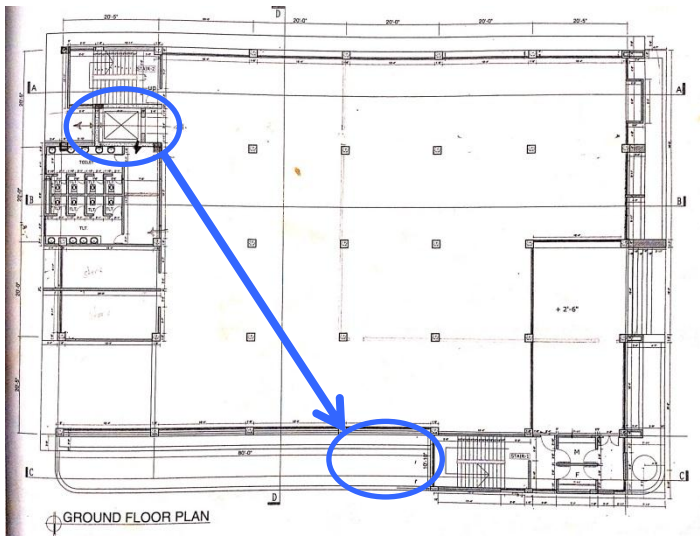
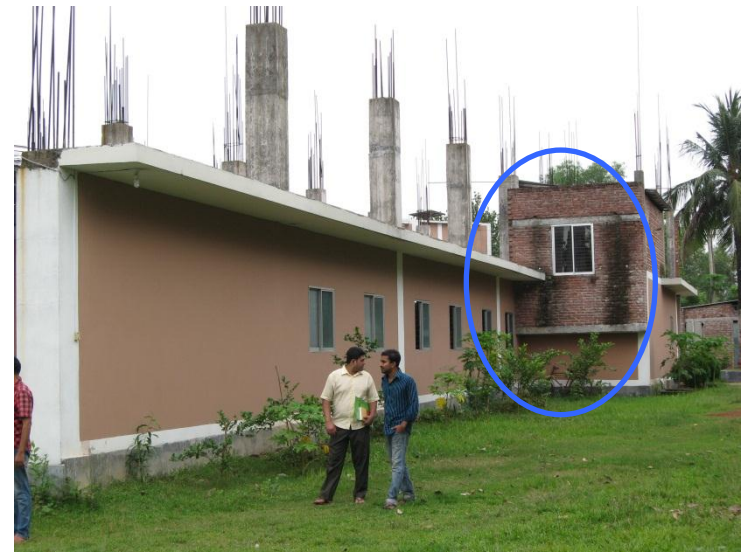
- Inconsistencies between the drawings and the actual as-built conditions of Building 1

We were informed that the shear wall will be constructed between grid line E-F/5-6 instead of grid line A'-B/2-3.

Item No.	Observation	Recommended Action Plan	Recommended Timeline
1	Priority 2 - Inconsistencies between the drawings and the actual as-built conditions of Building 1.	Factory Engineer to survey the actual conditions and revise the drawings. Factory Engineer to review design and lateral loads to confirm stability of this building under lateral loading.	6-weeks
2	Priority 2 - Inconsistencies between the drawings and the actual as-built conditions of Building 1.	Continue to implement load plan	6-months
3	Priority 2 - Overall stability system.	Request that an Engineering Assessment of the overall building to be carried out and in particular, stability and foundation aspects should be investigated in detail.	6-weeks
4	Priority 3 - Reinforcement left exposed at top level of Building 1.	Remove rust from rebar before further construction. For both durability and serviceability, rust proof paint or any appropriate methods is recommended.	6-months

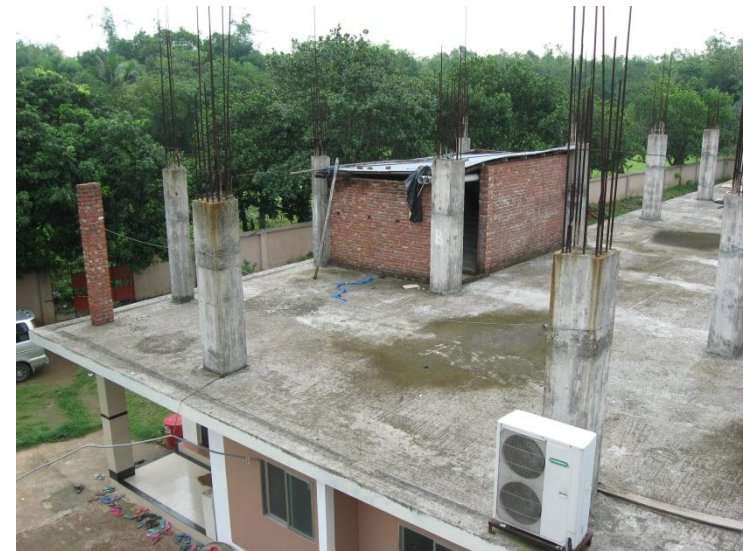
- Reinforcement left exposed at top level of Building 1

Reinforcement is left exposed at top level of Building 1.

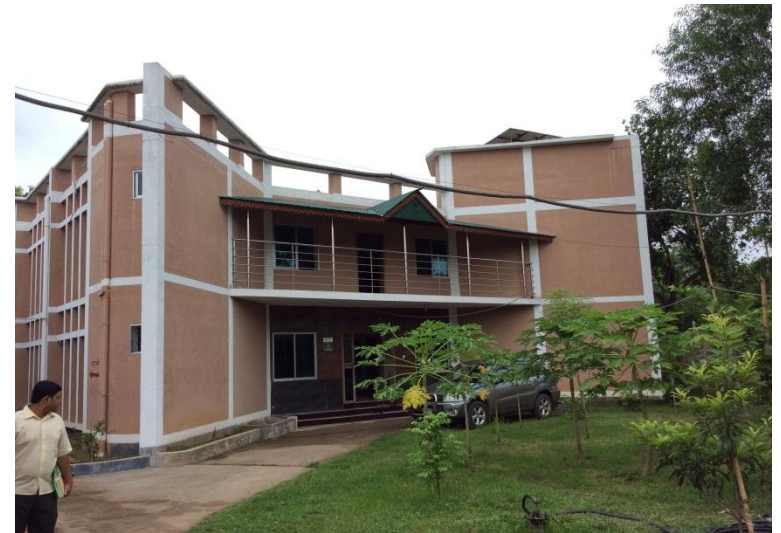
Concerns on the stability system for lateral loading. Shear wall of Building 1 was planned to be relocated. Stability of Building 2 was provided by brick bearing walls and slab action which lack of moment capacity in the connections between walls and slabs.

We require that these items be investigated in an Engineering Assessment.

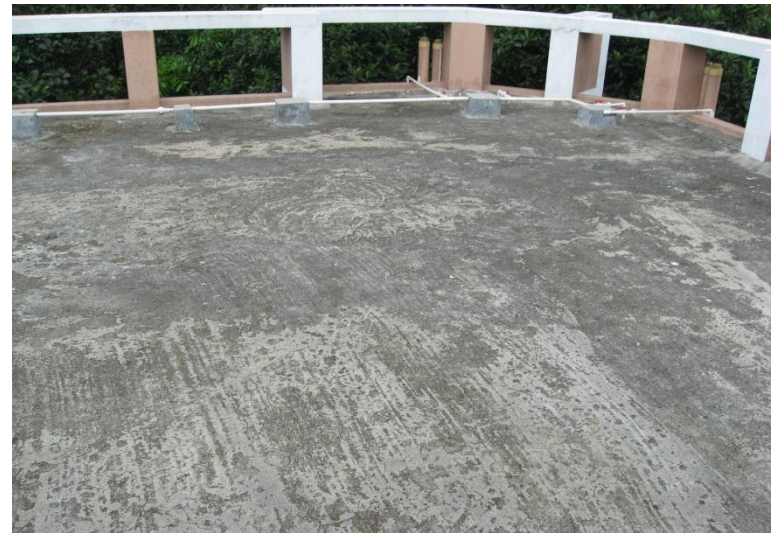
There is no distress due to water ingress found at top level. However, there is water ponding found after the rain. Waterproofing material should be applied.

5	Priority 3 - No waterproofing material applied at top level.	Factory Engineer to inspect water damaged structures and repair with a suitable method. Waterproofing on the roof slab is recommended. Moreover the slab drainage system should be investigated. Maintain standard of quality control.	6-months
