# Jointex Fashion Wears Ltd. (Unit-3)

02, Hossain plaza, Matbar bari, Tanga bari, Ashulia, Savar, Dhaka  
(23.906263, 90.322926)

13<sup>th</sup> September 2017

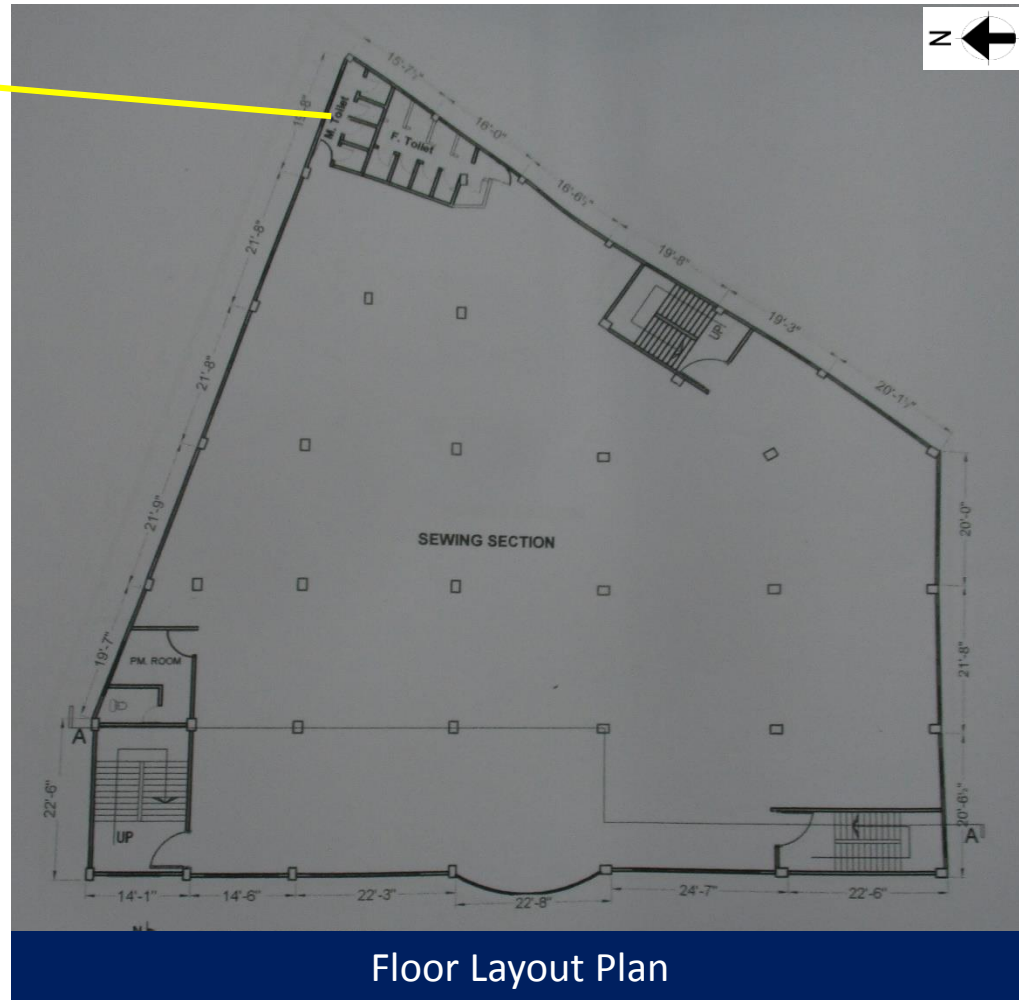
Floor Layout Plan

Toilet build up in several floor.  
Max 200 mm

Cursory calculation indicates that Columns appears to be stressed above normal design limits.

Item No.	Observation	Recommended Action Plan	Recommended Timeline
1	Column to be stressed above normal design limits	Factory Engineer to review design, loads and columns stresses	6-weeks
2	Column to be stressed above normal design limits	Produce and actively manage a loading plan for all floor plates within the factory giving consideration to floor capacity and column capacity.	6-weeks
3	Column to be stressed above normal design limits	Make any structural alterations as advised by Building Engineer	6-months
4	Column to be stressed above normal design limits	Continue to implement loading plan.	6-months
5	Discrepancies between provided drawings and on site condition	Building Engineer is required to investigate the foundation system of the additional columns. Also load path of the additional columns are required to verify.	6-weeks
6	Discrepancies between provided drawings and on site condition	Engage an Engineer to update an “as constructed” drawings which reflect the actual site dimensions with complete structural & architectural information.	6-weeks

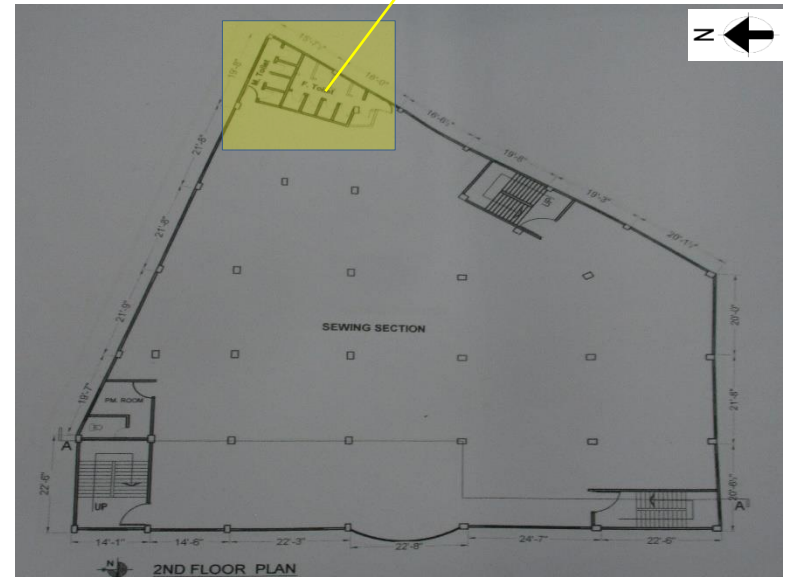
Floor Layout Plan

Slab details were not provided in structural drawings. Beam layouts were not match in some floors. Mismatches are shown in red on layout.
