# Jamuna Apparels

94/95 (Old), 46 (New), Block –C, Tongi I/A, Tongi, Gazipur  
(23.901086N, 90.399888E)

7<sup>th</sup> November 2013

# Building Observations

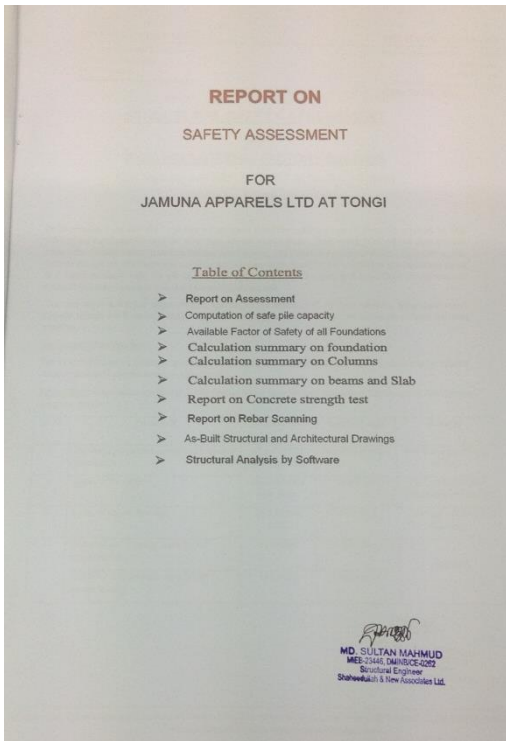
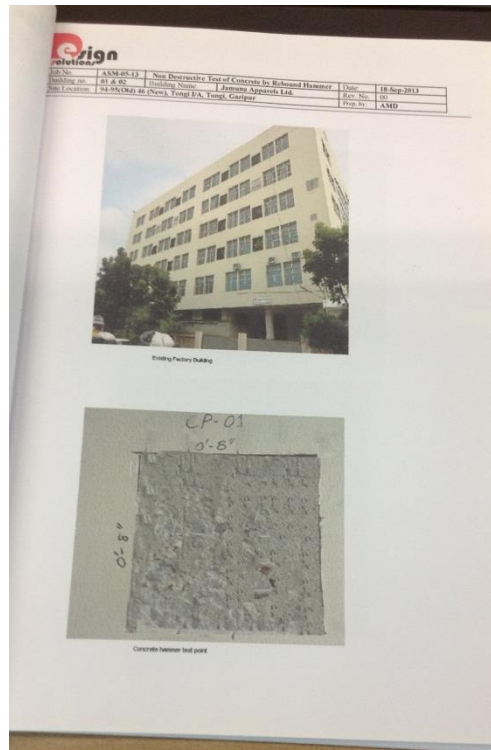
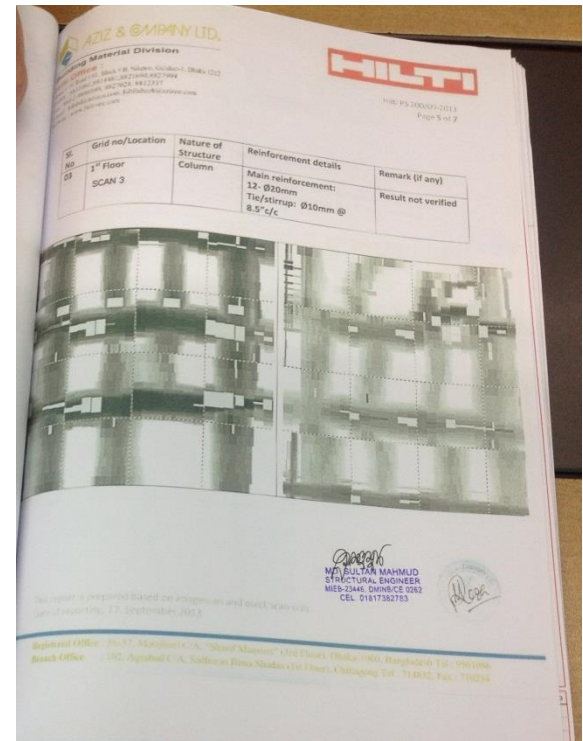
# Detailed Engineering Assessment

**A Detailed Engineering Assessment dated August 2013 was carried out by Shaheedullah & New Associates Ltd. This assessment includes detailed structural calculations and results of material testing onsite. It is recommended in the report that remediation to Beams grids G/6-7 & F/3-5 be carried out.**
