# Square Fashions Ltd

Rokeyapur, Jamirdia, Habir Bari, Valuka, Mymensingh, Bangladesh  
(+24.29540N,90.38831E)  
29<sup>th</sup> June 2014

# Observations

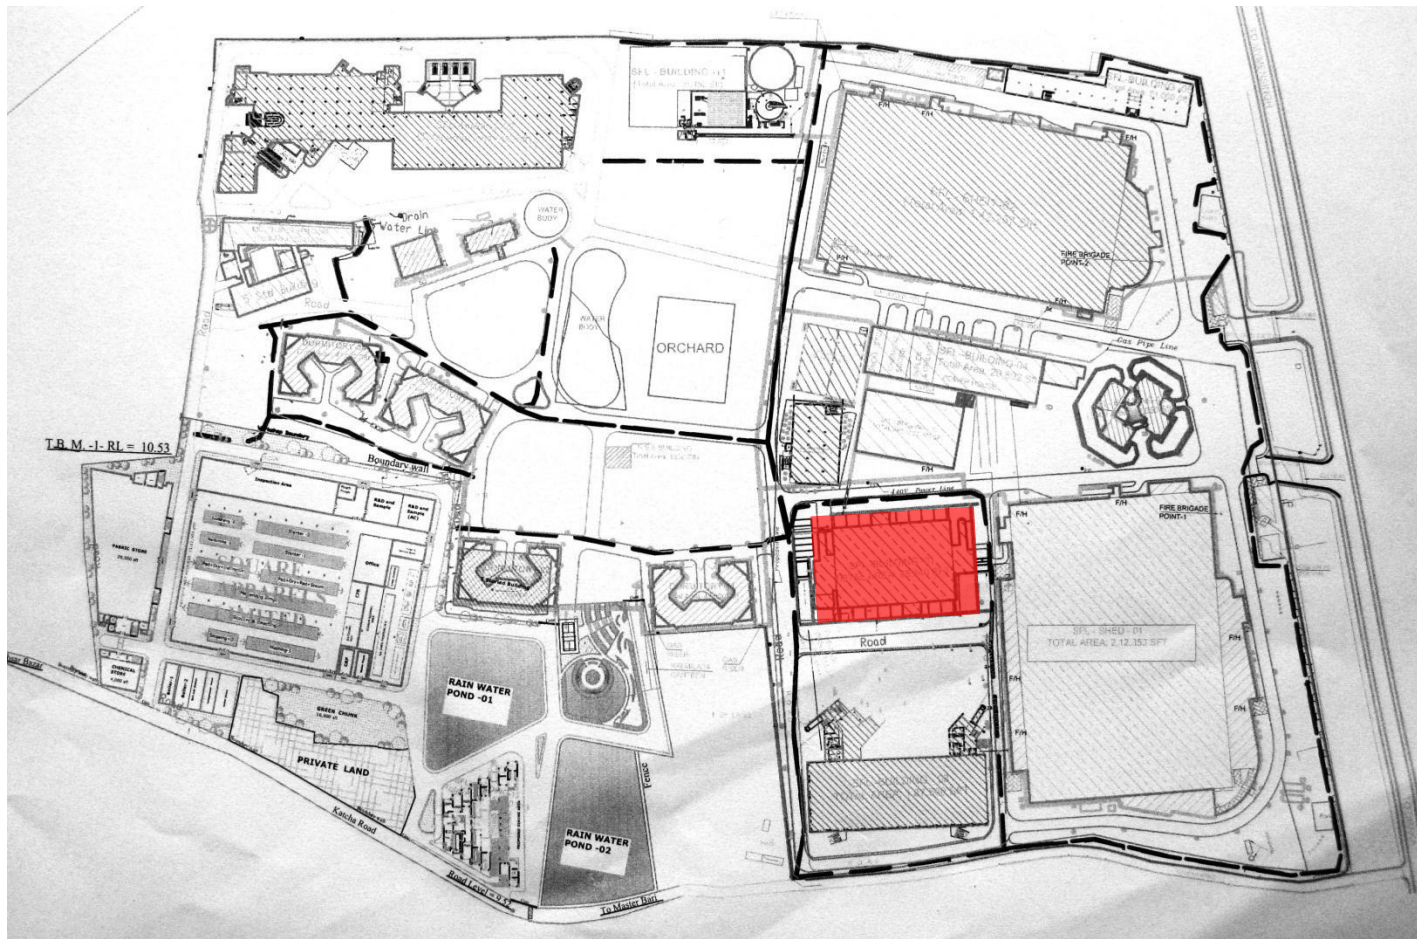
Location of  
Building 1

# **Building 1 - Cracking to load-bearing masonry wall**

Cracking was observed to a load bearing masonry wall supporting a lintel. The masonry wall is located along the East elevation of Building 1 where the RC stair core meets the steel frame structure. The connection detail between the structures is not clear.

| Item No. | Observation | Recommended Action Plan | Recommended Timeline |
|---|---|---|---|
| 1 | Building 1 - Cracking to load-bearing masonry wall | Building Engineer to review extent of cracking in masonry wall and carry out a design check on this element for the applied loads. | 6-weeks |
| 2 | Building 1 - Cracking to load-bearing masonry wall | Building Engineer to implement any actions / supervise remedial works to masonry wall as identified following the review. | 6-weeks |

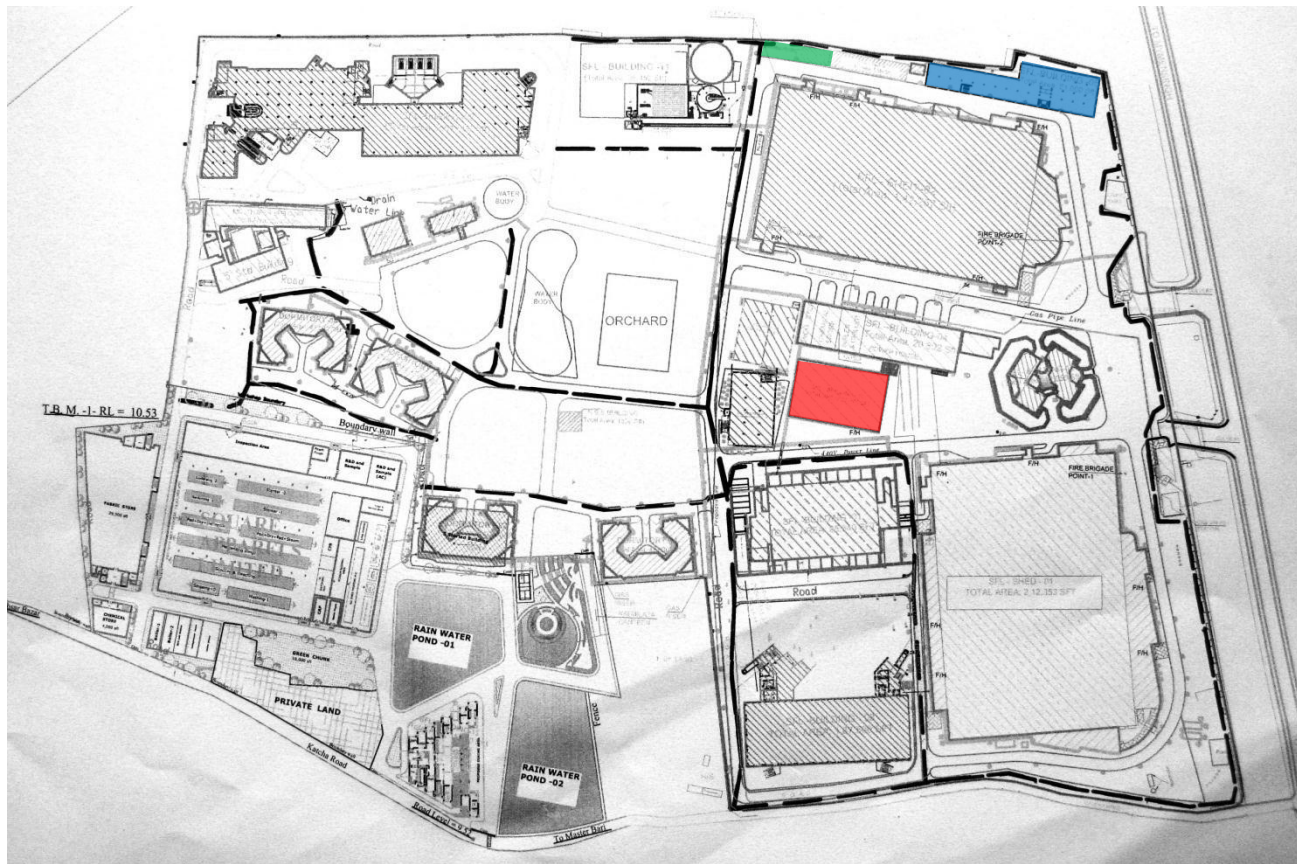
Location of Building 3

# **Buildings 3, 5 and 7 - Heavy loading to suspended floors and lack of adequate loading plans**

Heavy loading was observed to Buildings 3, 5 and 7. While these buildings appear to have been designed as storage buildings, the loading on the floors does not appear to be managed. While some loading plans were provided, these appeared to be based on loadings observed at the factory at a particular time; it is not clear whether the loads represent the maximum allowable floor loading.

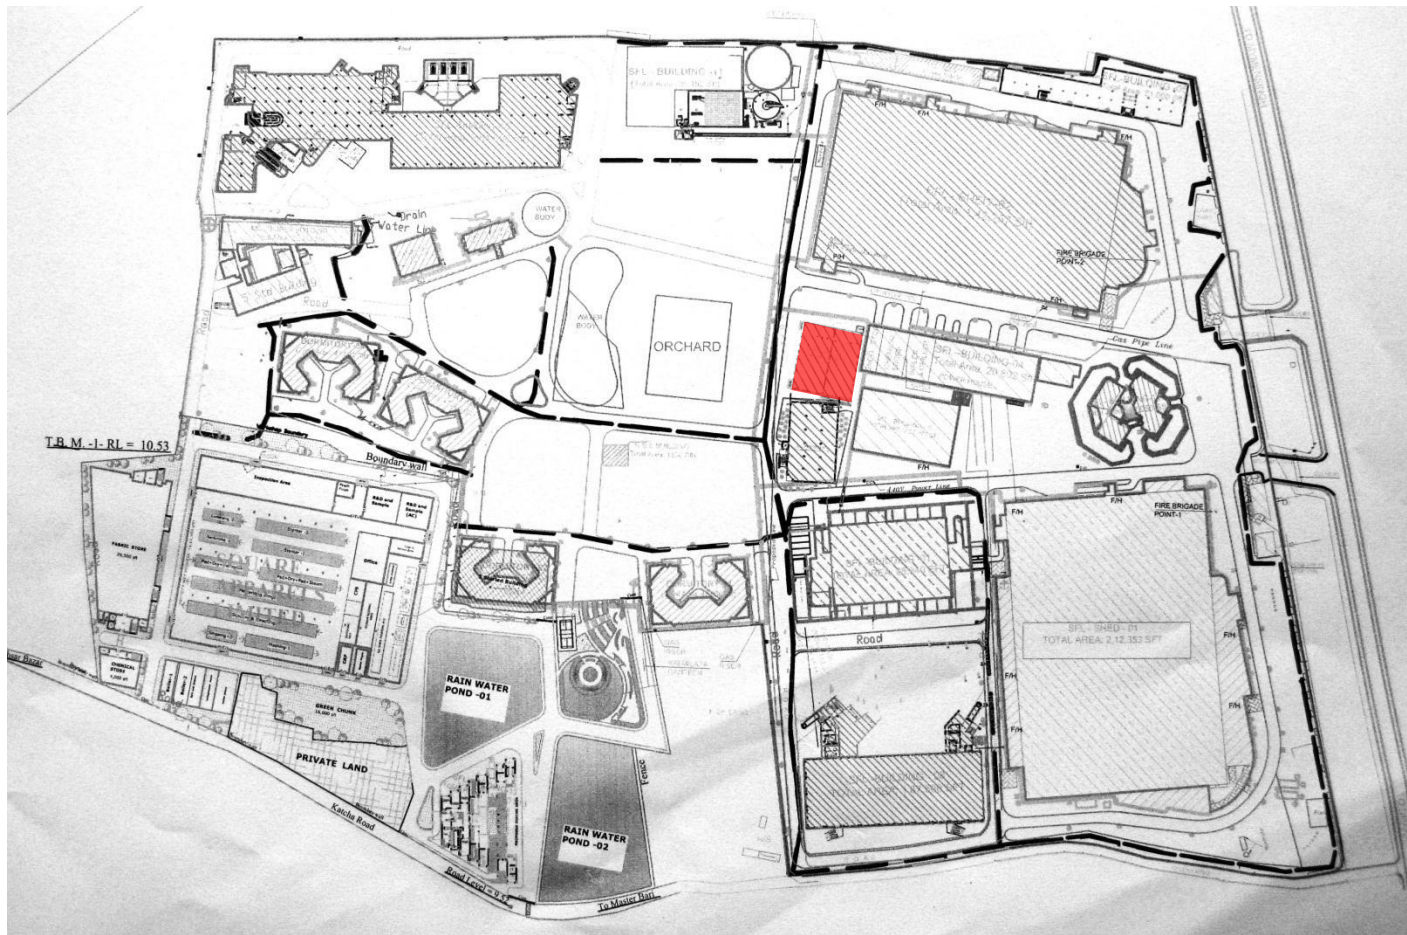
Location of Shed 3

## **Shed 3 - appears to be non-engineered**

Shed 3 appears to be non-engineered. The prefabricated roof trusses appear to be supported on a combination of masonry walls and RC-encased steel posts, the connections to which are unclear. The lateral stability system of the building is not clear. The design documents are incomplete.

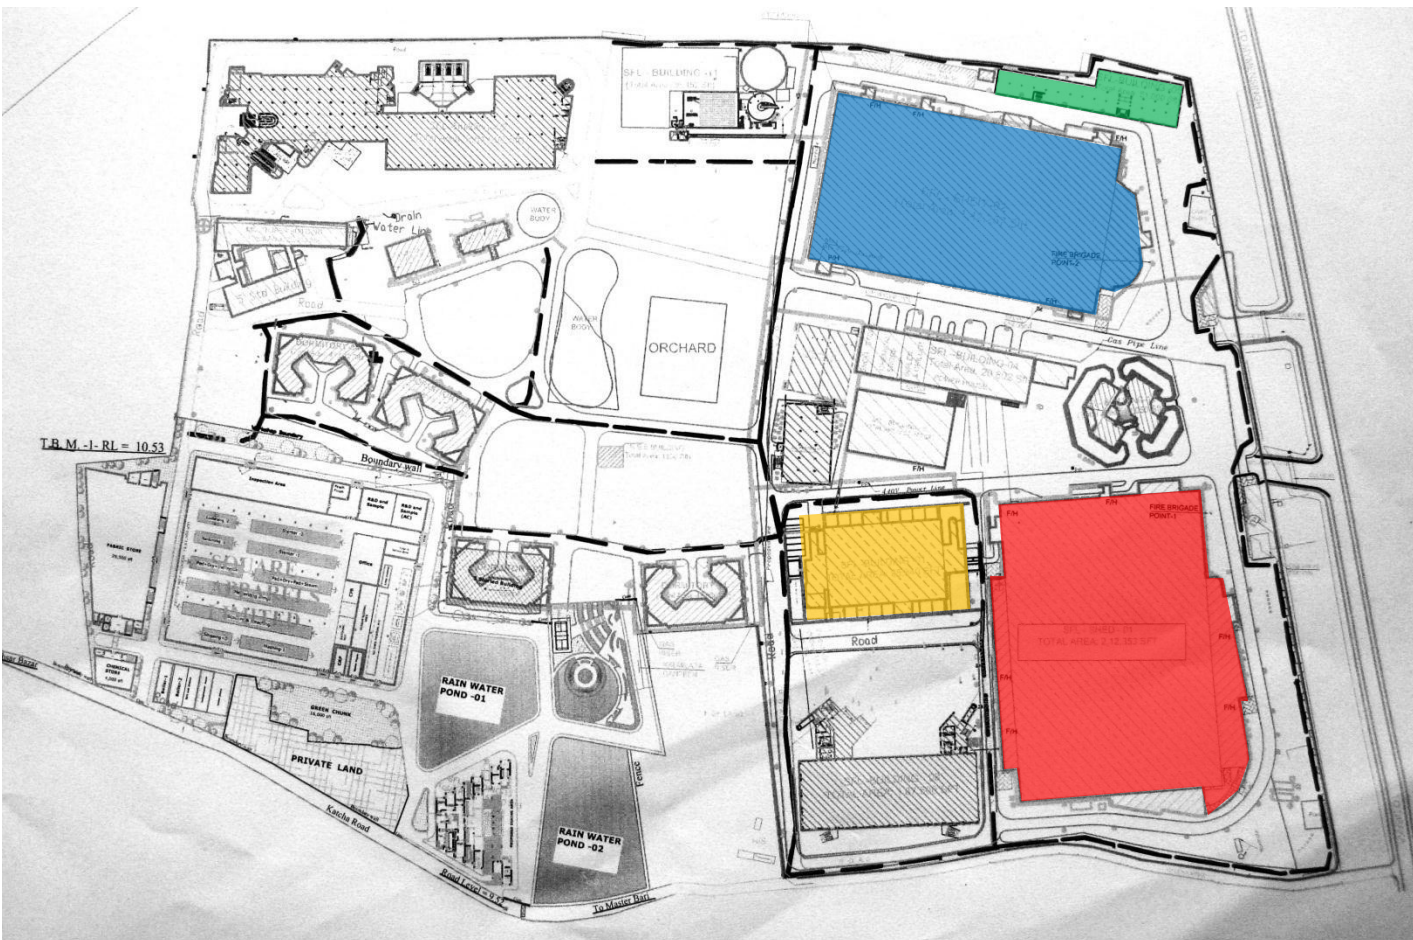
## Location of Building 5

# **Sheds 1 & 2 and Buildings 1 & 5 - Missing / loose bracing**

There is missing bracings to Shed 2 and Building 1 and, where provided, bracing to Sheds 1 and 2 and to Building 5 is loose and therefore ineffective.

| Item No. | Observation | Recommended Action Plan | Recommended Timeline |
|---|---|---|---|
| 20 | Sheds 1 & 2 and Buildings 1 & 5 - Missing / loose bracing | Building Engineer to provide adequate bracing to Shed 2, and to tighten bracing to Sheds 1 and 2 and Buildings 1 and 5. | 6-weeks |

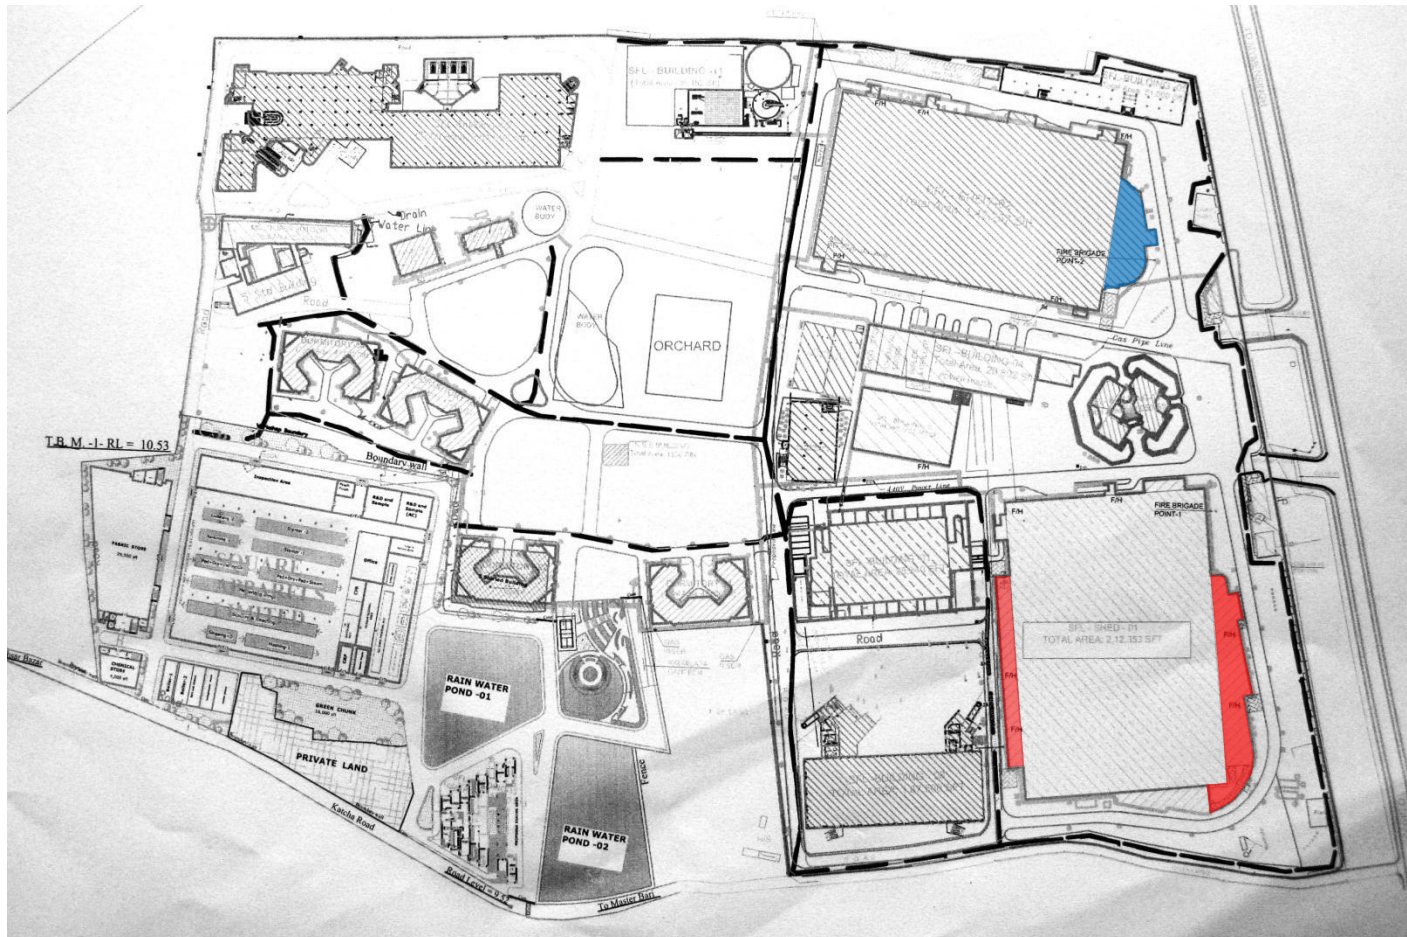
Extent of perimeter  
RC structures to  
Shed 1

# **Sheds 1 and 2 - Cracking, ponding and water damage to perimeter RC roof slabs**

Cracking, ponding and water damage was observed to the roof slabs of the perimeter single-storey RC structures to Sheds 1 and 2.

| Item No. | Observation | Recommended Action Plan | Recommended Timeline |
|---|---|---|---|
| 23 | Sheds 1 and 2 - Cracking, ponding and water damage to perimeter RC roof slabs | Building Engineer to review extent of cracking, ponding and water damage to roofs and to prepare a schedule of remedial works, as required. | 6-weeks |
