EH Textiles Ltd

221 – 225 Sataish Rd, Khortoil, Dhaka
(23.9208N, 90.3880E)

31 October, 2013

Building Observations

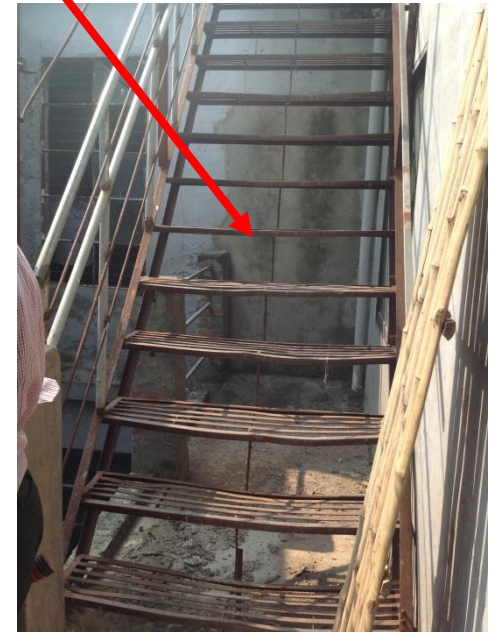
Stair 2

Steel stairs is badly corroded and may not support required access/escape loadings. The Concrete supports appear very slender and their design should be checked.

Flimsy corroding handrail

Very lightweight structure with significant corrosion apparent

Item No.	Observation	Recommended Action Plan	Recommended Timeline
12	Water causing damage and corrosion	Roof drainage system/water proofing to be installed	6-weeks
13	Fire stairs at roof level inadequate and in poor condition.	Inspect, repair/replace any badly corroded treads in stair	6-weeks
14	Fire stairs at roof level inadequate and in poor condition.	Repair/Replace all handrails where anchorage is damaged	6-weeks
15	Fire stairs at roof level inadequate and in poor condition.	Escape stairs/supports should be designed and upgraded to support code loads by the building Engineer.	6-months
16	Access and egress from fire exits is down a narrow passage beside the building	Remove/repair trip hazards so that fire escape passage is clear	6-weeks
17	Access and egress from fire exits is down a narrow passage beside the building	Review building fire escape routes and if possible do not use stairs leading to narrow passage as primary fire escape	6-months
