# Fashion 2000 Ltd.

367/1, Senpara, Parbata, Mirpur-10, Dhaka  
(+23.80486667N, 90.37358333E)

03 October 2013

# Building Observations

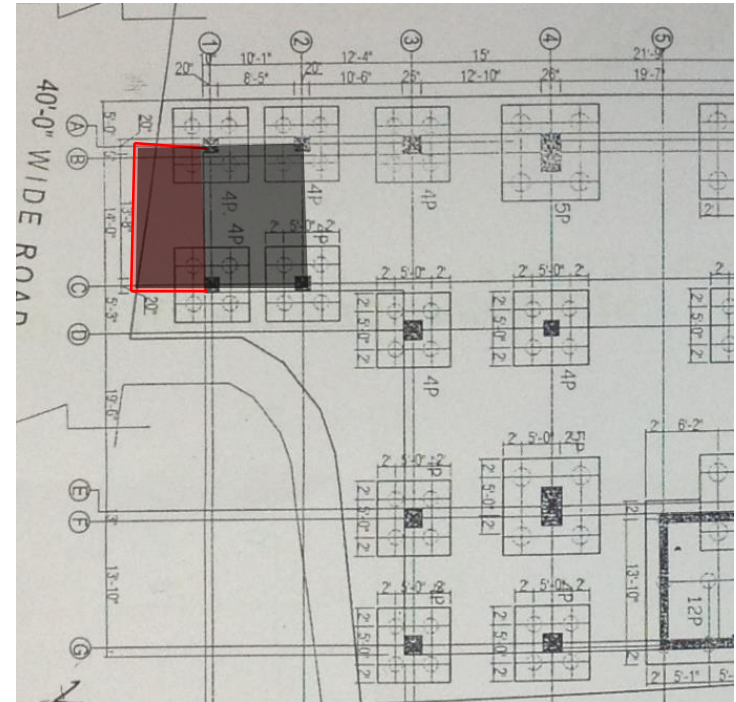
## Two Storey Cantilever

Structure of 2<sup>nd</sup> floor cantilever could not be determined because of stored material

Structure of 1<sup>st</sup> floor cantilever could not be determined because of false ceiling and floor finishes in place (office space)

It is unclear if the slab alone is supporting the cantilever, or if there are beams in place

**Building Engineer to confirm by calculations that column and cantilever slab are designed adequately.  
If necessary, reduce loads (loading plans to be prepared)**

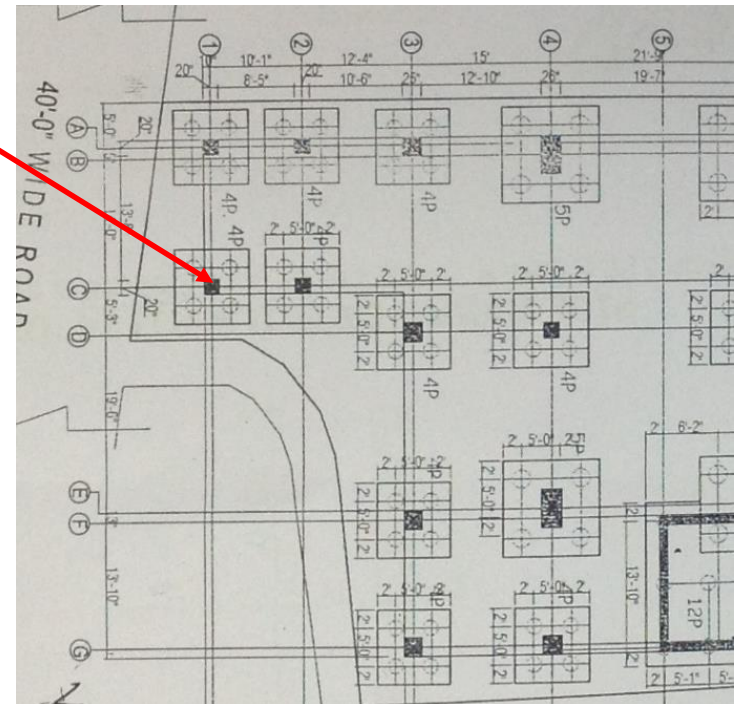
## Two Storey Cantilever

## Storage loading on 2<sup>nd</sup> floor cantilever
