Harry Fashion Ltd. (9690)

Voradoba, Valuka, Mymensing

02.July.2014

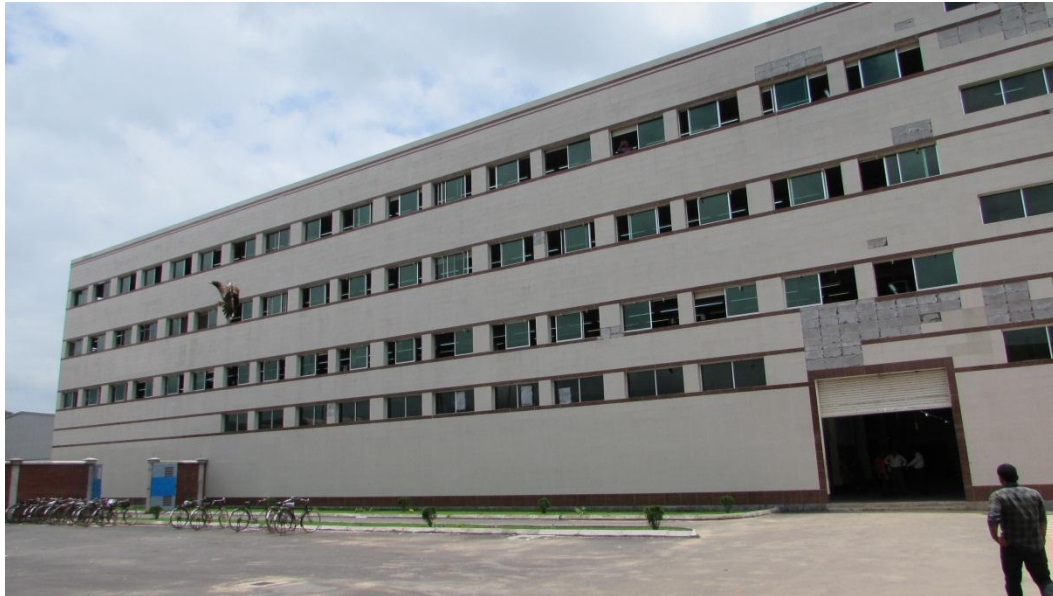
The foundation of the **Building (Individual column footing)** may be provided at a depth of 5 feet from existing ground level. The allowable bearing capacity of soil at the recommended depth to be considered as 1.00 tsf.

According to soil test report, allowable bearing capacity of foundation is 1 tsf and for that reason footing size should be about 180 sft. However, in foundation design footing size is less than 180 sft which is the main concern for this building

Typical footings are under designed as per soil test and as-built components

Do not construct any further buildings connected to the existing factory, without thorough structural design and full building approval.
