Sterling Creations Ltd. (9620)

Beron, Earpur Union, Ashulia, Dhaka

02.July.2014

Identified Priority 1 Concerns

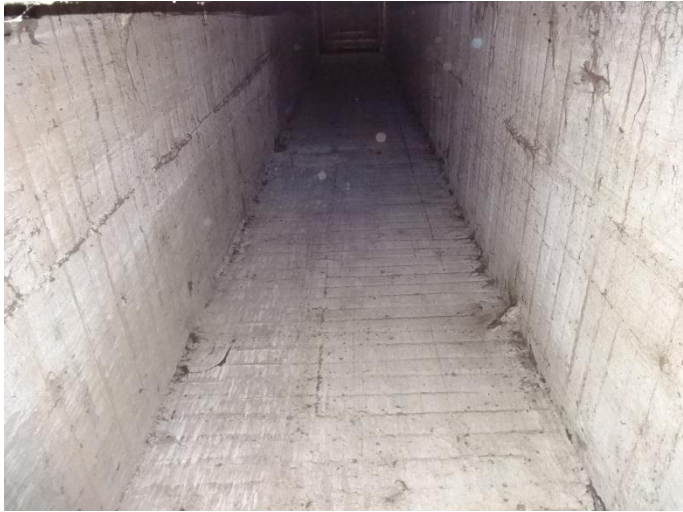
The building featured two reinforced concrete cores at the ends of the building. These were observed during the surveys and appear to be constructed as the design drawings show. These would appear to provide some lateral stability for the building. However the adequacy of the lateral stability system needs to be further assessed.

Item No.	Observation	Recommended Action Plan	Recommended Timeline
8	Priority 2 - Lateral stability system requires further assessment.	Carry out a Detailed Engineering Assessment on the building to verify that the building is stable under its lateral loading.	6-weeks
9	Priority 2 - Lateral stability system requires further assessment.	Carry out all recommendations of the Engineering Assessment.	6-months
10	Priority 3 - No waterproofing membrane to roof.	Cover the concrete roof with a suitable waterproofing membrane, e.g. waterproof screed.	6-months
