# Far East Knitting & Dyeing Industries Ltd. (Building-3 & 4)

Chandona, Thana-Kaliakoir, Gazipur  
(24.042354N, 90.263318E)

17<sup>th</sup> September 2017

# Discrepancies between drawings and on site condition

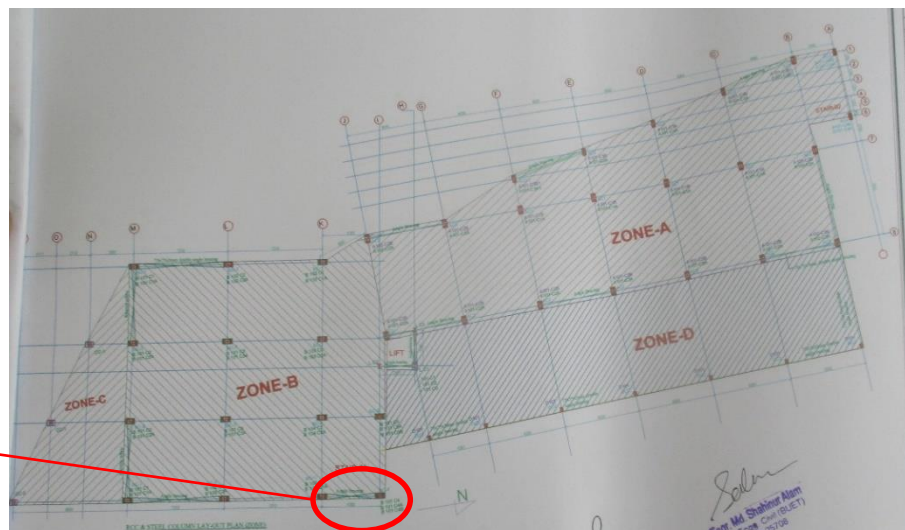
Bracing layout plan

Sectional detail of bracing not found in provided drawings. Bracing is missing at south stair on ground floor.

| Item No. | Observation | Recommended Action Plan | Recommended Timeline |
|---|---|---|---|
| 7 | Bracing were not properly installed at GF | Install missing bracing at mentioned location. | 6-weeks |

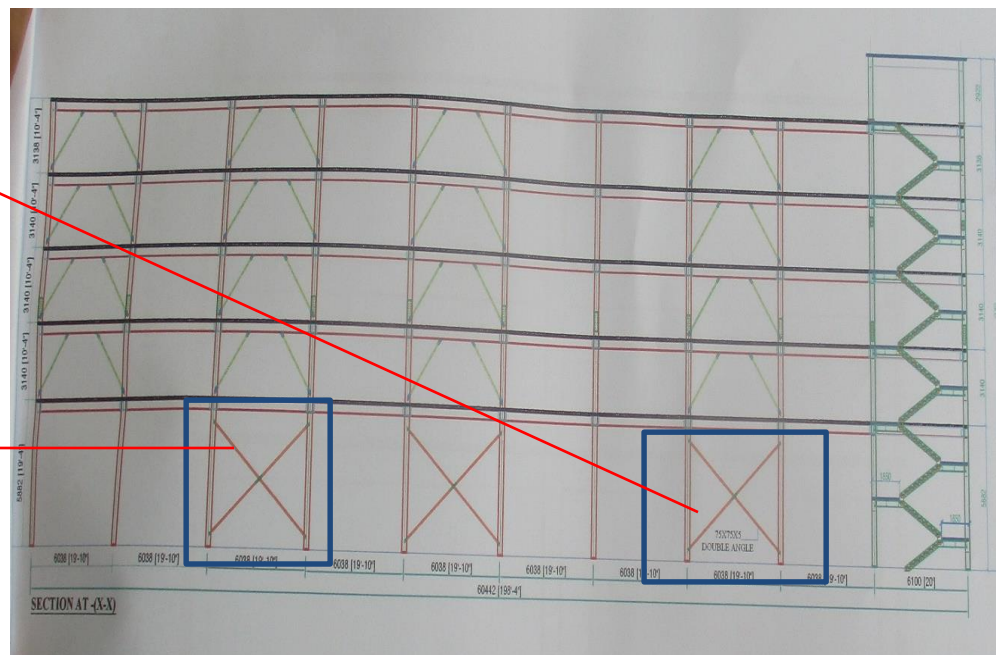
Sectional bracing details

Bracings were not installed properly. Bracing was missing at one direction and a bracing was not continued to the column at GF.
