Billah Resources Ltd (9284)

17/1, Khataldia, Squid Road, Nishad Nagar, Tongi, Gazipur

26.APRIL.2014

ACC RD
on Fire and Building Safety in Bangladesh

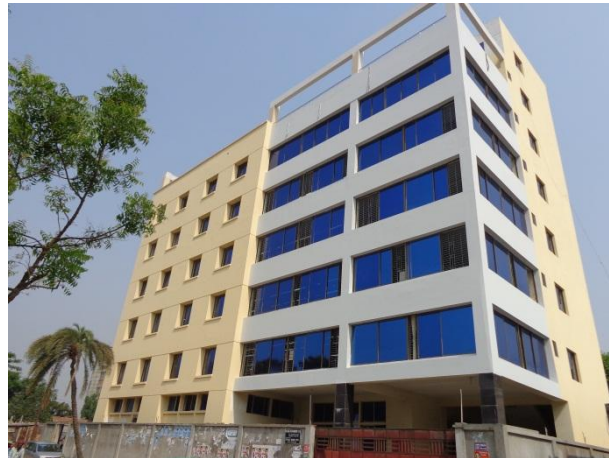
Potentially High Column Stresses and Questionable Reinforcing Quantities in Critical Columns.

Although Ferroskan results were not definitively conclusive, scans indicate a deficiency in the critical column reinforcing (scans show 20 bars, drawings show 24). In addition the column load run-downs indicate higher than desirable stress in the columns in question (G.L. C/7). However, we were provided with Compressive Strength Test results and Mill Test Certificates which indicate favourable material strengths.
