Liz Fashion Industry Limited (10228)

HMN Fashion Ltd (11250)

Holding 1, Block C, Shaheed Mosharaf Hossain Road, Purba Chandora, Sofipur, Kaliakoir,
Gazipur, Bangladesh

07.APRIL.2014

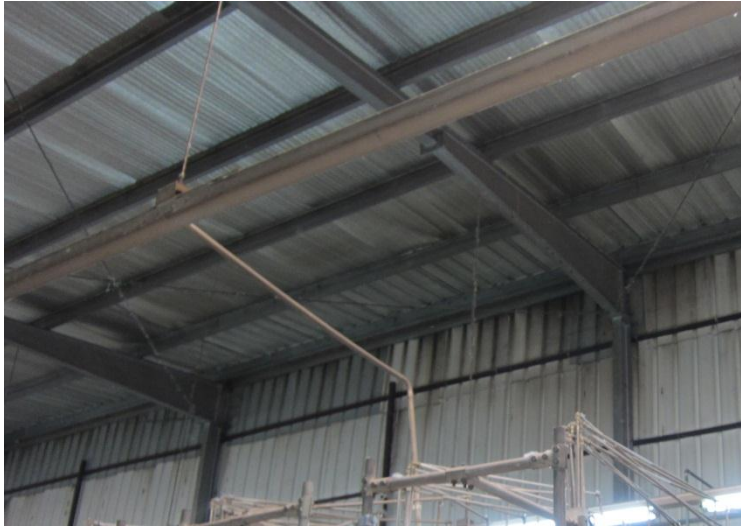
It appears that protective paint is applied to the steelwork elements, however, it is unclear if fire protective paint is also applied or required.

5	Uncontrolled heavy storage loading.	Maintain standards of quality control to ensure that storage procedures are correctly followed so that overloading does not happen in the future. Develop and maintain a loading plan.	6-months
6	No fireproofing material for steel structures.	Fireproofing material for structural steel elements is recommended based on Bangladeshi regulations.	6-weeks
7	No fireproofing material for steel structures.	Maintain standard of quality control.	6-months

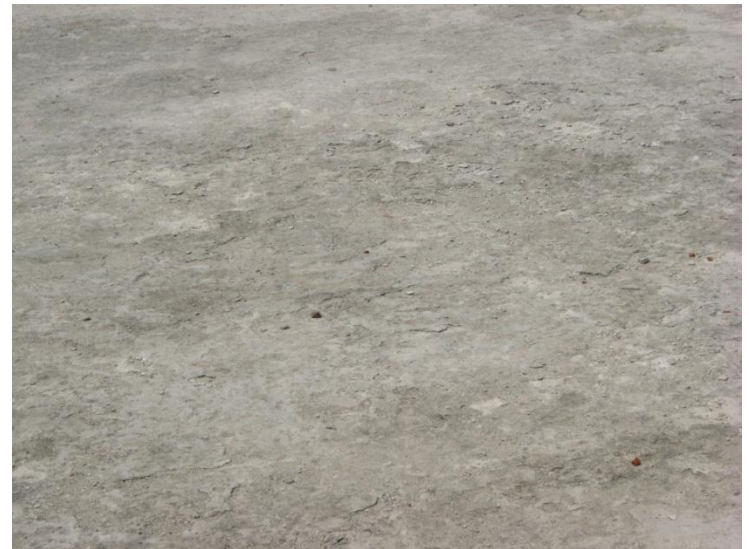
There are cracks on the roof slabs of Liz-1 building. There was no noted distresses due to water ingress but it is unclear if waterproofing material is present.

12	No movement joint properly established.	Do not construct any further buildings connected to the existing factory, without thorough structural design and full building approval.	6-months
13	No waterproofing material noted at any roof level.	For both durability and serviceability, waterproofing on the roof slab is recommended. Moreover the roof slab drainage system should be investigated.	6-months

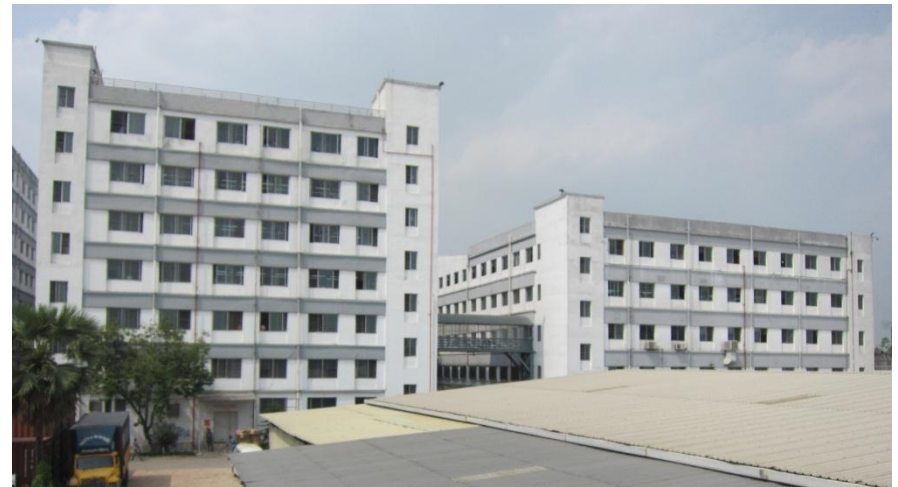
Overall Stability System

Concerns on the stability system for lateral loading and seismic loading. Façade brickwork walls lack moment capacity connection between columns and beams.

We require that these concerns be investigated as part of a Detailed Engineering Assessment

Item No.	Observation	Recommended Action Plan	Recommended Timeline
8	Overall stability system / moment frame capacity.	A Detailed Engineering Assessment of all of the buildings is to be carried out and in particular, stability and foundation aspects should be investigated in detail.	6-weeks
9	Adequacy of columns to support loading.	Factory Engineer to review design, loads and columns stresses Verify in-situ concrete stresses either by cores or existing cylinder strength data for [the identified columns / cores from 4 columns].	6-weeks
10	Adequacy of columns to support loading.	Produce and actively manage a loading plan for all floor plates within the factory giving consideration to floor capacity and column capacity.	6-months
11	No movement joint properly established.	The Factory Building's Structural Engineer should carry out a Detailed Engineering Assessment to prove the capacity of the building in its existing state, a further building approval should be gained for the building as it exists, as altered since the original approval. Alternatively, the extension building should be separated by a non-structural joint and allowed to act as a fully structurally independent structure.	6-weeks
