# Shovon Knitwear Ltd. (10922)

West Masdair, Fatullah, Narayanganj

27.APRIL.2014

## Identified Priority 2 Concerns

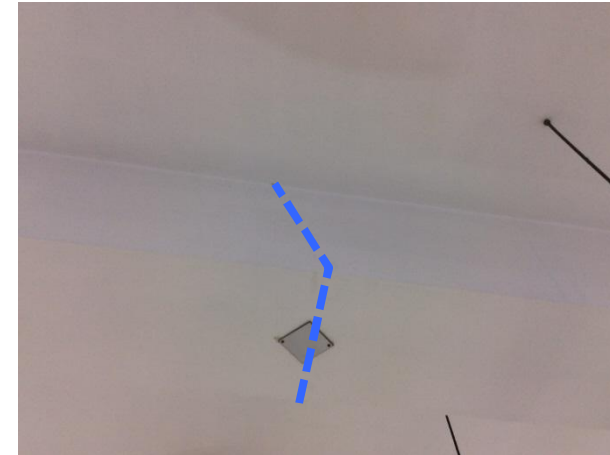
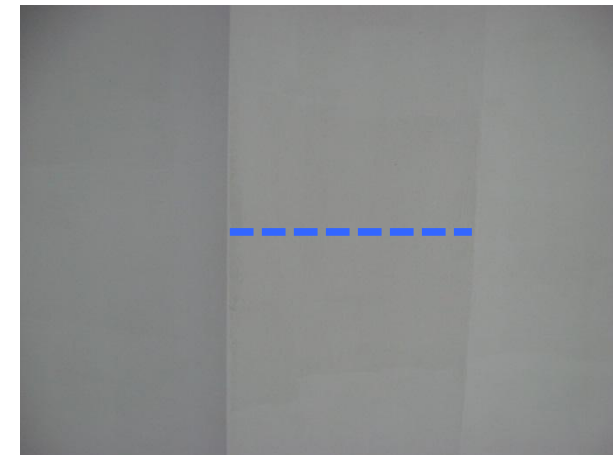
Cracks on 4<sup>th</sup> floor beam.

Several cracks found on 4<sup>th</sup> floor beams spanning approx. 8.50m. We were informed that structural elements in this building were covered with plasterwork. It is not clear if these cracks are structural. They should be investigated further.

- The Factory Engineer to investigate the cause of cracks by appropriate methods.
- The distress found is to be suitably rectified and then repaired.

- Create loading plans for each floor level.
- Maintain standards of quality control to ensure that loading plan is correctly followed so that problems do not arise in the future.
- Maintain and enforce the loading plans.

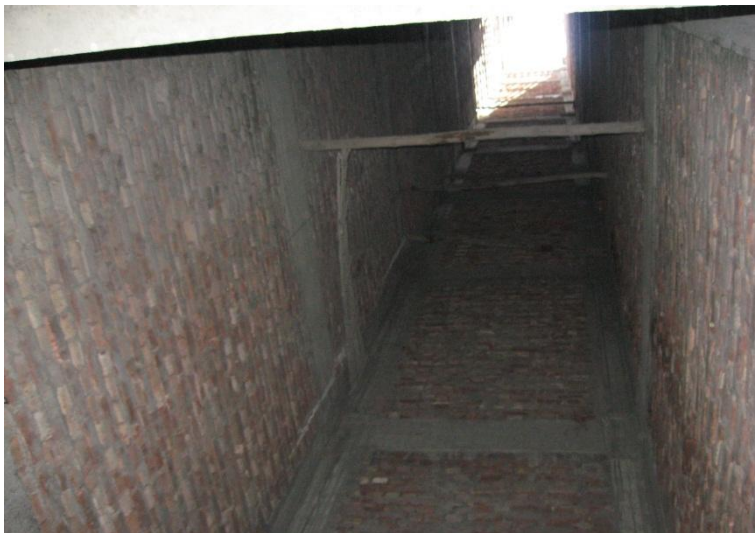
Overall stability system / moment frame capacity

It is appeared that the original Engineer was aware of lateral loads. However, there is no evidence that a lateral stability system had been used. Therefore, we require that these items are investigated as part of a Detailed Engineering Assessment .

- Request that the Detailed Engineering Assessment of overall building to be carried out again with the actual built conditions.
