# Sinha Knit Industries Ltd. (10184)

Chamurkhan, P.O - Uttarkhan, P.S – Uttara, Dhaka, Bangladesh.

29.APRIL.2014

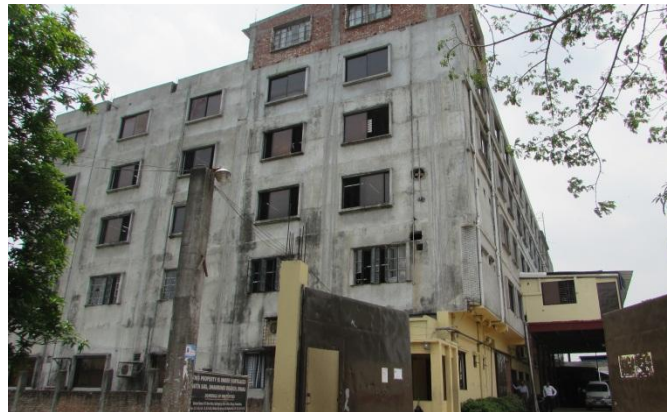
These columns (300x380 mm ) on the 2<sup>nd</sup> grid line have been checked for their loading capacity.

Based on the structural design and the Ferro-scan results, the column reinforcement in some columns appears to be inconsistent with the rebar arrangement at the ground level. According to the load rundown calculation, typical columns have been found to possess marginal loading capacity, thus attaining an 'AMBER' warning.

Column possesses low factor of safety
