# Prime Sweater Ltd.

Naibari, Pubail, Gazipur.  
(23.933718N, 90.450326E)

26<sup>th</sup> November 2017

# Observations

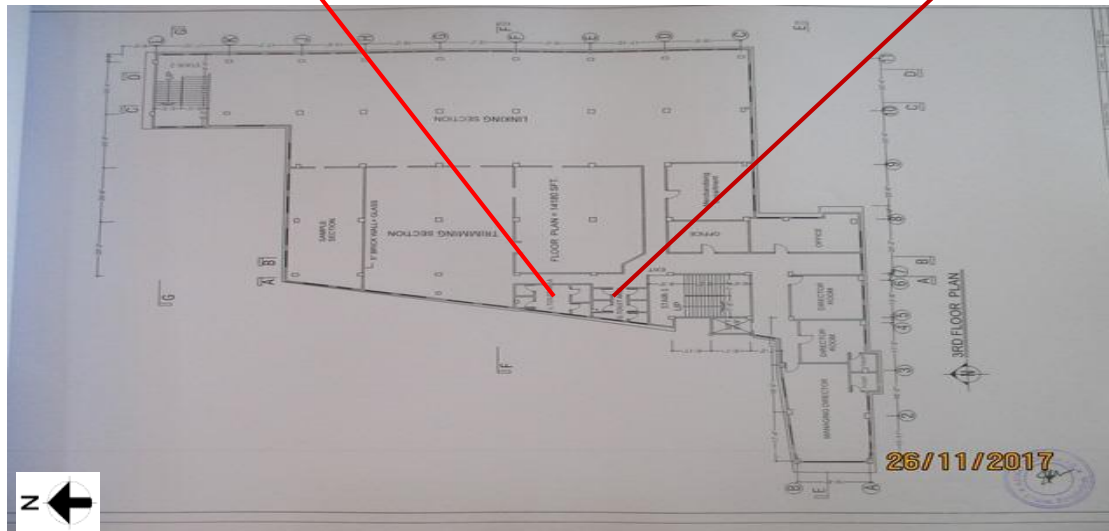
Typical floor Layout

**High stress level in columns that require immediate review**

Cursory calculations indicate that the column stress are exceed normal design limit. A Detail engineering assessment must carried out immediately.

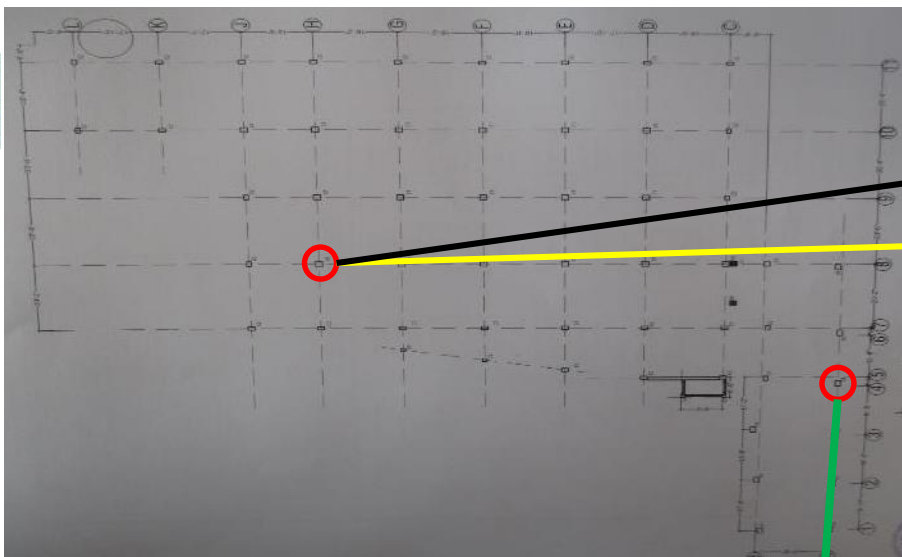
Column layout

Stone aggregate was found in basement floor column but in 1<sup>st</sup> floor column, brick aggregate was found. Moreover, mixture of stone and brick aggregates were found in ground floor column. Whereas, stone aggregate was mentioned in all provided reports of compressive strength test. For this reason, except basement column cores test result were not considered in cursory calculation.

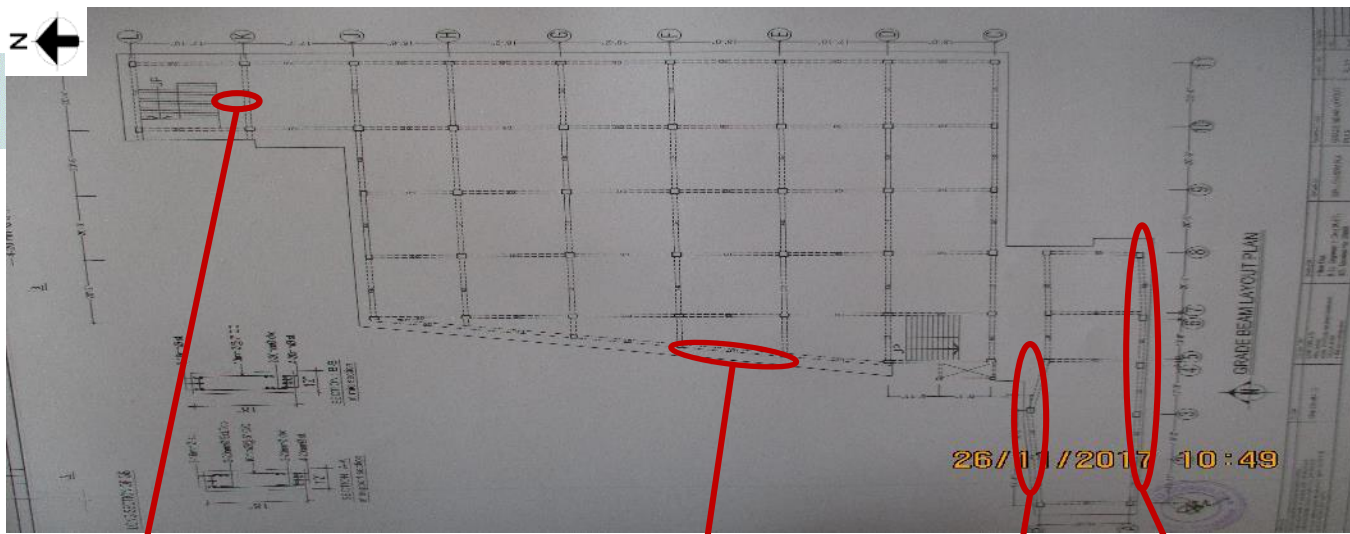
Provided Column Layout

Marked Beam size found 300mm x 400mm at  
1<sup>st</sup> floor which are denoted as B2 (300mm x  
450mm) type beam in beam layout

| Item No. | Observation | Recommended Action Plan | Recommended Timeline |
|---|---|---|---|
| 10 | Discrepancies between provided drawing and on site condition | Building Engineer required to prepare As –Built drawings reflecting the on site condition. | 6-weeks |

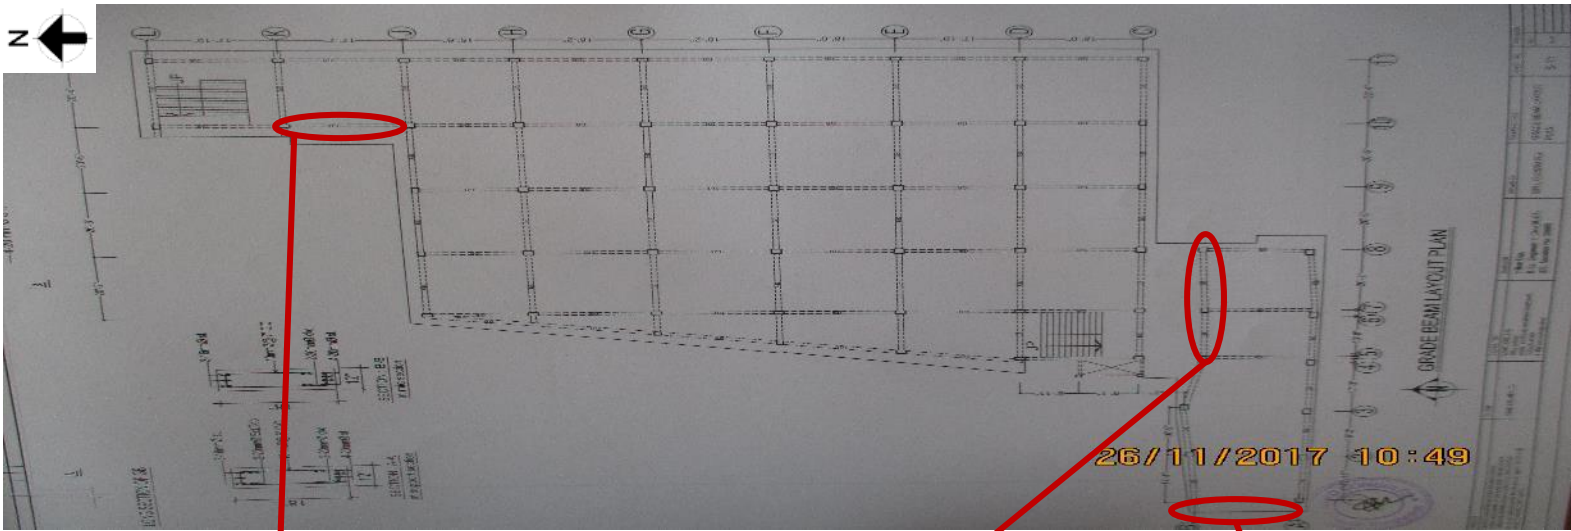
Provided Column Layout

Marked Beams were missing in 1<sup>st</sup> floor which are denoted as B2 type beam in beam layout
