# Fiat Fashion Ltd

878,879 Sharifpur, Gazipur Sadar, Gazipur, Dhaka  
(+ 23.966146 N, 90.37799 E)

07 November 2013

# Building Observations

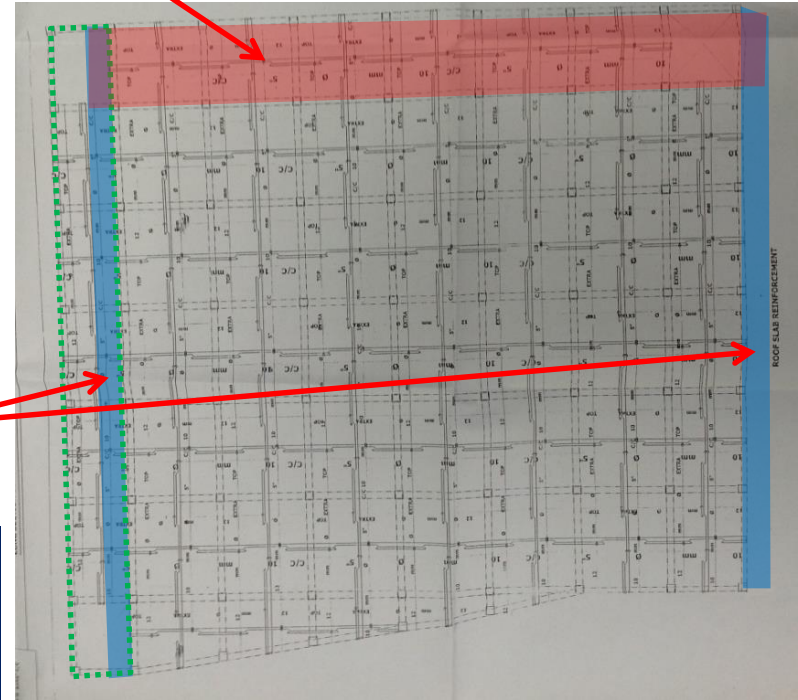
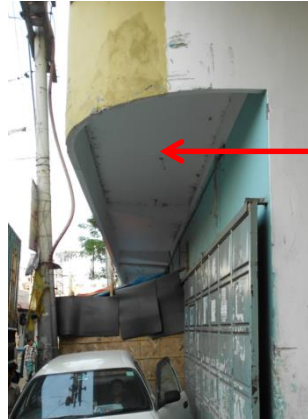
As built drawings

No downstand beams in this area. This is not reflected on the drawings

2m cantilever is not shown on drawings

Current structural drawings do not match the as built conditions – accurate as built drawings are required

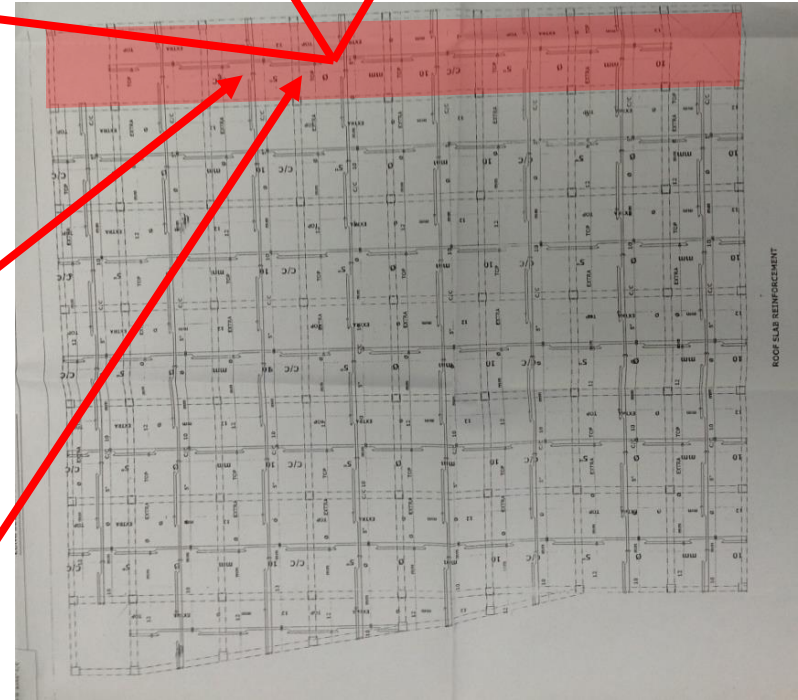
Heavy additional loads due to 500mm raised floor on 1<sup>st</sup> floor office area

As built condition shows no beam at this location (Drawings assume beams at in all bays)

Check on slab design required

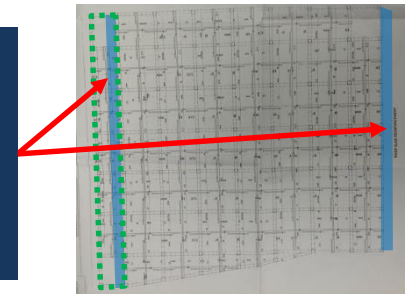
## Load Management

**Cantilever slabs are not part of the existing design drawings**

**Engineer to produce loading plans based on as built conditions. Load management set in place.**

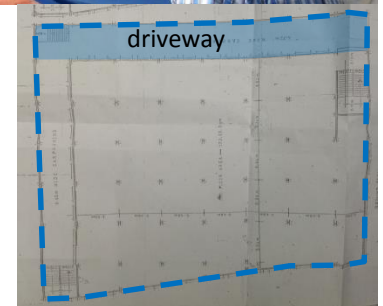
## Loading

Fabric bag  
pile loading  
perimeter  
columns

Do not store loads against wall  
and columns, on either side of  
the wall
