Knit Asia Limited

East Narshingapur, Ashulia, Savar
(+23.930205N, 90.309940E)

01 October 2013

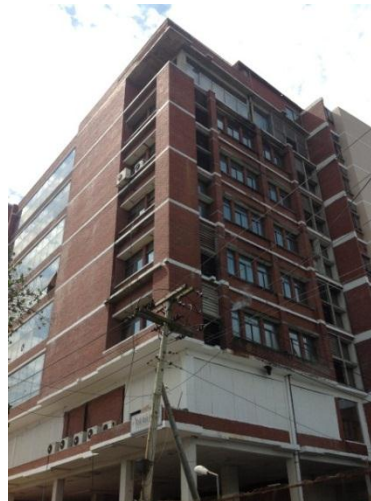
Boilers compressors located on Ground Floor slab (suspended over water tank)

Engineer is to perform detailed calculations to prove slab thickness and (if required) :

- Reduce loads by removing machinery
- Reinforce slab
