# Padma Satel Arab Fashions Ltd. P & K Fashion Ltd. Luna Fashion Ltd.

Luna Complex, Joybangla road, Borobari, Gazipur, Dhaka

29<sup>th</sup> June 2014

# Observations

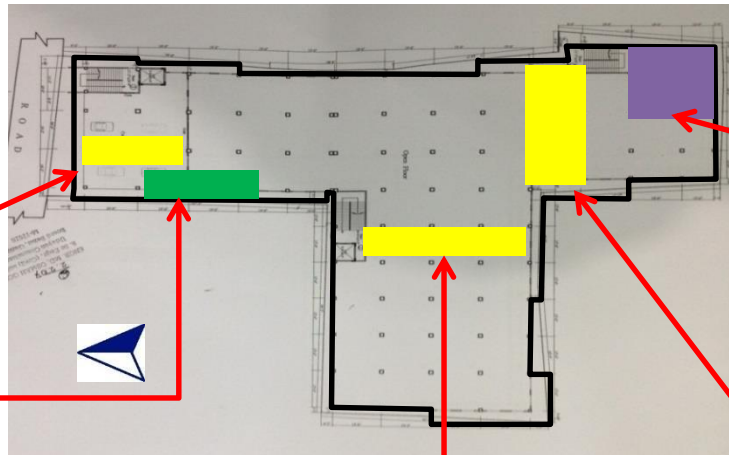
Typical Floor Plan

# Localized areas of high loading

Areas of high loading on structure including cantilevers. No load management plan available for the building.

Item No.	Observation	Recommended Action Plan	Recommended Timeline
8	No floor load management plan	Produce and actively manage a loading plan for all floor plates within the factory giving consideration to floor capacity and column capacity (refer to Item 1).	6-weeks
9	No floor load management plan	Continue to implement load management plan.	6-months
10	Apparently non-engineered steel fire escape stairs on southern elevation of the EW building	Building engineer to review capacity of steel stair giving consideration to overall stability, section sizes used, stair bearing details and quality of fabrication	6-weeks
11	Apparently non-engineered steel fire escape stairs on southern elevation of the EW building	Building engineer to propose an necessary alterations/strengthening works	6-weeks
12	Apparently non-engineered steel fire escape stairs on southern elevation of the EW building	Ensure any necessary remedial works as advised by the Building Engineer are undertaken.	6-months

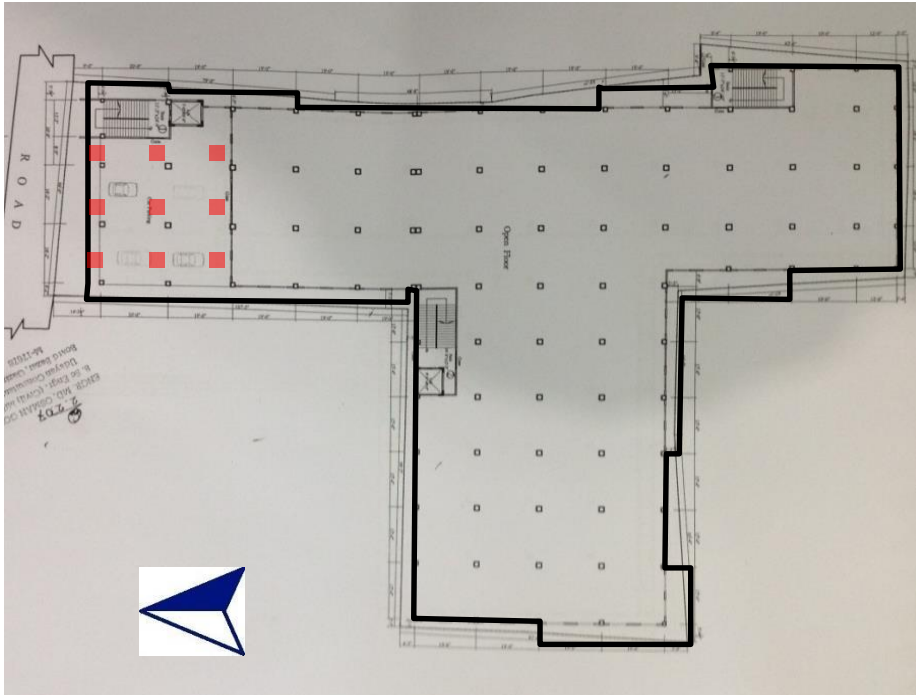
Typical floor Layout

# Column protection at ground floor delivery area

The ground floor columns in the parking/delivery area were partially surrounded by a metal angle frame. These frames appeared light and may provide little protection to the column if struck by a vehicle.

Ground floor columns with steel angle protections
