# Parkview Dresses Ltd. (9902)

30/2, Darail Sataish, Gazipura, Gazipur .

19.AUGUST.2014

# Identified Priority 3 Concerns

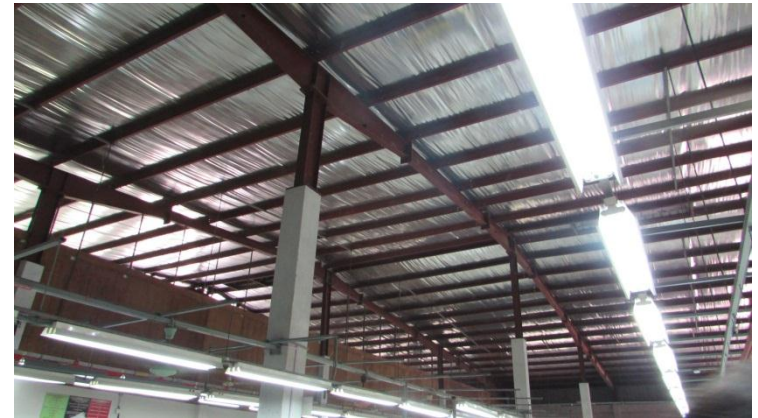
Foundation and Column Layout Plan

Shed building

The number of columns shown on the drawing does not match what is on site.

The As-built drawings need to be updated and supplemented where necessary to more accurately reflect the actual existing construction.
