# Sabarang Fashions Ltd. (9709)

Plot – 85, 86, Block – K, Rupnagar I/A., Section 2, Mirpur, Dhaka-1216

18.AUGUST.2014

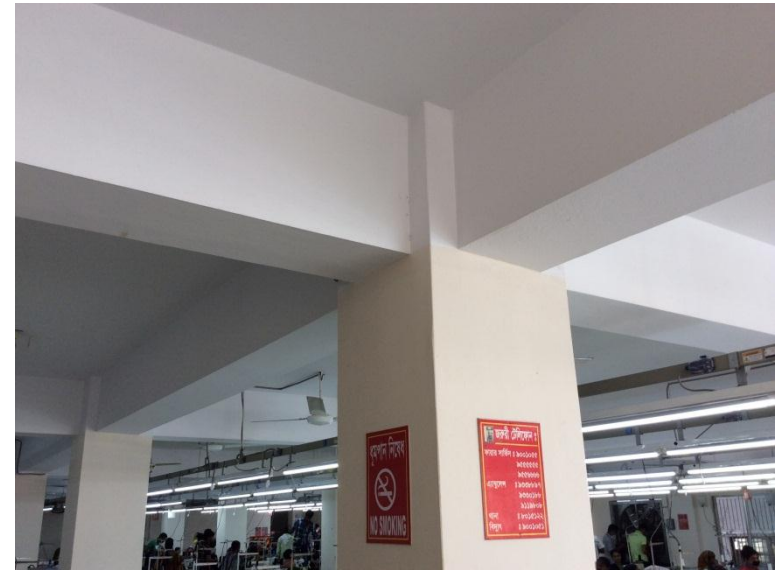
The lateral loading resistance for this 6-storey building is provided by moment frame action without any shear walls and the façade brickwork walls lack moment capacity due to their poor connections with the surrounding columns and beams.

We require that the stability of this building is investigated as part of an Engineering Assessment.

| Item No. | Observation | Recommended Action Plan | Recommended Timeline |
|---|---|---|---|
| 4 | Priority 2 - Overall stability system. | An Engineering Assessment of the overall building to be carried out and in particular, stability and foundation aspects should be investigated in detail. | 6-weeks |
