# Tusuka Trousers & Jeans Ltd

5 February 2014

# **Building Observations Jeans Building**

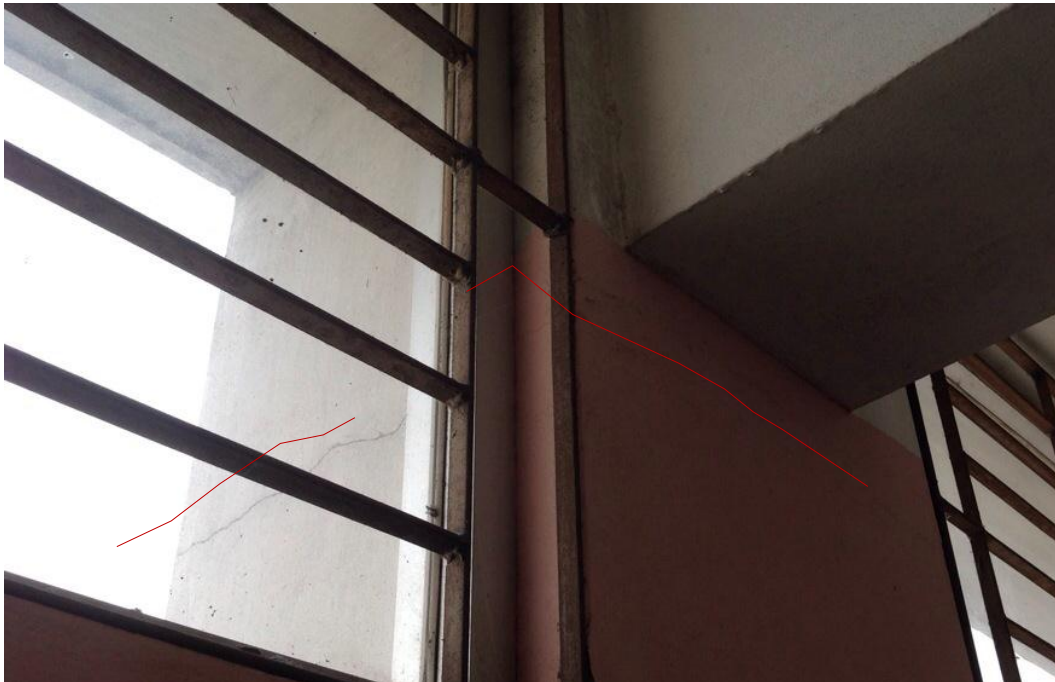
Many of these brick piers from 1<sup>st</sup> floor upwards are cracked at the line of the interface between concrete beams and the pier.

Horizontal Crack around  
brick pier. This example  
was taken on the 6<sup>th</sup> floor.

The Building Engineer  
should review and ensure  
that these piers are stable  
without support from the  
concrete structure above.
