# MZM (CEPZ) Ltd. (11782)

Plot # 8-9, Sector # 2/A, CEPZ, Chittagong-4223

30.August.2014

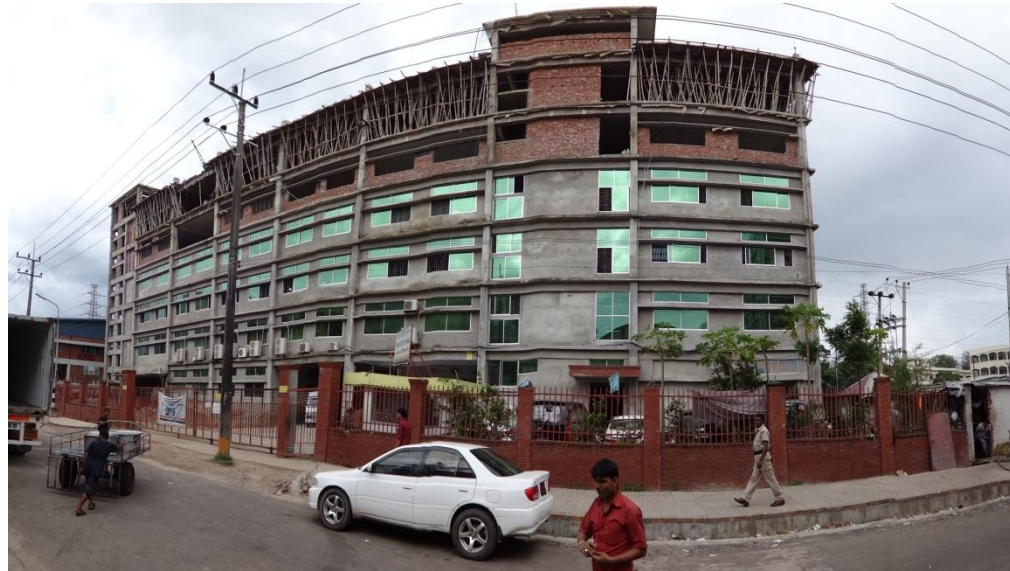
High column stresses to all internal column. The factor of safety was found to be between 1.25 & 1.5 for C2 columns and between 1.86 & 1.5 for C1 columns by calculation based on existing loadings.

| Item No. | Observation | Recommended Action Plan | Recommended Timeline |
|---|---|---|---|
| 3 | Priority 1 - High column stresses to all internal columns. | Carry out the recommendations highlighted in the Detailed Engineering Assessment. | 6-months |
