# Interstoff Apparels Ltd. (9493)

Chandra, Kaliakor, Gazipur

29.April.2014

ACCORD  
on Fire and Building Safety in Bangladesh

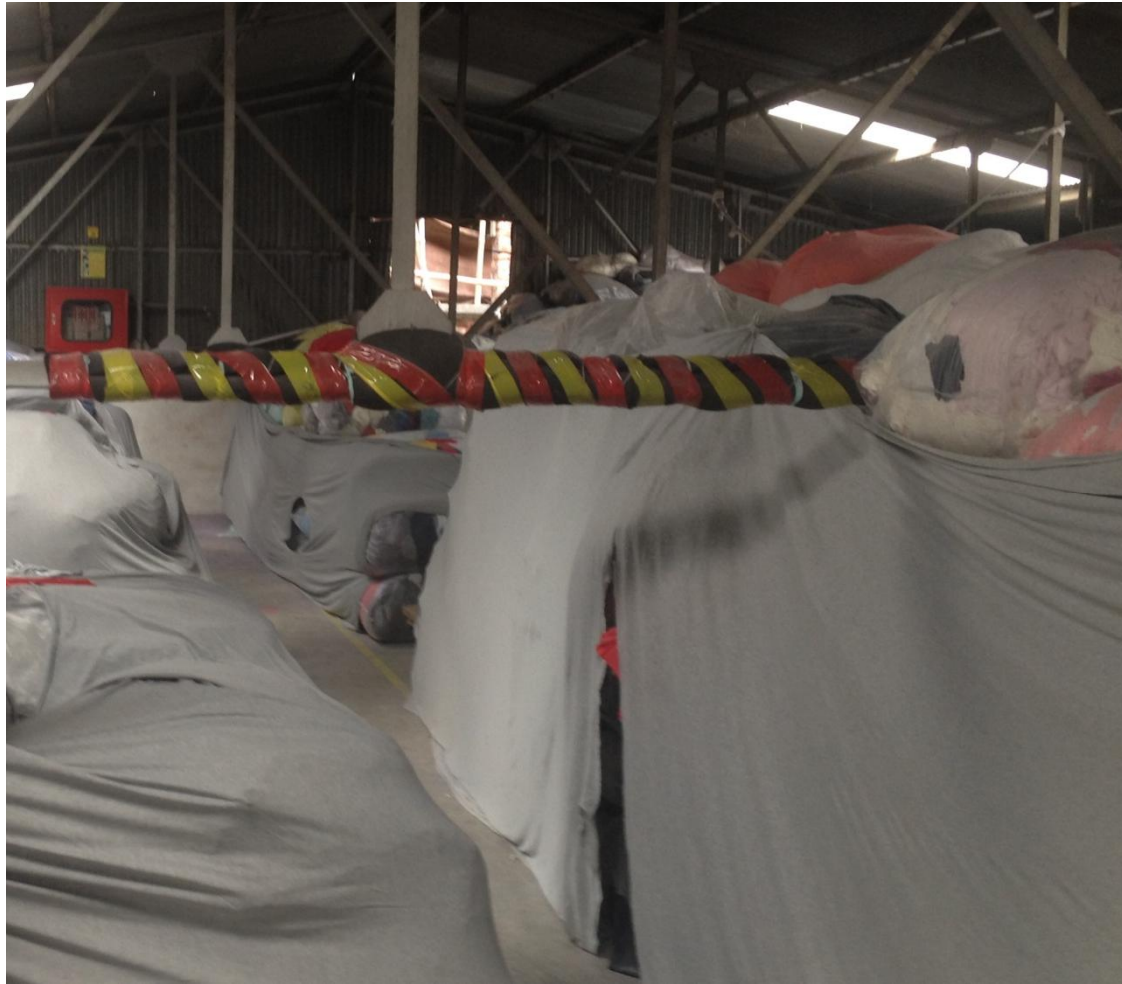
### 1<sup>st</sup> Priority 1 – Major concern

The Dining Area, Building 6. is a single storey building with a steel roof and an improvised steel mezzanine heavily loaded. No construction documents were provided for the mezzanine. The mezzanine showed advanced signs of instability and distress. The Director was advised to evacuate the area and reduce the loading.

At the closing meeting, the Director said the mezzanine would be dismantled.

Upon our departure, most of the storage was outside and being shipped off to another facility.

Building 6. Dangerous mezzanine in dining area with inadequate steel elements.

- Dangerous mezzanine in dining area with inadequate steel elements.
- Mezzanine to be dismantled immediately.
