# S.Suhi Industrial Park Ltd. (New Building)

Hazi Liakat Mir Sarak, Zamgora, Savar.

4<sup>th</sup> February 2018

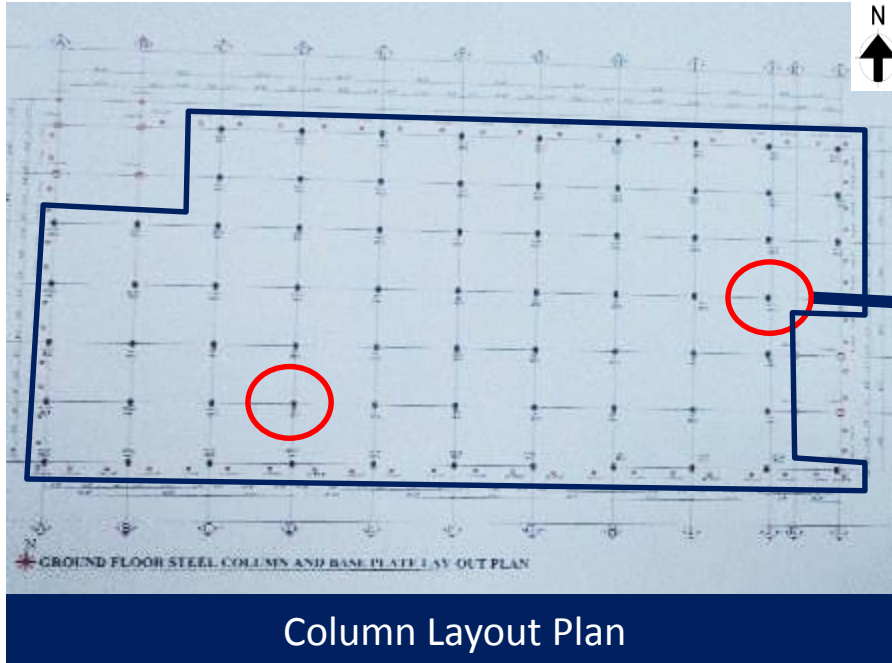
Column Layout Plan

# **Discrepancy observed between provided drawing & on-site condition**

Depth of web was observed 315 mm instead of 325 mm

During inspection, Steel section of the highlighted columns were found undersized at ground floor and 1<sup>st</sup> floor level.

| Item No. | Observation | Recommended Action Plan | Recommended Timeline |
|---|---|---|---|
| 5 | (Sweater Building)<br>Discrepancies between provided drawings and on site condition | Building Engineer to survey as-built structure and prepare accurate as-built survey information for the building | 6-weeks |

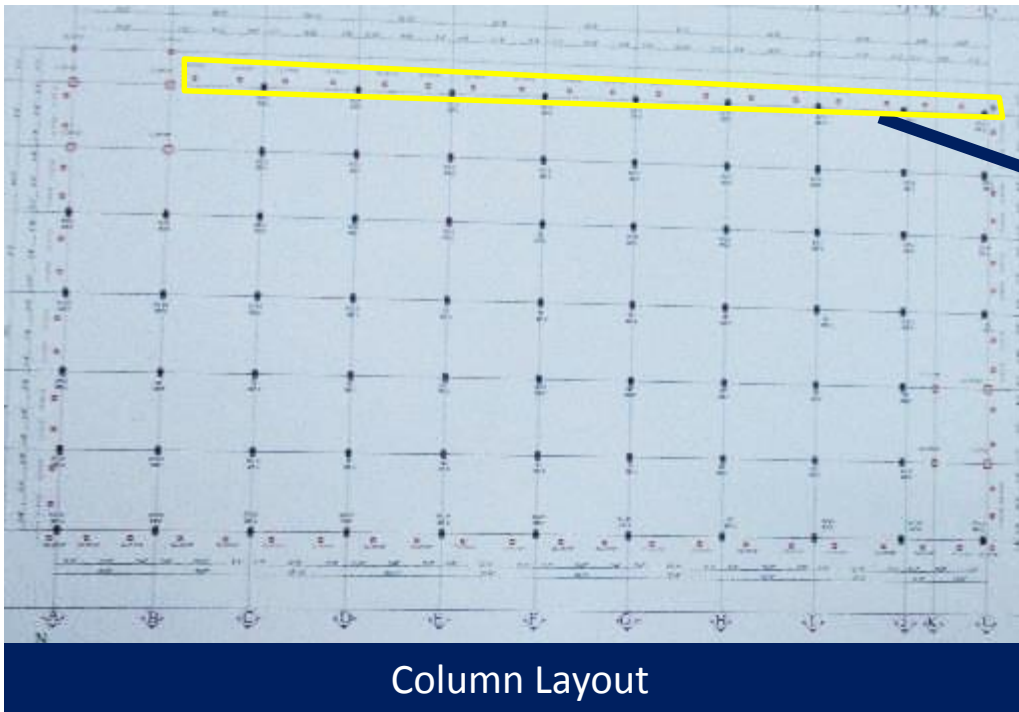
Column Layout

In drawing, RCC columns were mentioned on ground floor for the highlighted portion. But Brick columns were observed on site.

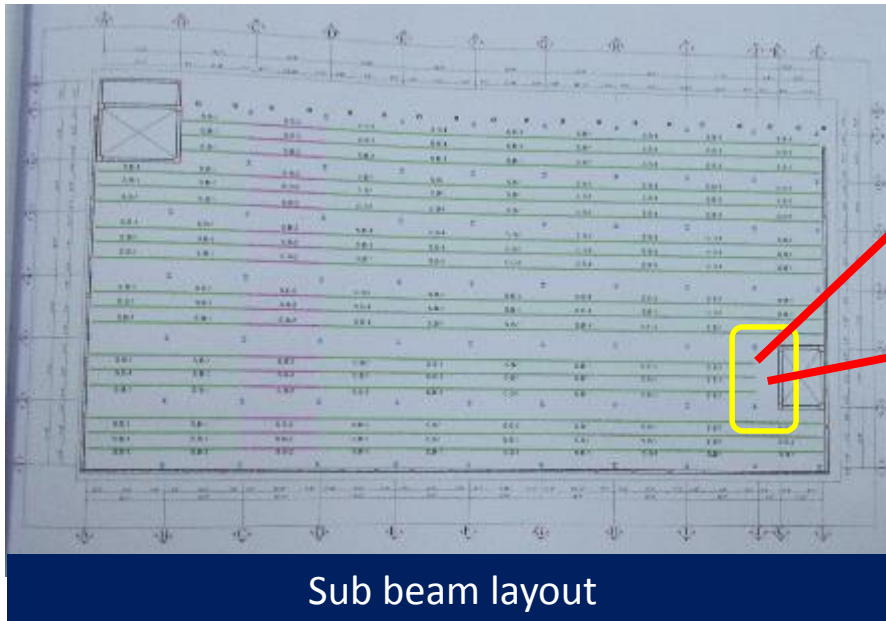
Sub beam layout

Almost 5 feet width deck slab found near Eastside stair without sub-beam on 1<sup>st</sup>, 2<sup>nd</sup> and 3<sup>rd</sup> floor. Factory engineer is required to confirm that deck has adequate capacity to take the floor load otherwise provide additional beams.

Deck without sub-beam

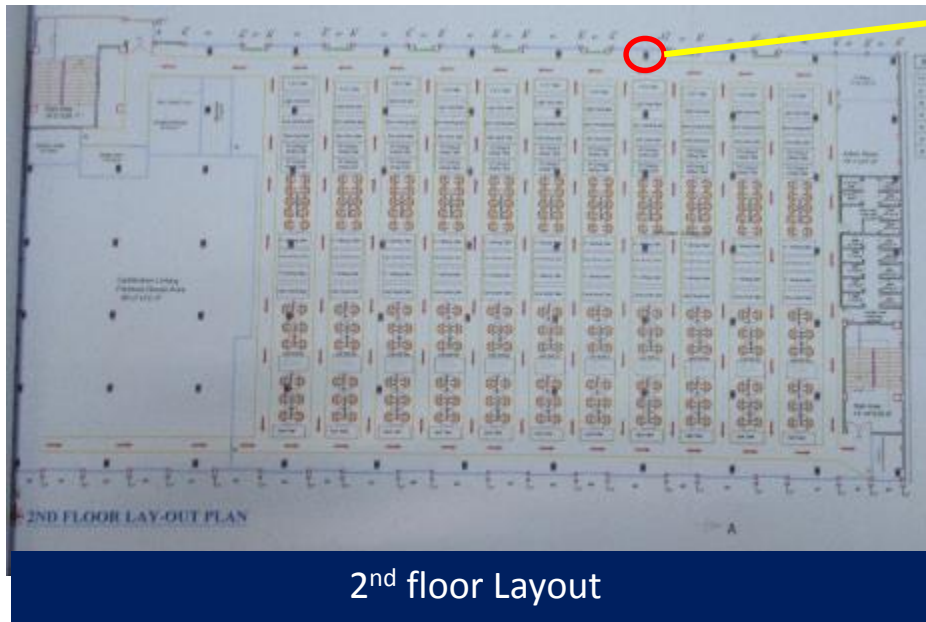
2<sup>nd</sup> floor Layout

A distorted steel column found on 2<sup>nd</sup> & 3<sup>rd</sup> floor of the main production building. Stability for the distorted columns and related elements need to be checked. Factory Engineer to review design, loads and column stress in the area identified above.

Distorted column

| Item No. | Observation | Recommended Action Plan | Recommended Timeline |
|---|---|---|---|
| 7 | (Sweater Building)<br>Distorted column | Building Engineer to review design of distorted steel column taking into account the as-built condition of the column. | 6-weeks |

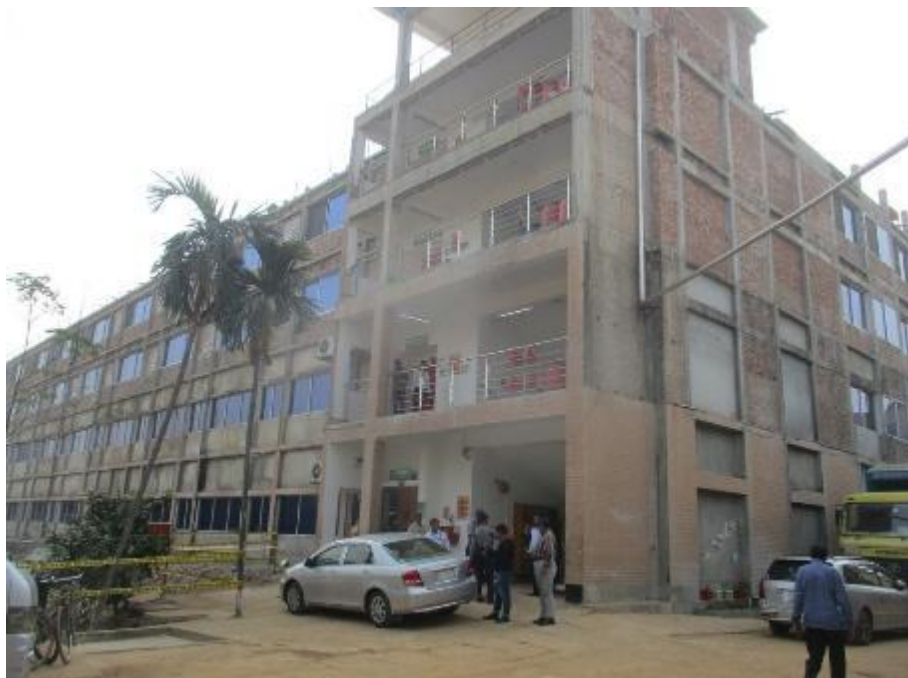
Elevation

Currently the building is 4 storied. There is a possibility of one storey extension in future. Factory engineer is required to carried out a Detail Engineering Assessment considering BNBC provision prior to commencement of any extension work.
