PNG (BD) LTD

Korerhat, Shattaroa, Jorargonj, Mirsharai, Chittagong, Bangladesh

9th January, 2018

Observations

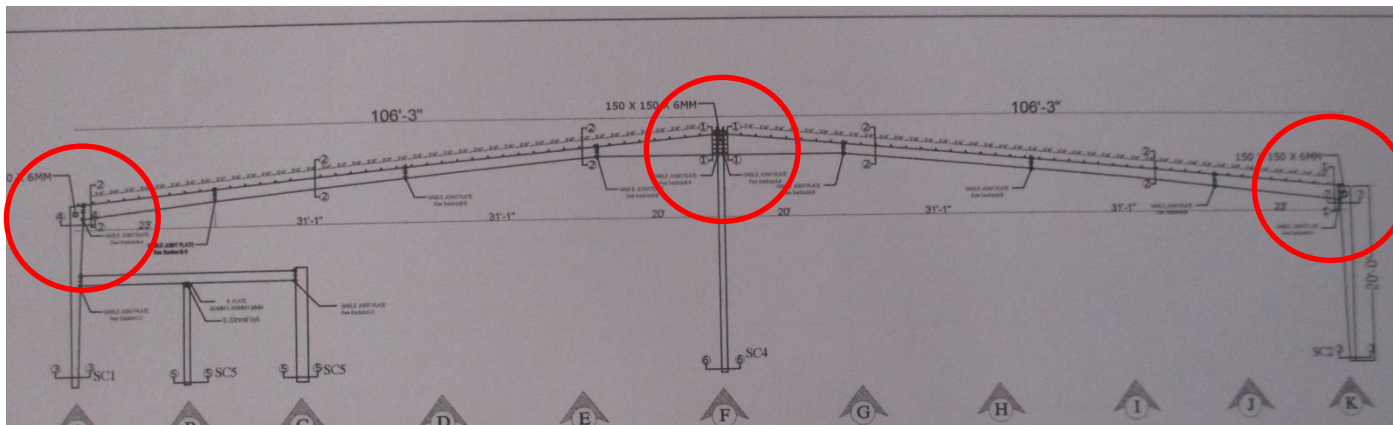
Frame sectional drawing

Vertical bracings and struts members are part of lateral stability system. Vertical bracings and strut member at eave points were not installed as per drawing. Building engineer is required to check the lateral stability of the shed considering lateral forces as per BNBC provision.

Item No.	Observation	Recommended Action Plan	Recommended Timeline
1	Lateral stability of Main Production Shed. (Shed#1 - Main Production Shed)	Factory engineer need to check stability system against lateral load and install bracing where required as per calculation.	6-weeks
2	Lateral stability of Main Production Shed. (Shed#1 - Main Production Shed)	Carry out remedial works where necessary.	6-months
3	Significant gaps and missing bolts at several connections. (Shed#1 - Main Production Shed)	Identify all the location and carryout suitable repair works where necessary.	6-weeks
4	Mismatched in as built drawings. (Shed#1 - Main Production Shed)	Building Engineer to survey as-built structure and prepare accurate as-built survey information with connection details for the building.	6-weeks
5	Lateral Stability of Finishing Shed. (Shed#2 – Finishing Shed)	Factory engineer need to check stability system against lateral load and install bracing where required as per calculation.	6-weeks

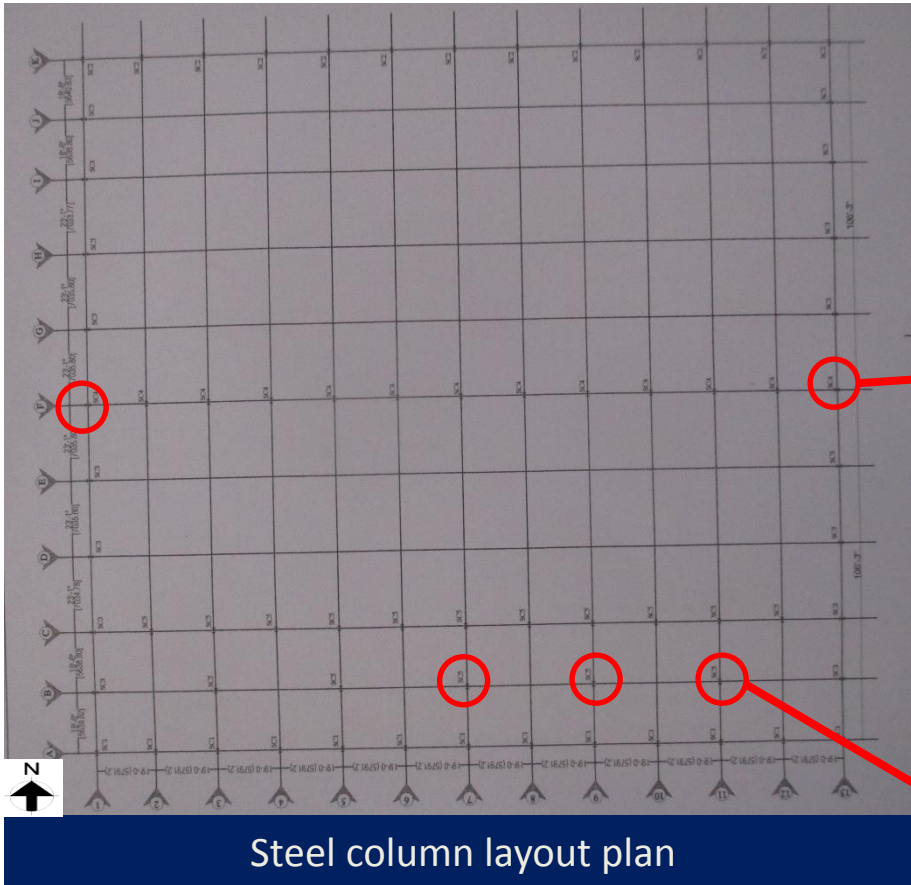
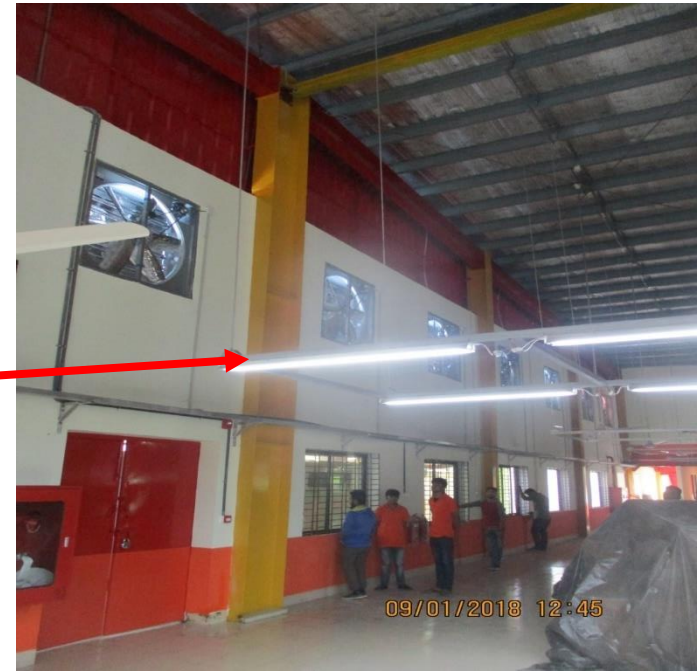
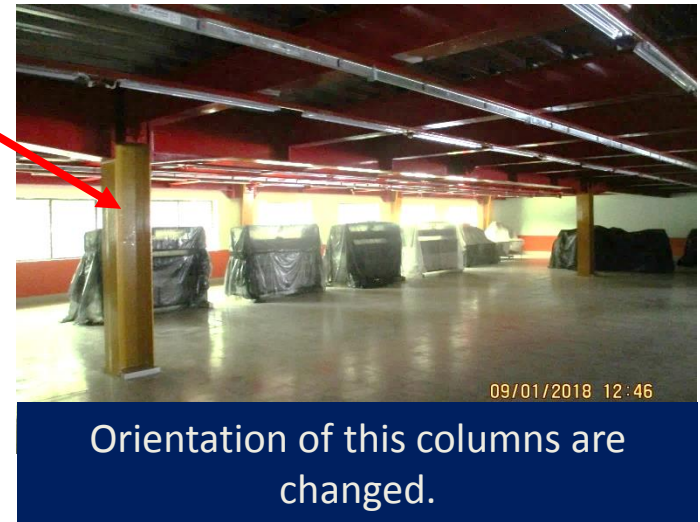
Column extended up to rafter with pin head not shown on drawing.

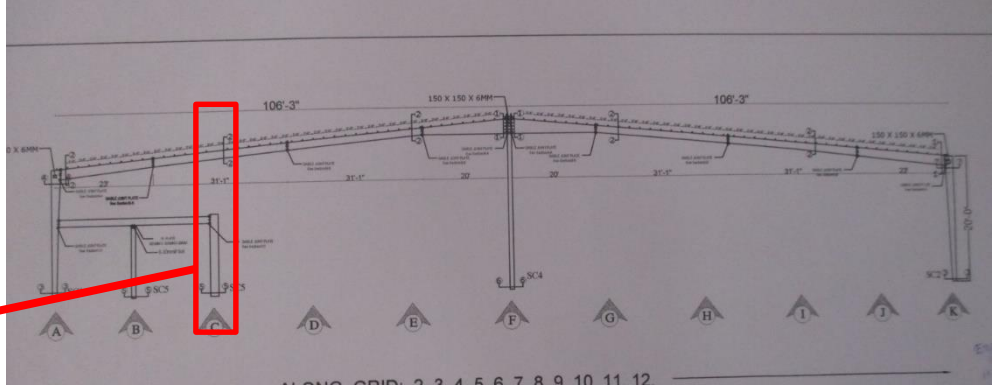
Section drawing

Connection of end frames are moment connection as per drawing. Onsite pin connection observed.

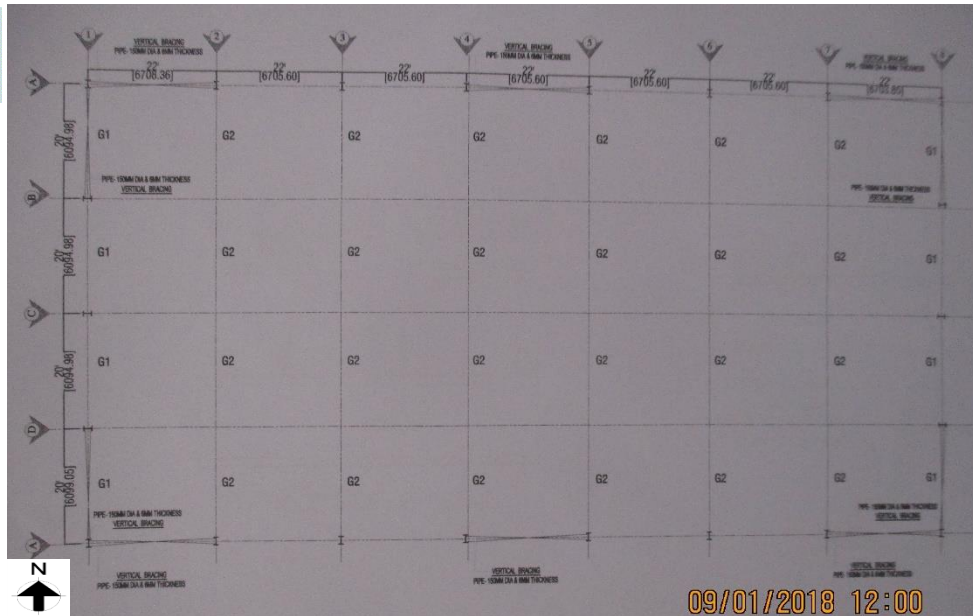
Vertical bracing layout

Vertical bracings have designed as stability system against lateral loading. On site no vertical bracings were installed.

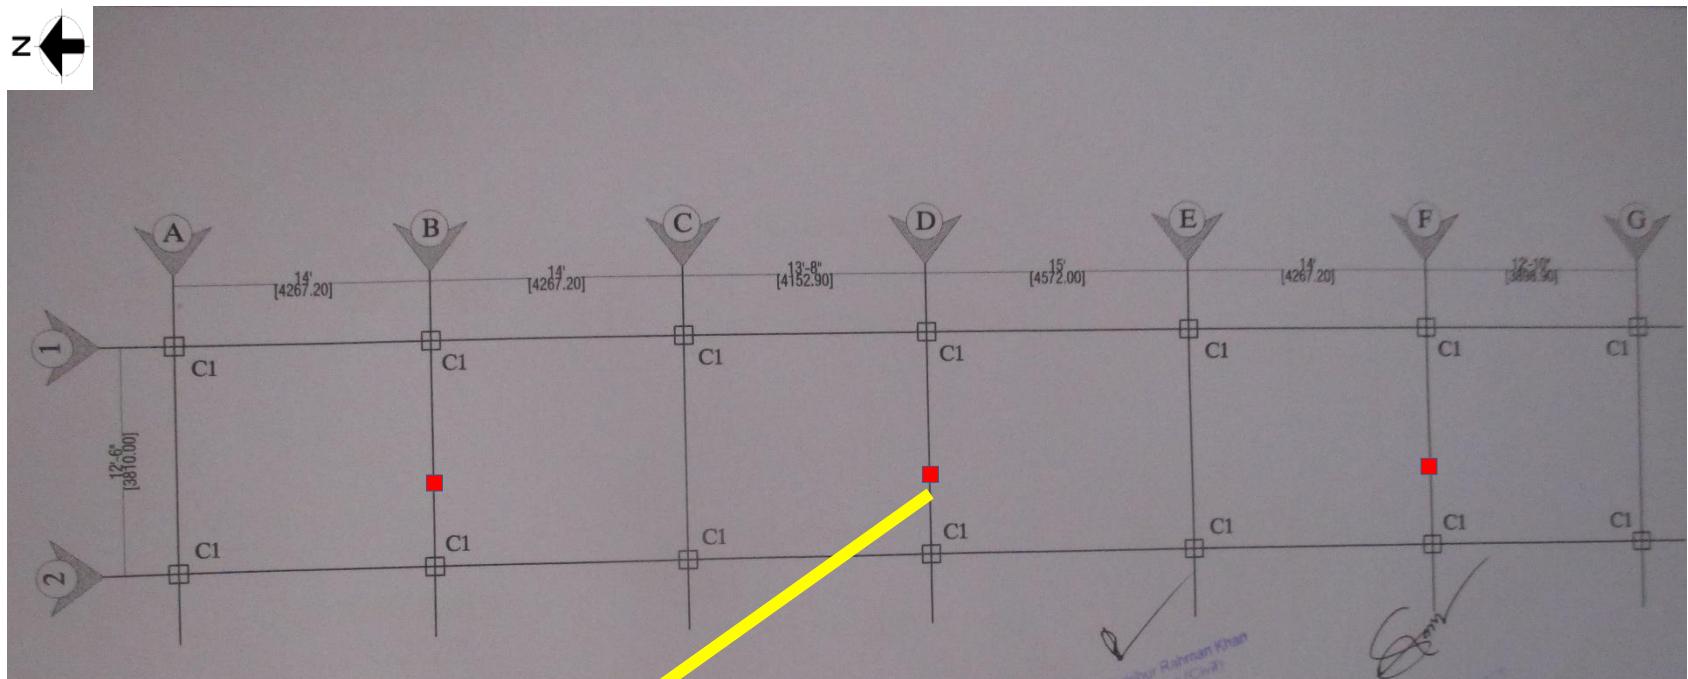
Column Layout

Column layout, number of rebar in column and grid dimension did not match with drawings. Red marked columns are not shown in drawings. 8 nos. of rebar were found in each column instead of 10. on drawings.

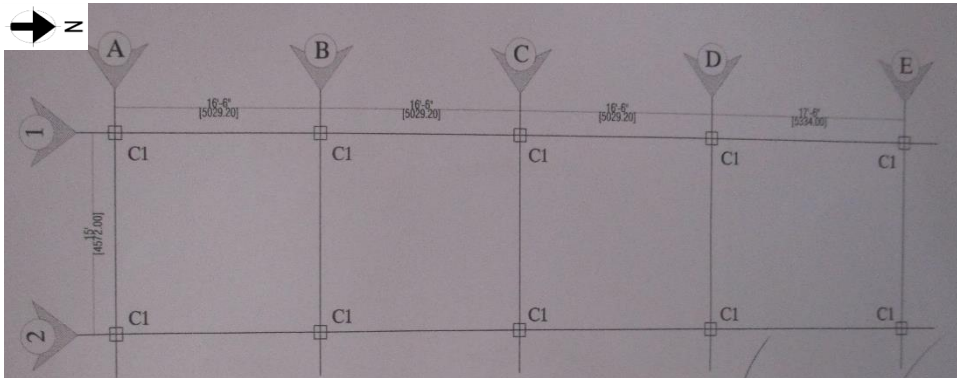
Column Layout

Nos of rebar in column and grid dimension did not match with provided drawings. 6 nos. of rebar were found by Ferro scanning in each column instead of 10.

Slab layout did not match with drawing. At west extended portions are not shown in drawing. Also, beam slab are shown in drawings whereas flat slab was found.

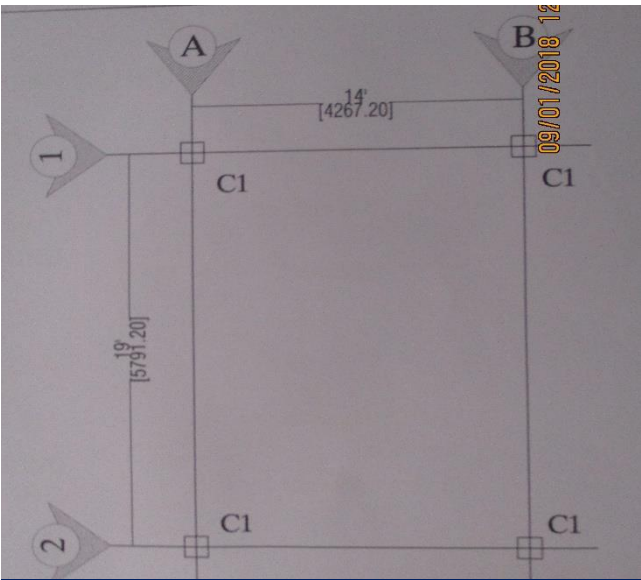
Column Layout of Prayer Building

Orientation of column and grid dimension did not match with drawing. Also no over head RC water tank details were found.
