# Southeast Sweaters Ltd. (New)

278/A, Mehernagar, Dobadia, Uttarkhan, Dhaka.

19<sup>th</sup> February 2018

# Observation

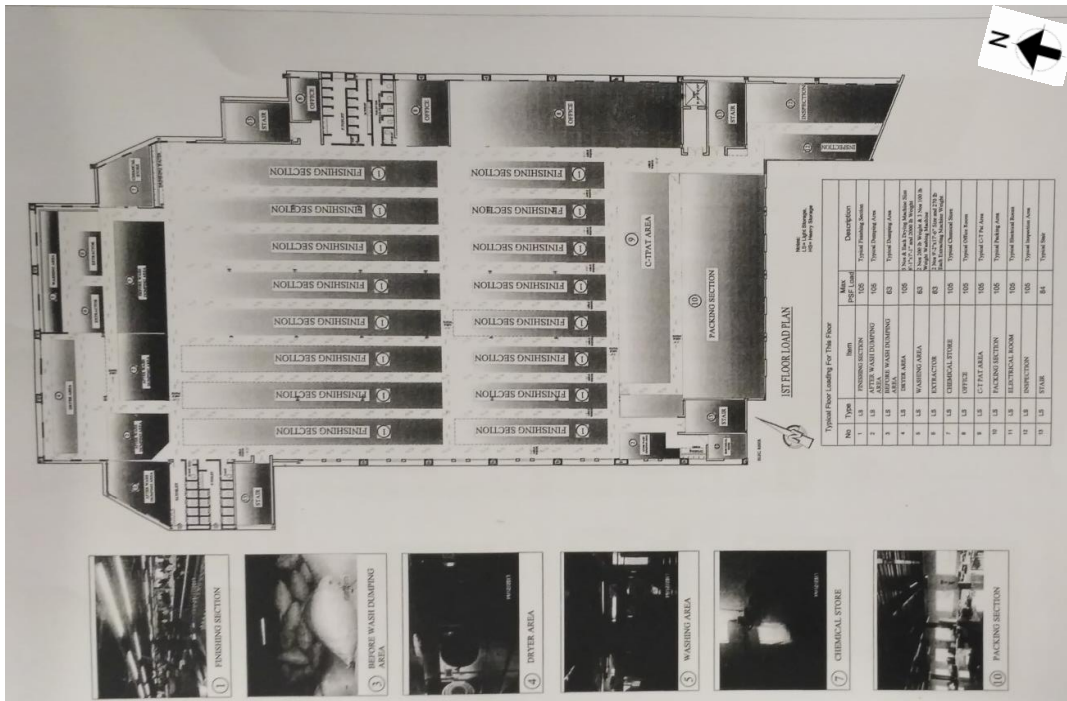
Load was measured below 2Kpa on every floor and FOS calculation for internal column was found satisfactory considering 3kPa allowable floor live loading.

Factory engineer prepared a load plan for 1<sup>st</sup> to 3<sup>rd</sup> floor considering 5 kPa as allowable load and 3Kpa for 4<sup>th</sup> floor dining area. Factory is required to verify the load plan by ACCORD if factory management intends to maintain the load plan.

Factory is required to maintain the floor live load 3 kPa until further verification by ACCORD.

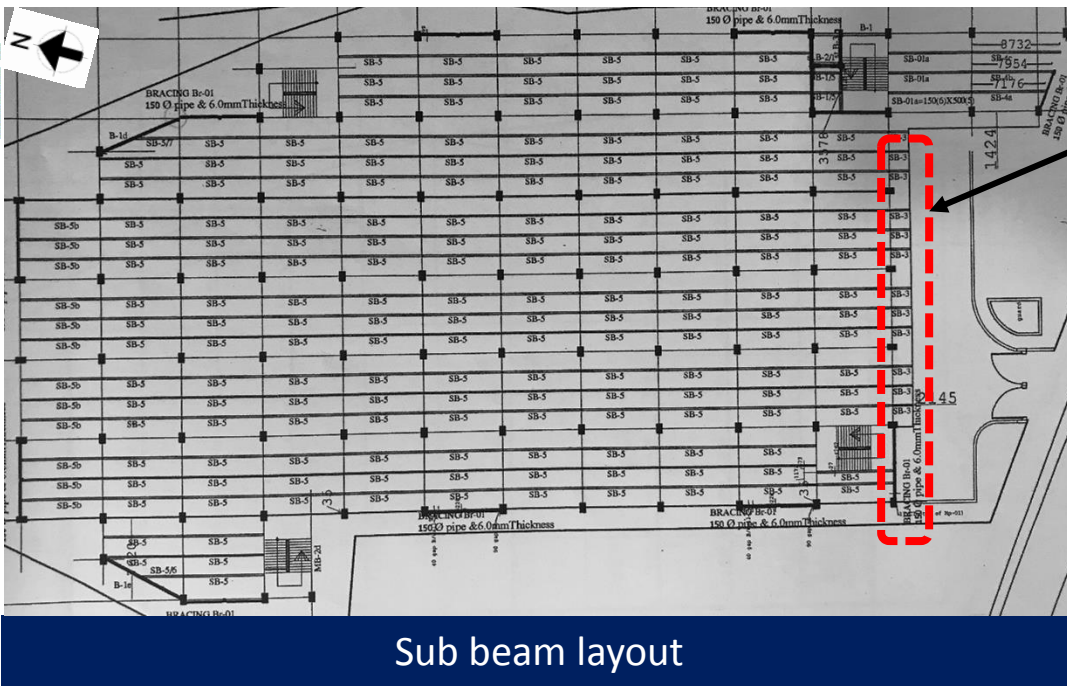
Sub beam layout

Detail of SB-3 type sub-beam was absent in drawing

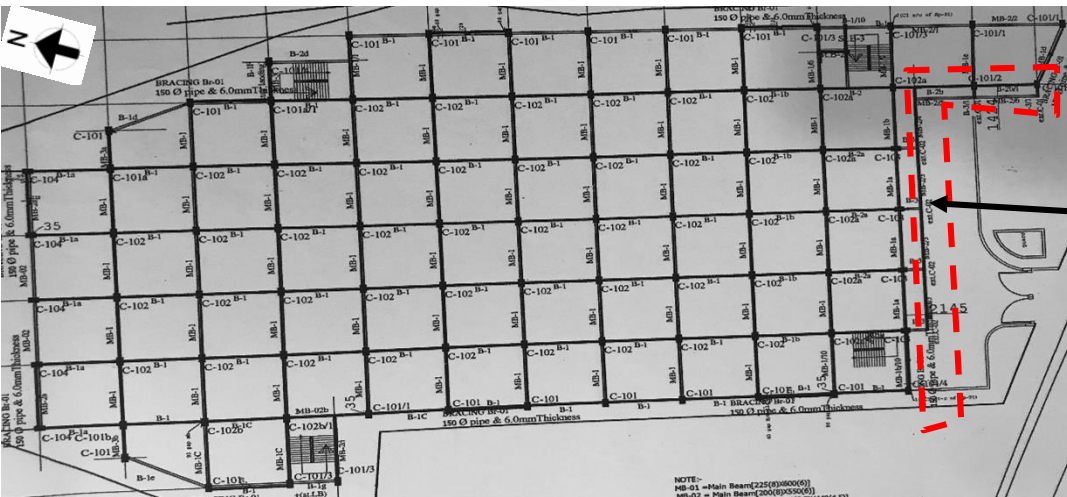
Column layout for 1<sup>st</sup> to 3<sup>rd</sup> floor

On south side, some non load bearing steel strut was observed and no detail was found in drawing

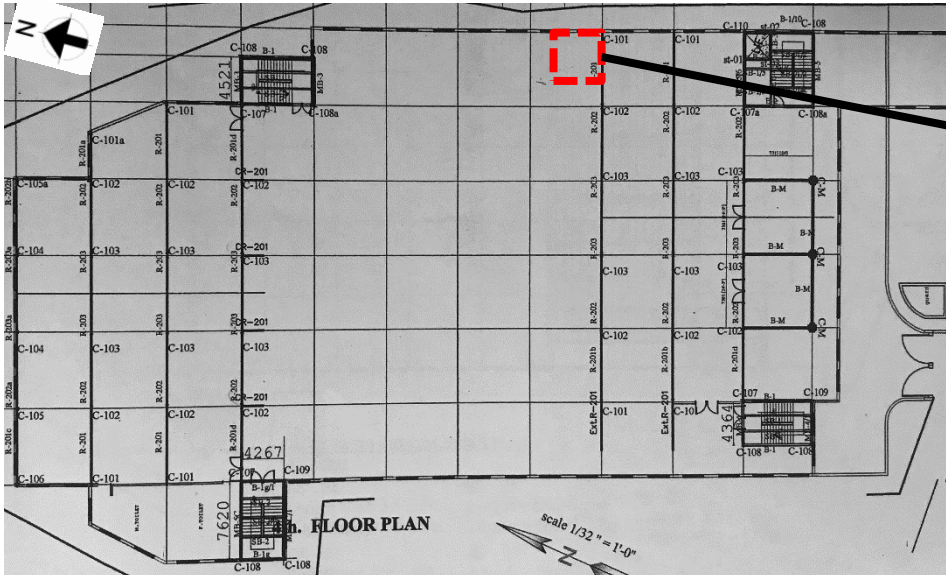
4<sup>th</sup> floor layout

The support condition of roof top shed was vulnerable and non engineered due to poor detailing. The stability system is required to be verified under lateral loads.

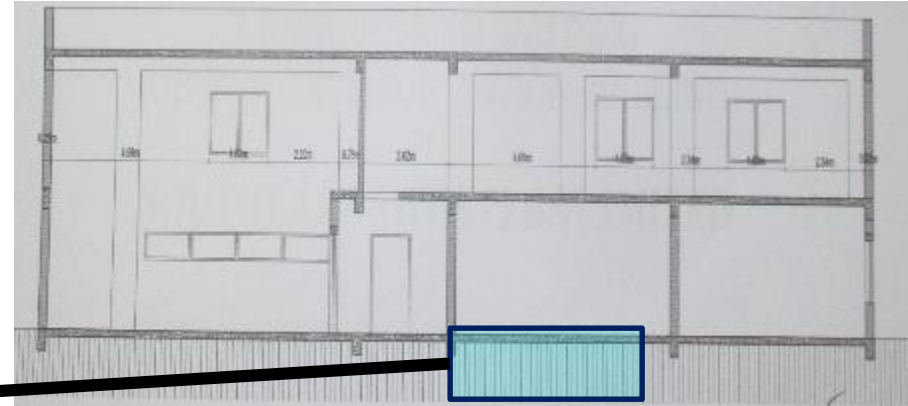
Section of Utility Building

During inspection, a pump room was observed on the marked position below ground floor level of the utility Building which was not included in As-Built drawing. Factory is required to update the As-Built drawing as per actual condition.

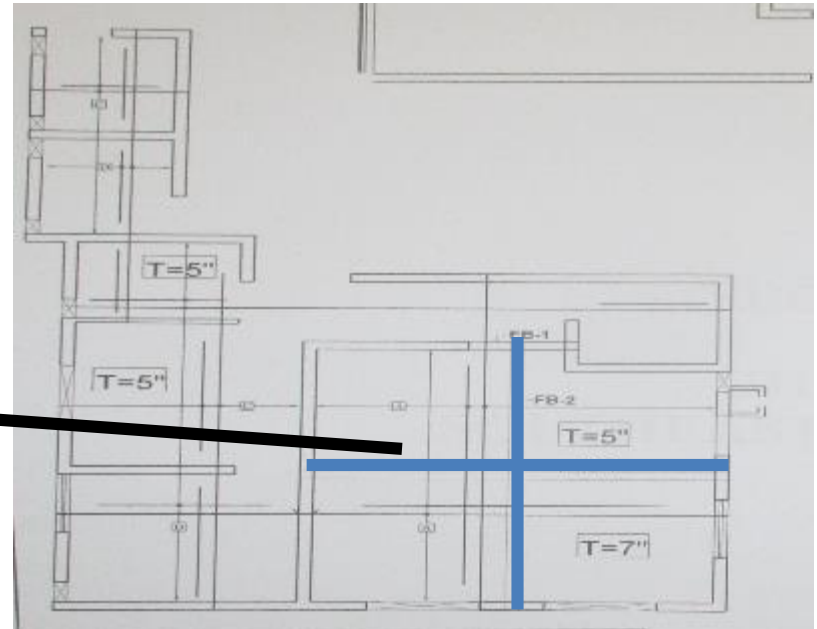
Slab Reinforcement Plan

Down stand of the roof beam on generator room was observed 300 mm instead of 475 mm. Factory is required to revise the As-Built drawing as per actual condition.
