# Radial International Ltd. Array International Ltd.

Zirani Bazar, Kashmirpur, Gazipur Sadar.  
(23.997823, 90.254950)  
20<sup>th</sup> April 2014

# Observations

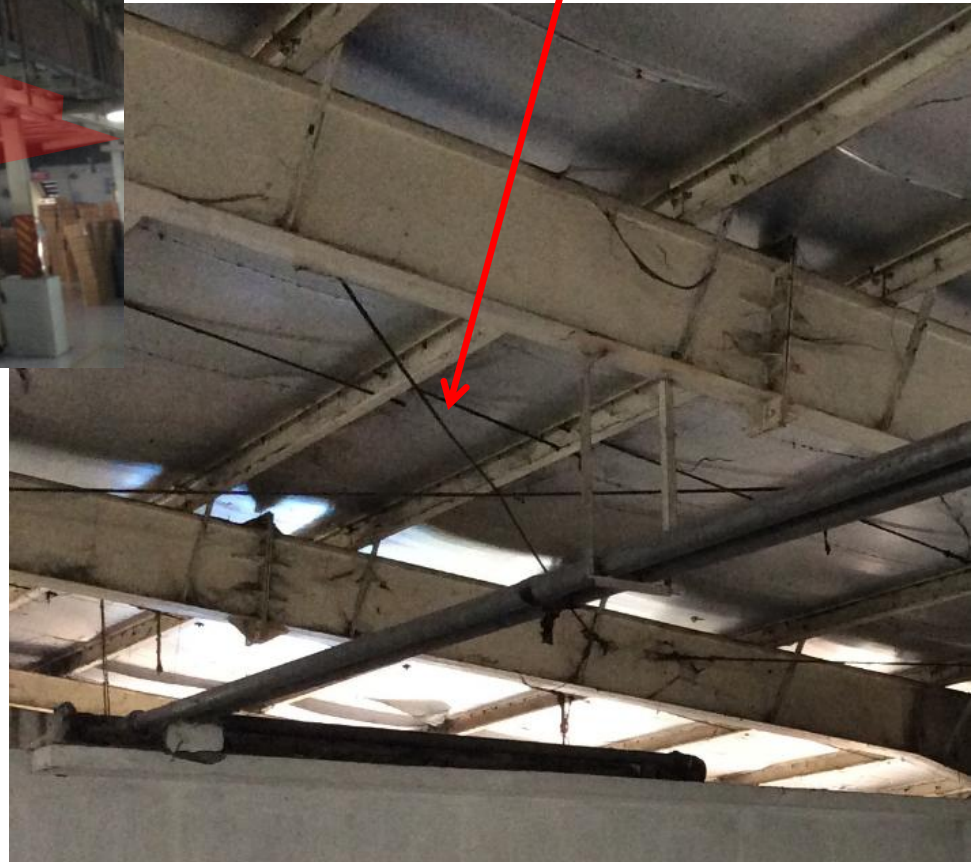
## **Steel Roof over Main Production Building**

**New composite floor**

**Changes have been made to the structure with part of the portal frame removed and replaced with a composite deck for fire safety reasons. This modification has removed an entire bay of roof bracing.**

**Some bracing elements are slack and should be tightened to ensure they are functioning properly.**

| Item No. | Observation | Recommended Action Plan | Recommended Timeline |
|---|---|---|---|
| 6 | Main Building Steel Roof Structures over Fifth Floor | Diagonal bracing, removed to construct new concrete flat roof, to be replaced | 6-weeks |

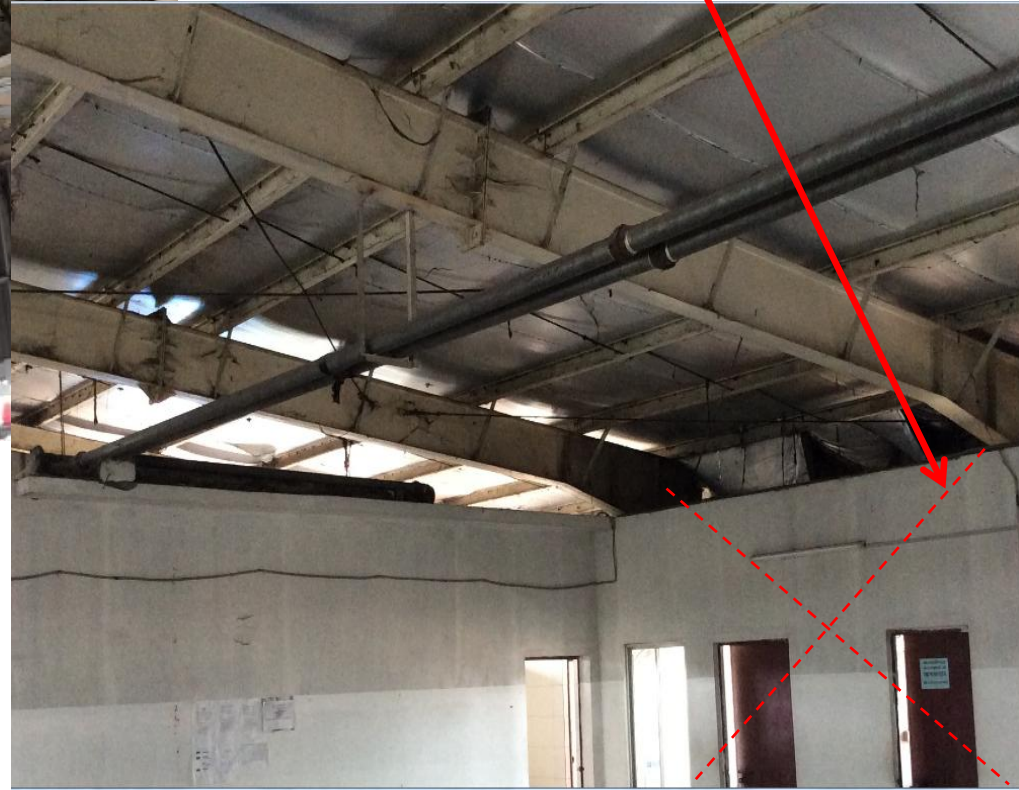
## **Steel Roof over Main Production Building**

**Bracing in steel roof for lateral restraint.**

**Bracing elements missing on elevation both sides (north and south).**

| Item No. | Observation | Recommended Action Plan | Recommended Timeline |
|---|---|---|---|
| 7 | Main Building Steel Roof Structures over Fifth Floor | Missing diagonal bracing (walls and roof) to be installed | 6-weeks |

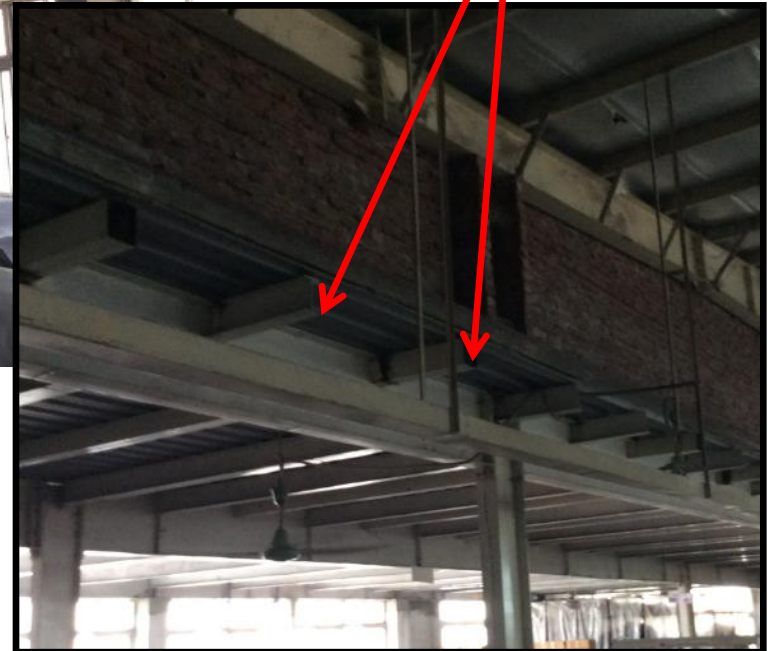
## Composite Deck

Displacement

Deck is constructed from a mixture of welded box/channel sections and I-Sections.

New composite deck above the 5<sup>th</sup> Floor appears to be deflecting slightly.

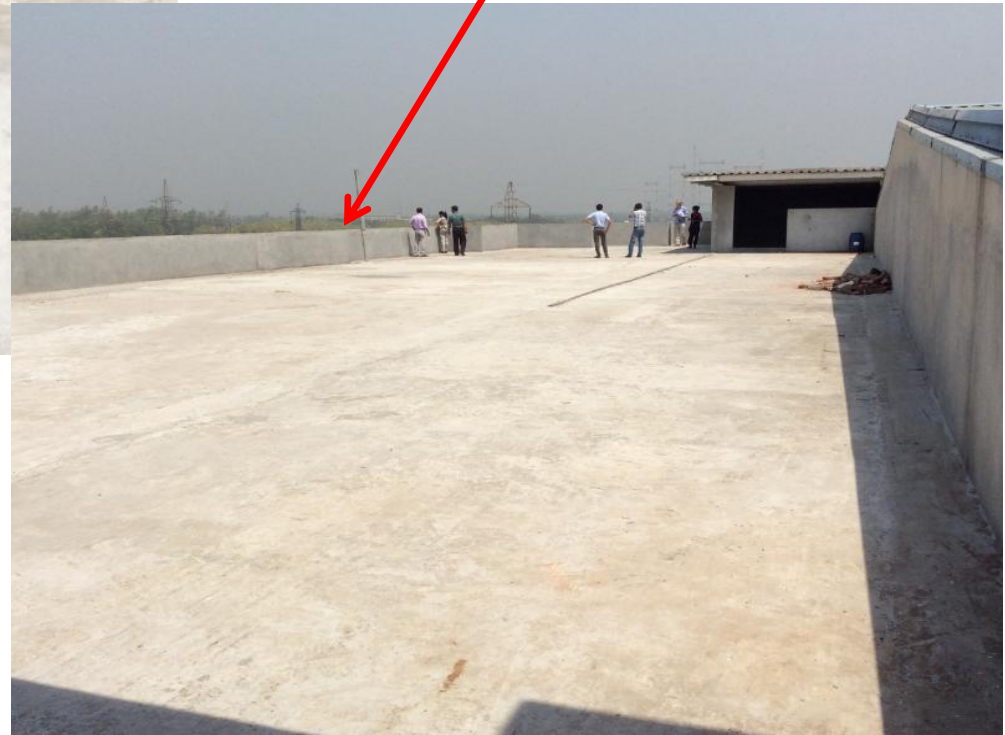
## **Drainage to Flat Roof of Main Building**

**No other drainage routes provided to the roof.  
New concrete parapet walls.**

**Only one drainage route on the roof to let water escape.  
Surrounding debris can block this one route and can cause an accumulation of water in a severe weather event.**

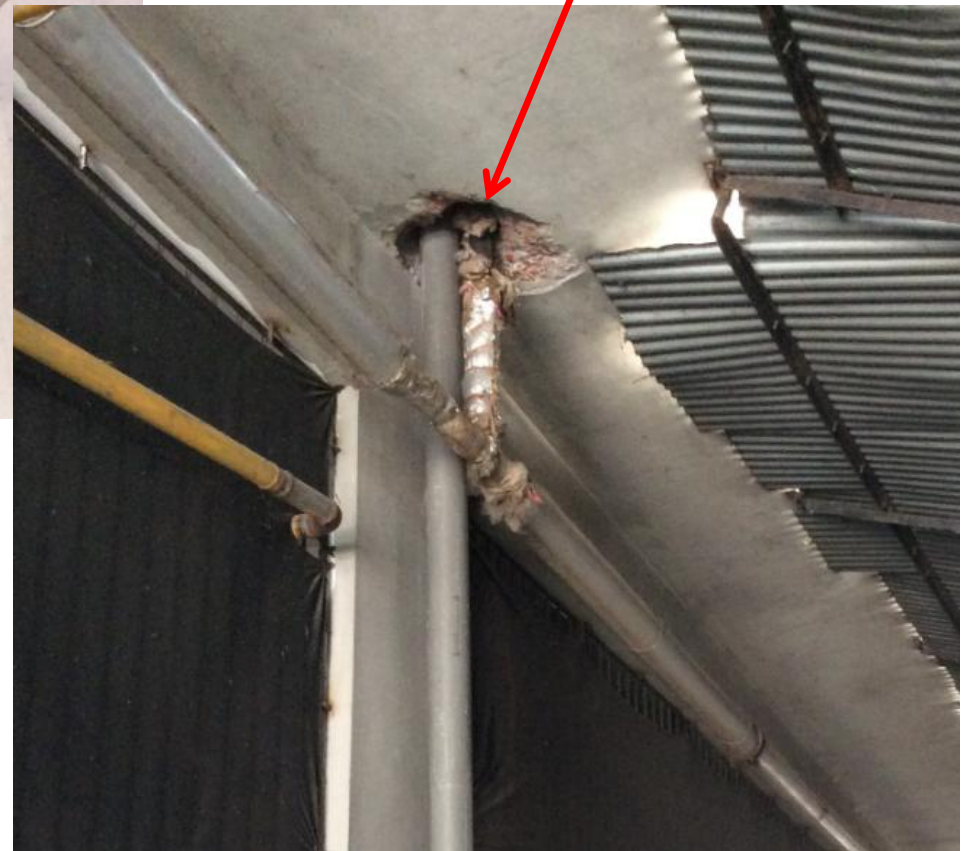
## **Local Damage to Beams and Slabs**

**New service opening broken in slab at toilet block to allow for pipes to pass through. Not good practice but has not compromised strength here.**

**New service openings broken/drilled in beams to allow electric cables to pass through. Not good practice but has not compromised strength here.**

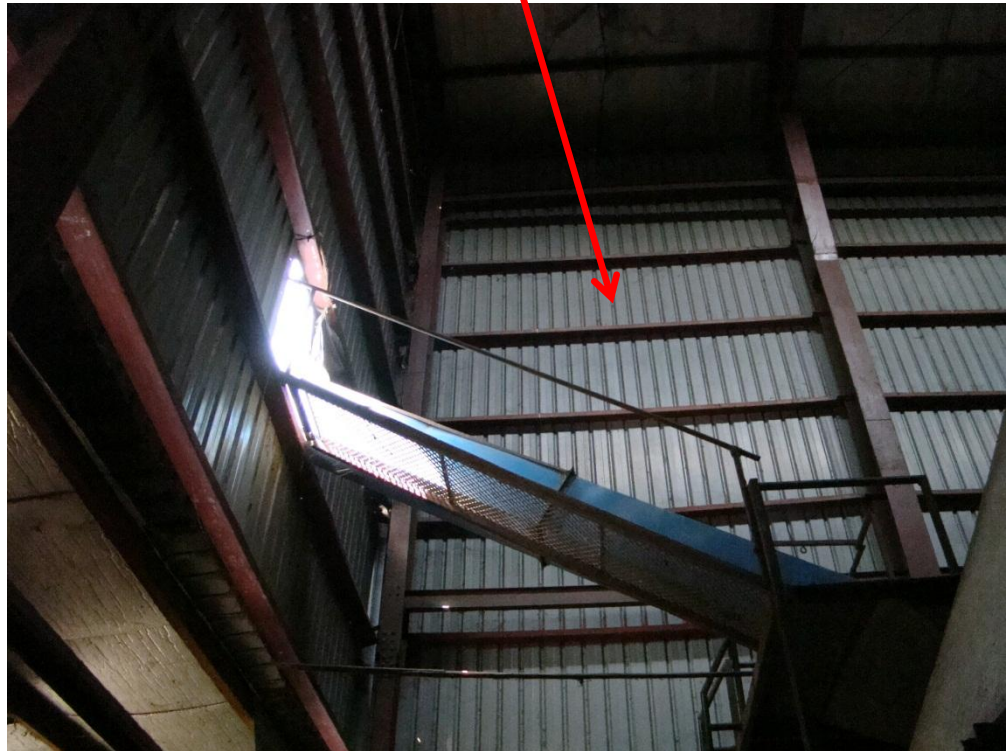
## Single-Storey Building: Boiler House

**Boiler house columns are larger section at higher levels than at lower levels. Bolted connection at mid-height is poorly aligned.**

**Boiler house steel structure is tall without the benefit of floors or effective bracing.**

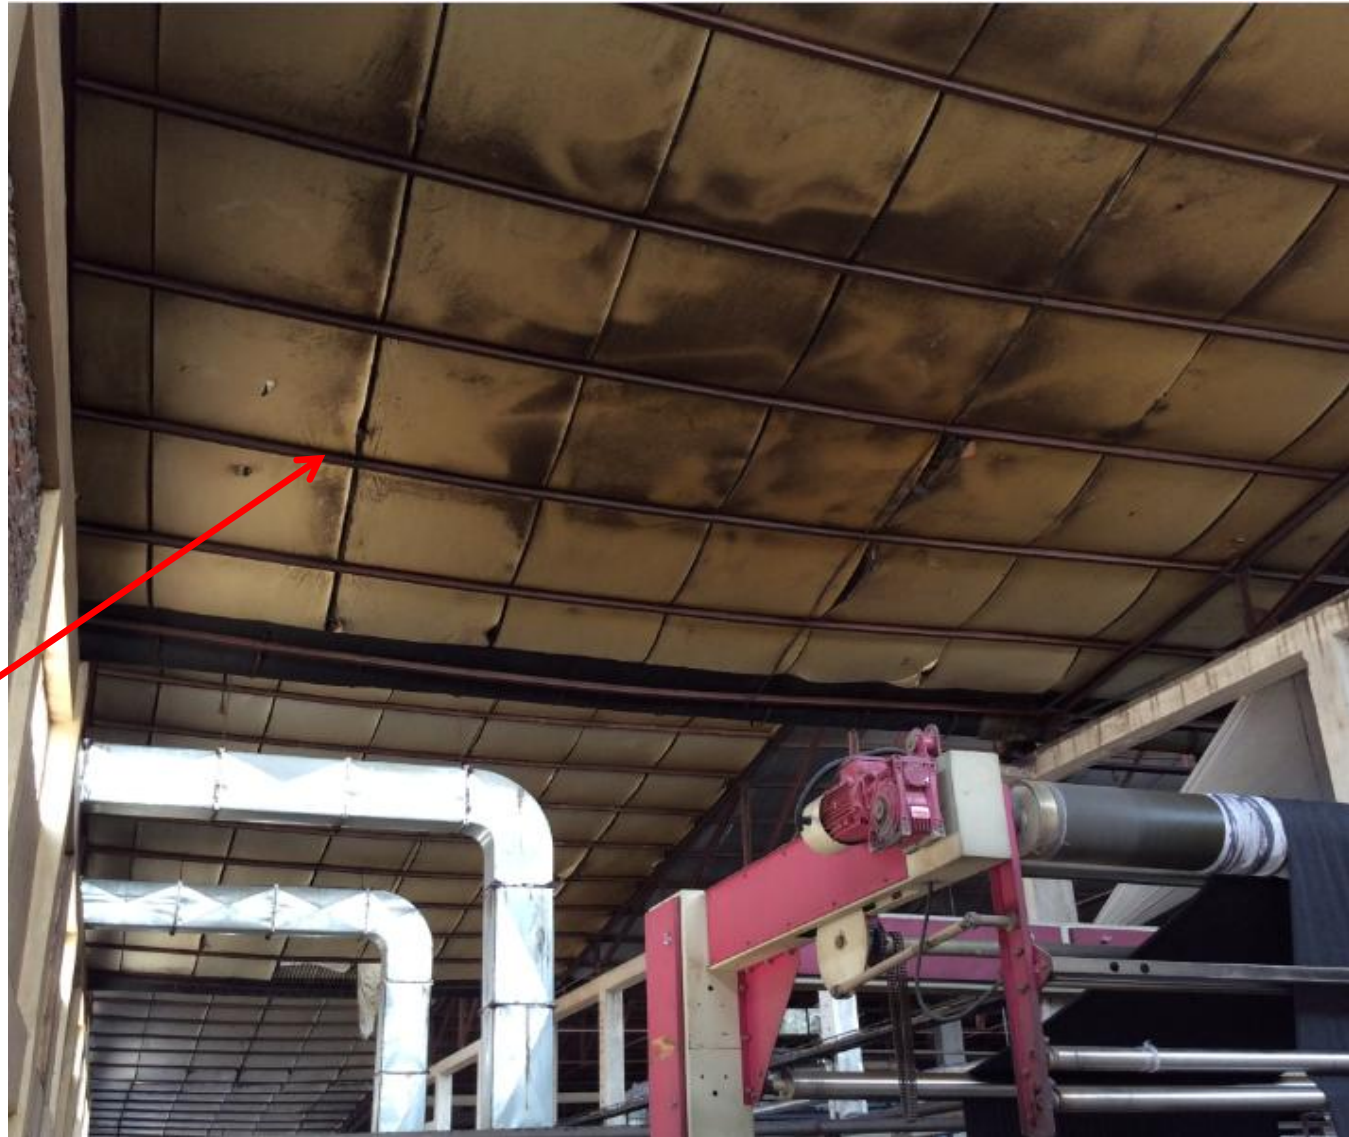
**Single-Storey Building: Dyeing Shed**

**Steel purlins in roof  
of Dyeing Shed are  
deflecting heavily.**

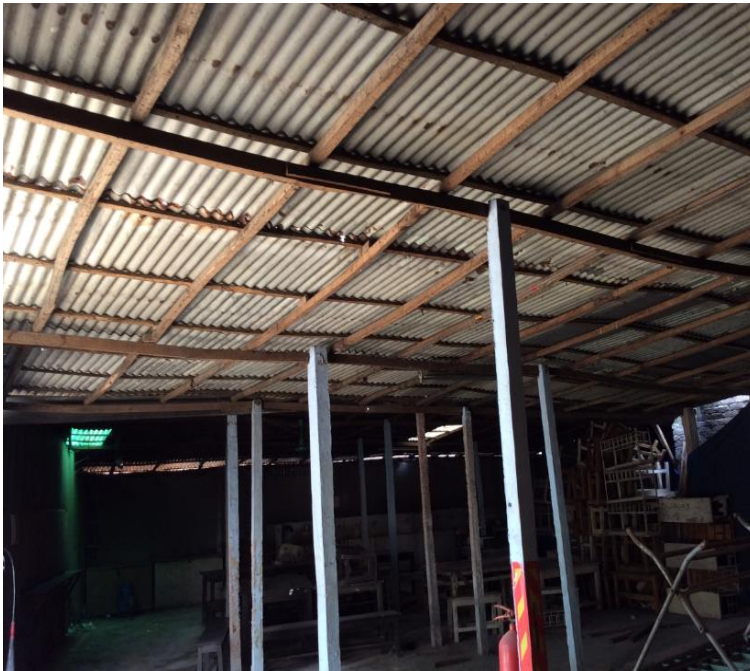
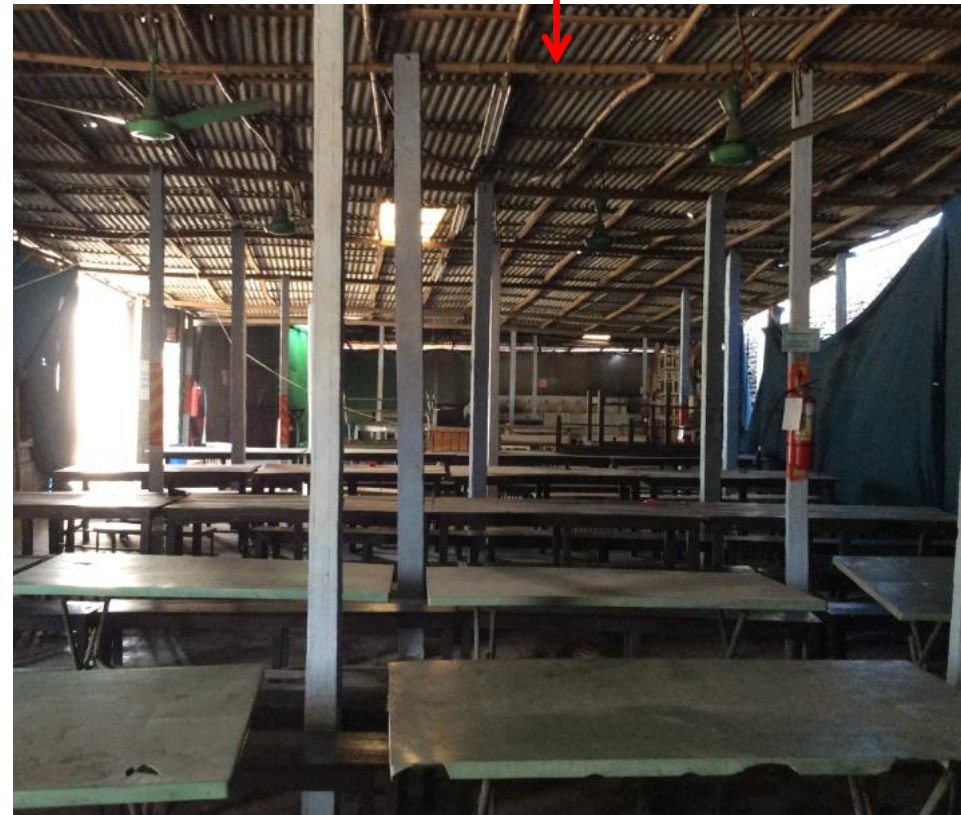
Single-Storey Shed: Dining Area

Ad-hoc  
bamboo/timber/steel roof  
on concrete posts arranged  
haphazardly over canteen  
area used by approx. 300  
workers.

| Item No. | Observation | Recommended Action Plan | Recommended Timeline |
|---|---|---|---|
| 25 | Single-Storey Buildings:<br>Dining Area Shed | Provide alternative dining accommodation which is safe and structurally sound until the existing roof structure is properly strengthened or replaced | <b>Immediate - Now</b> |
