# Base Fashions Ltd. - New Unit

93 Sataish Road, Tongi, Gazipur

31<sup>st</sup> December 2017

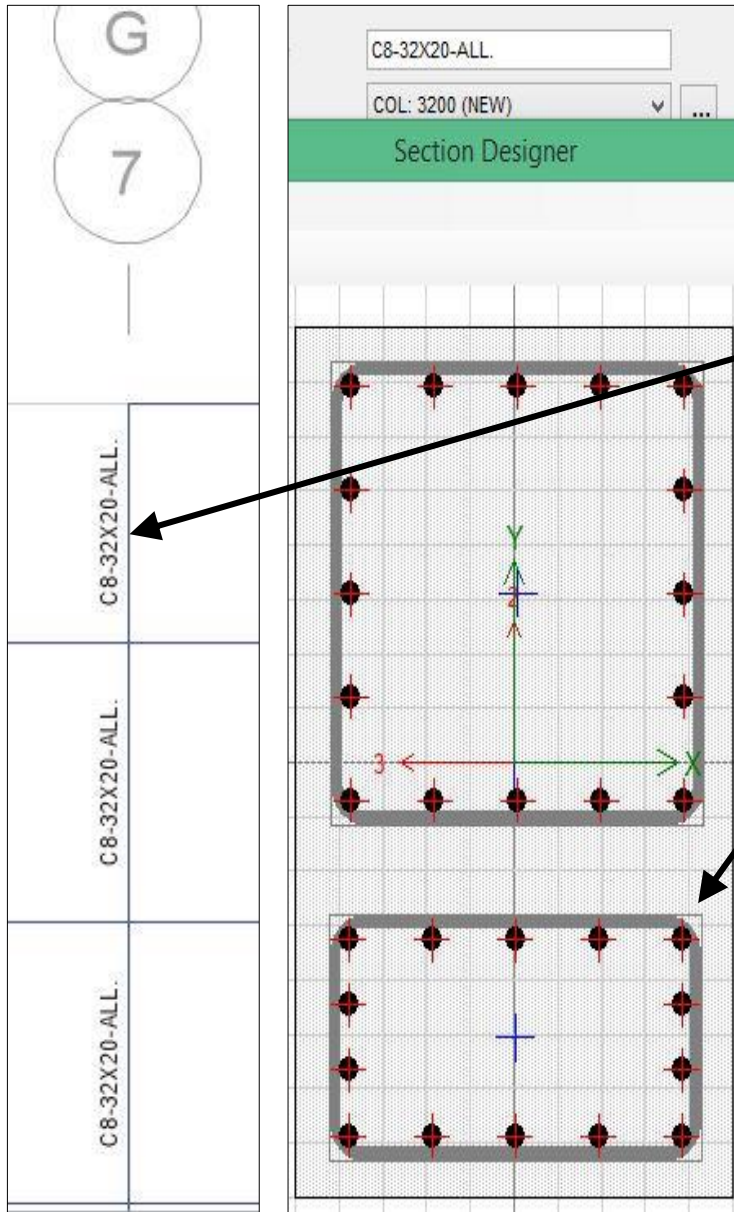
18 rebars found in FEA instead of 16 for C6 column

The column layout did not match with provided Finite Element Analysis (FEA) model. Also, the reinforcement of C6 column; size & retrofitting scheme of C5 column did not match. Factory engineer is required to check the drawings and update the FEA accordingly.

| Item No. | Observation | Recommended Action Plan | Recommended Timeline |
|---|---|---|---|
| 1 | Discrepancy between as-built drawings and on site condition | Building Engineer to survey the structure and update as-built drawings to the as-constructed status. | 6-weeks |
