# Mega Dyeing Ltd.

Shardagonj, Gabindabari, Joydevpur, Gazipur, Dhaka  
(+23.965735N, 90.285605E)

13 & 26 April 2014

# Observations

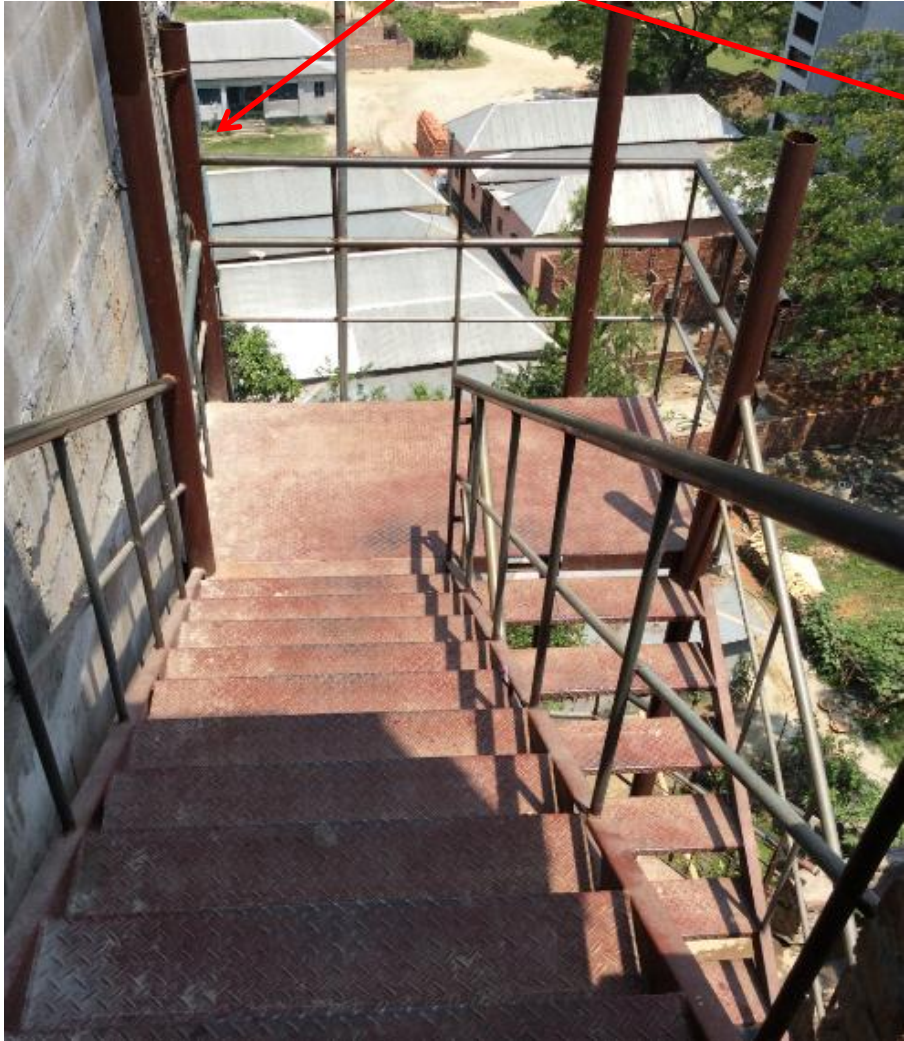
Steel stairs around and within buildings

Fire escape stairs adjacent to Building 3 has no apparent lateral stability system and is not tied into the Building 3 structure.

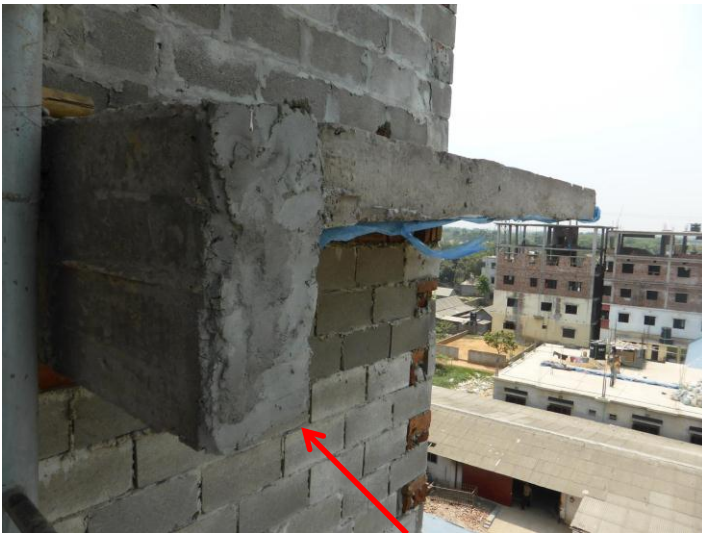
**Workmanship issues with concrete**

**Poor compaction of concrete in columns and other structural elements observed.**
