# Mondol Knit Tex Ltd (9959)

## Alim Knit (BD) (11273)

13.April.2014

ACCORD  
on Fire and Building Safety in Bangladesh

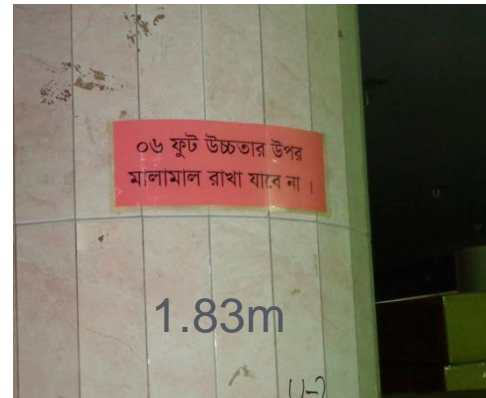
## 1<sup>st</sup> Priority 1 Concern

During our visit, we found that floors used for storage were loaded above the prescribed limits indicated on signs a few columns.

We also noticed that loading varied in weight density. A loading plan would be more appropriate for each floor level.

This concern is applicable for both buildings.

- Factory engineer to produce and actively monitor a loading plan for all floor plates within the factory complex, with consideration given to slab, column and foundation capacity
