Mayc's Garments Ltd.

House No. 18/19, Road no. 1, Block –KHA, Section-6, Mirpur, Dhaka.
(23.805996 N, 90.367568 E)

2nd April 2018

Observations

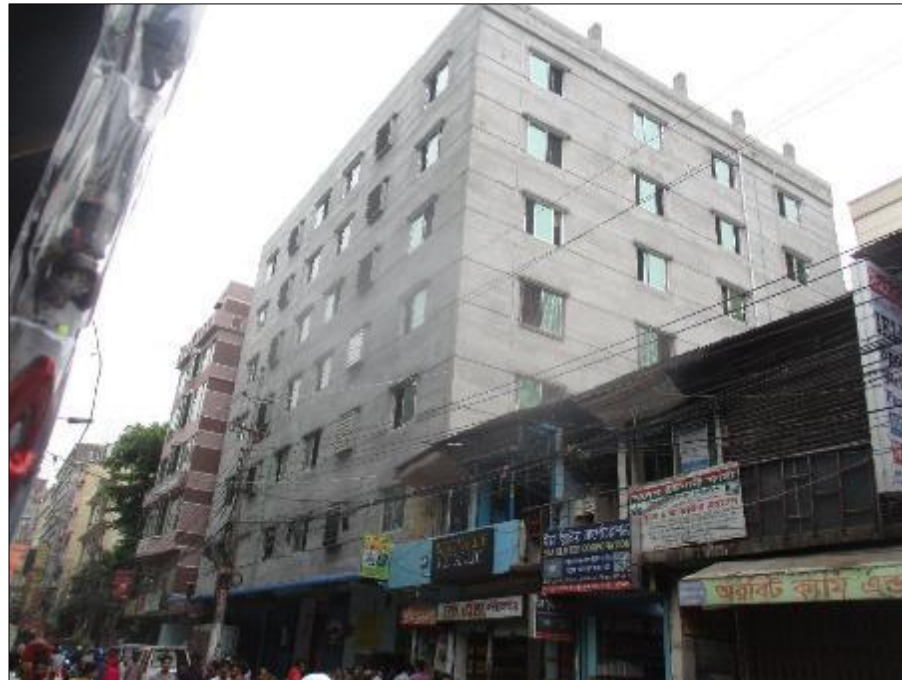
Design check required for the foundation system

As per soil test report, R.C.C. strip footing or individual column footing was recommended. But during inspection, pile foundation was observed on structural drawing of the building. No recommendation was found on soil test report regarding pile bearing capacity.

Cursory calculation indicates that pile appears to be stressed above normal design limits. Factor of safety (FoS) is less than the minimum requirement of BNBC. Factory engineer is required to review the adequacy of pile considering actual bearing capacity of soil and comply with BNBC.

Item No.	Observation	Recommended Action Plan	Recommended Timeline
1	(Factory Building) Design check required for the foundation system	Factory Engineer to review design, loads and footings stresses.	6-weeks
2	(Factory Building) Design check required for the foundation system	Produce and actively manage a loading plan for all floor plates within the factory, giving consideration to floor, column and foundation capacity.	6-weeks
3	(Factory Building) Design check required for the foundation system	Complete implementation of any remedial works deemed necessary by the reviewed design.	6-months
4	(Factory Building) Discrepancies between provided drawings and on site condition	Building Engineer required to prepare As –Built drawings reflecting the actual condition.	6-weeks
5	(Factory Building) Prepared engineering assessment and load plan are required to be verified	Maintain 3 Kpa load on all floors until verified the load plan.	6-weeks

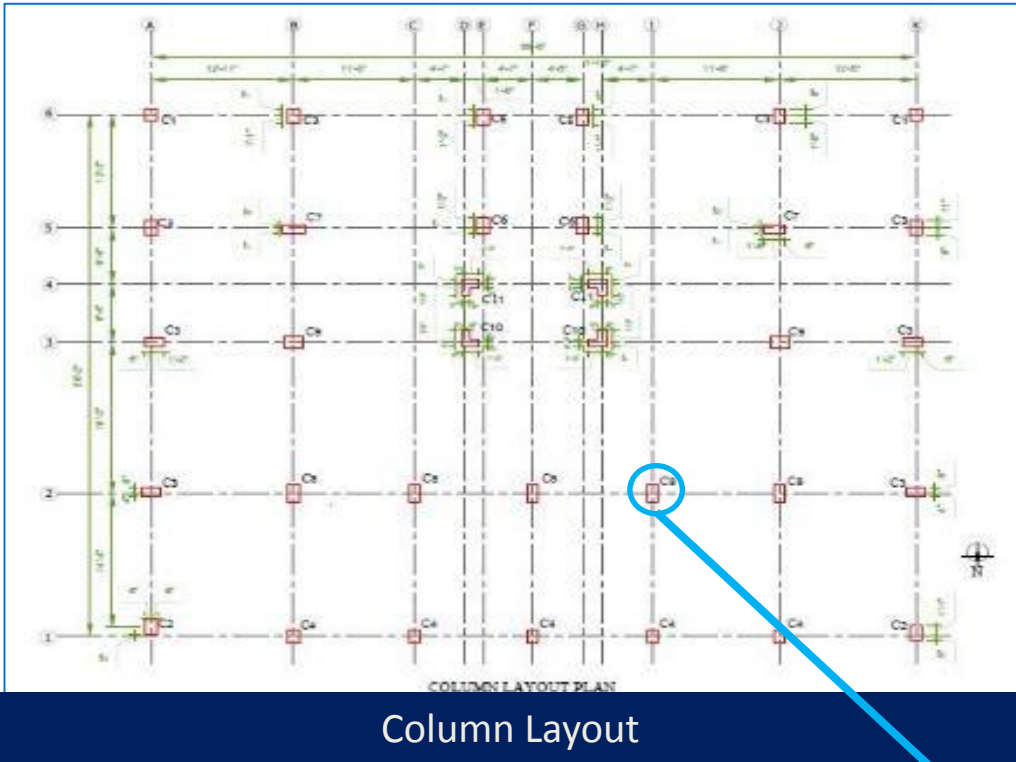
Discrepancy between provided drawing and on-site condition

Nos. of rebar in all C-8 type column at basement level does not match with provided column schedule. 16 nos. of rebars were found by ferro scan where as 22 nos. rebars were shown in column schedule.

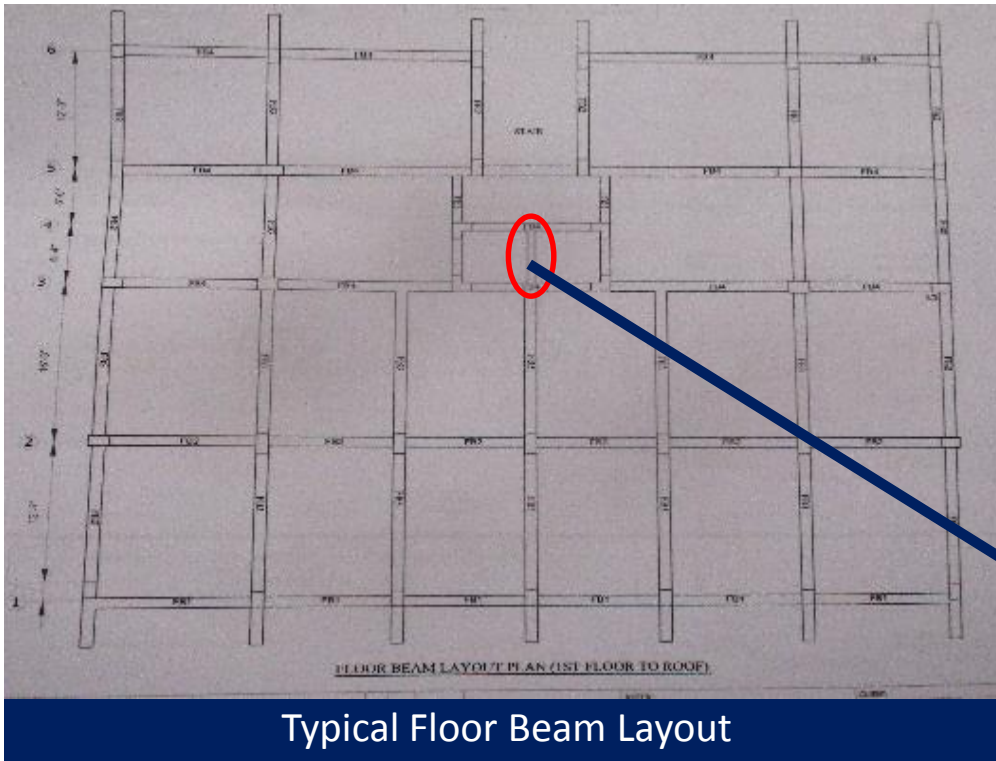
Typical Floor Beam Layout

The width of marked FB-4 type was found less than the provided drawing section in every floor. Factory is required to revise As Built drawing as per actual condition.

The width of the marked FB-4 type beam was observed 150 mm instead of 325 mm.

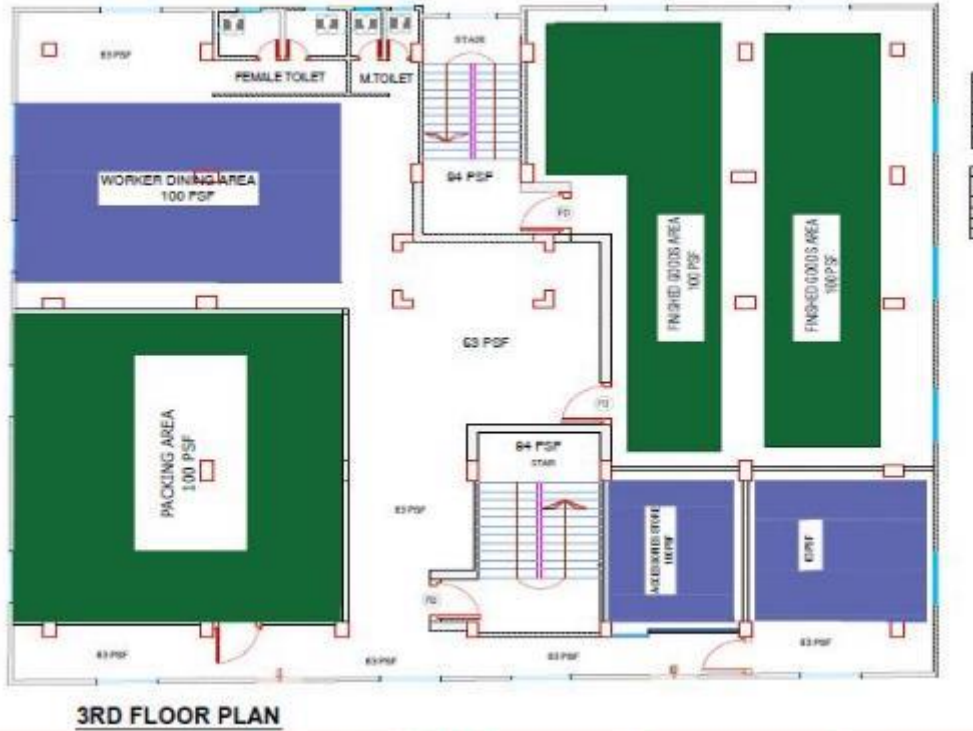
Loading on 3rd floor packing section

Factory designated consulting firm has prepared a load plan considering 5kpa maximum allowable floor loading for 2nd & 3rd floor storage areas.

During inspection, no over loading was observed and FoS calculation for internal column was found satisfactory considering 3 kpa allowable floor live loading for existing structure.

Factory is required to maintain the floor live load 3 kpa until prepared load plan reviewed by Accord.

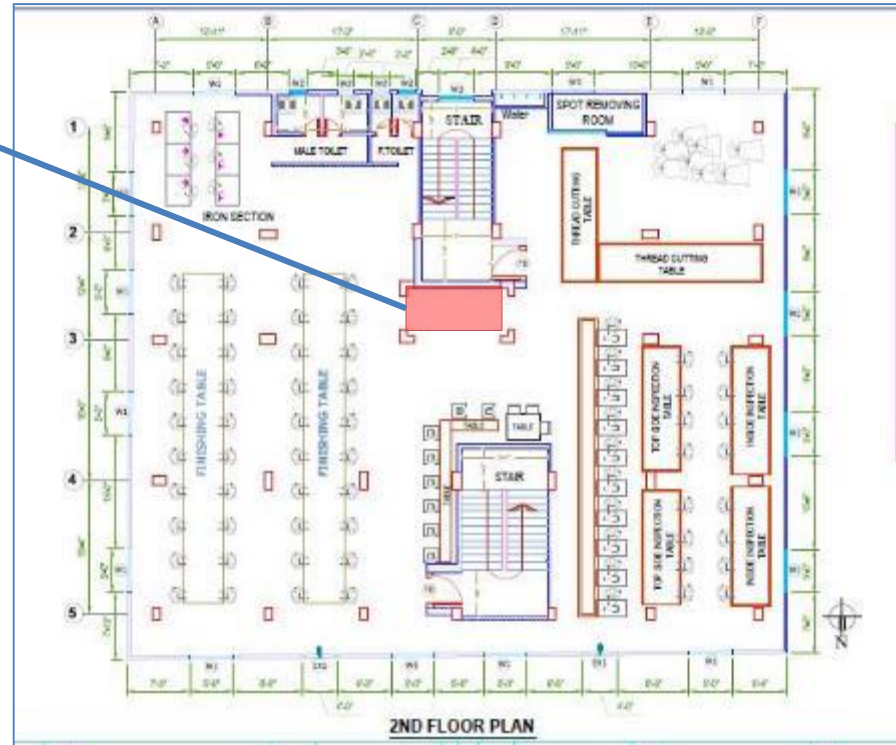
2nd floor plan

Slab opening was found on GF to 3rd floor slab which was covered by steel sheet supported by angle. Factory is required to replace the steel sheet as per engineer's recommendation.
