Islam Garments

Islam Knit Design

Zarun, Konabari, Gazipur, Dhaka
(+23.9955N, 90.3263E)

16 September 2013

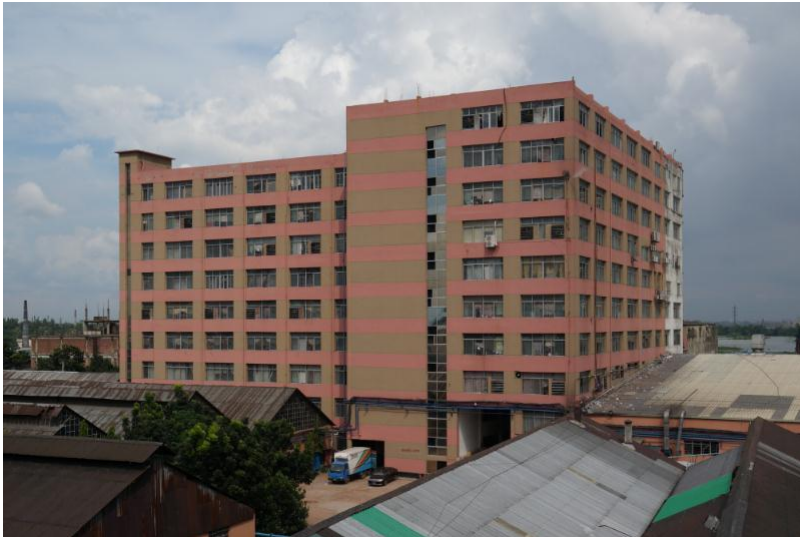
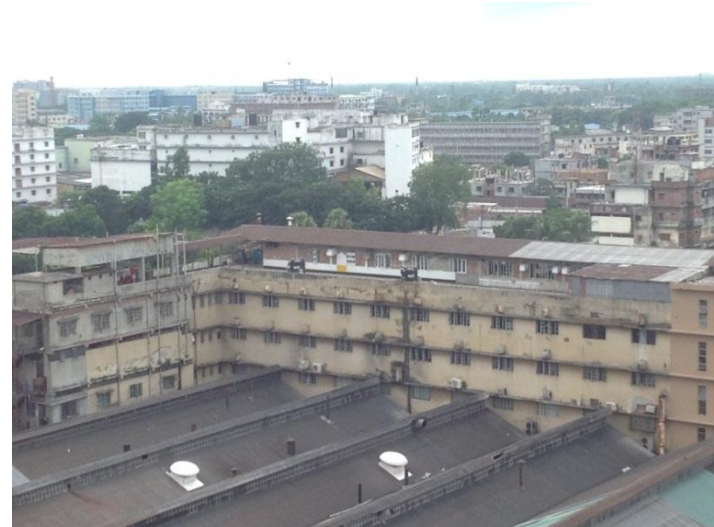
**Check on Column stress levels immediately
required to the 5 storey block**

Item 1 High Stress to Building internal columns

ITEM 1: High Stresses on Internal Columns Observed to 5 Storey Block , We require removal of personnel now, with column strength checks and the production of a Detailed Engineering Assessment before this building is used again

Verify concrete strengths in internal columns and reduce loads

**Remove all personnel
from this building
until results of
columns strengths
and Building
Engineering
assessment is
complete**

Item No.	Observation	Recommended Action Plan	Recommended Timeline
1	Verify the structural adequacy of all building columns at all levels in the 5 storey Block based on as built dimensions and material properties , Evacuate Building	Remove all Personnel from the 5 storey block and extension pending a full check on column strengths and Detail Engineering Assessment.	Immediate - Now
2	Verify the structural adequacy of all building columns at all levels in the 5 storey Block based on as built dimensions and material properties , Evacuate Building	Detailed Engineering Assessment of as built structure to be commenced as per attached scope.	Immediate - Now
3	Verify the structural adequacy of all building columns at all levels in the 5 storey Block based on as built dimensions and material properties , Evacuate Building	Verify insitu concrete strengths and existing reinforcement for all columns	Immediate - Now
