# Redpoint Jackets Ltd

Dhaka Export Processing Zone, Ganakbari, Savar, Dhaka  
(+23.7514N, 90.3917E)

8 December 2013

# Survey Observations

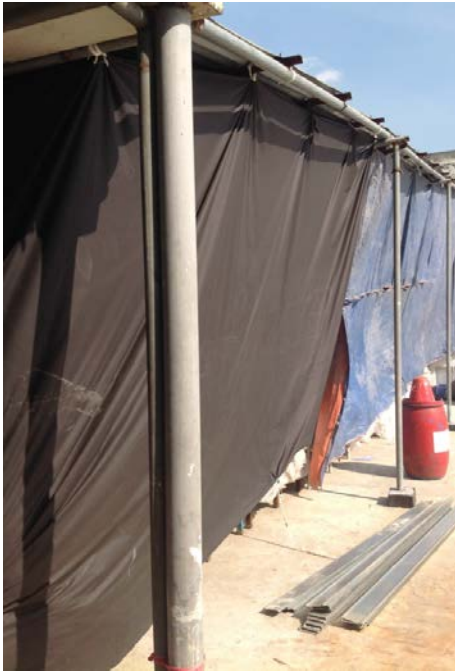
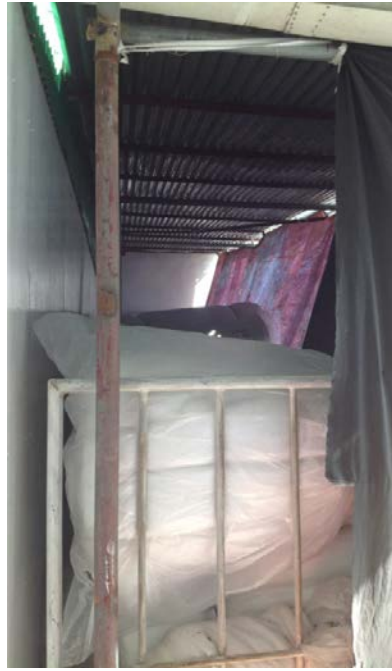
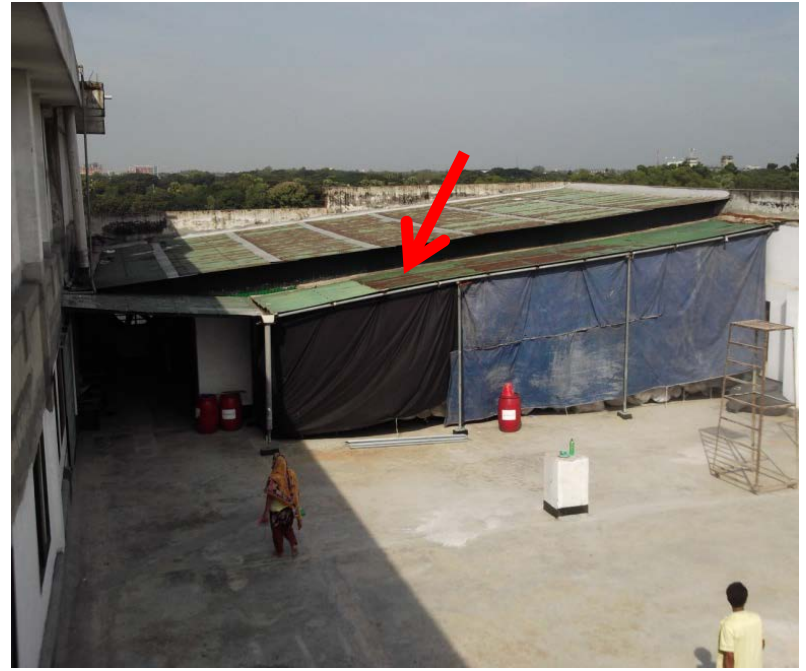
**Steel roofs to dining and store area on 2<sup>nd</sup> floor do not appear to be strong enough to resist high wind loading**

**Secondary roof structures, comprising metal deck/purlins and columns, not shown on the structural design drawings, may be susceptible to wind uplift.  
No obvious stability system is evident.**

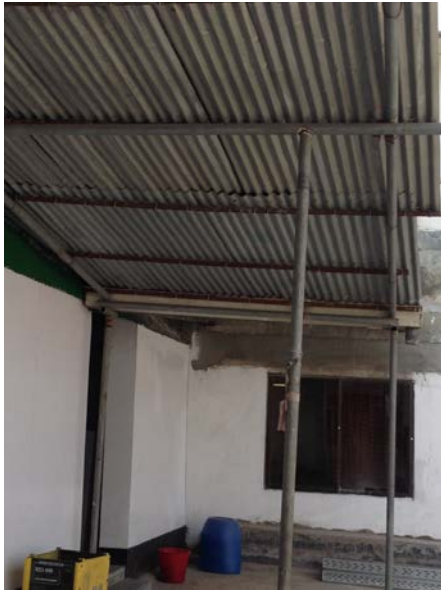
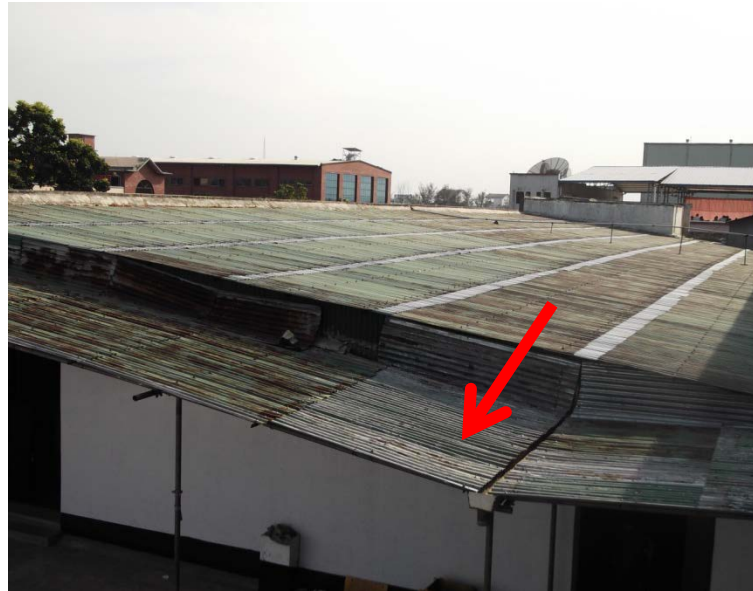
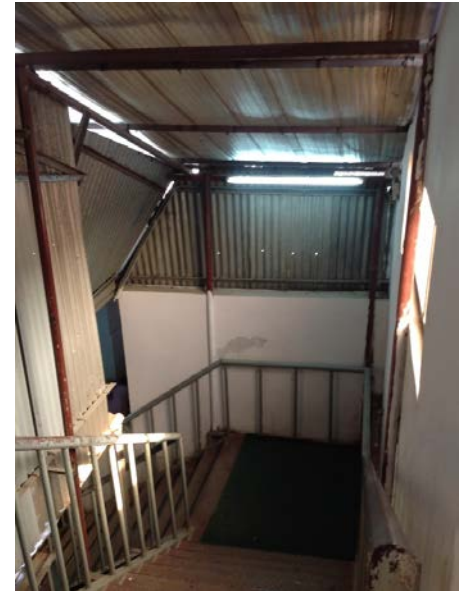
**Steel roof to 2<sup>nd</sup> floor store**

**Secondary roof structures, comprising metal deck/purlins and columns, not shown on the structural design drawings, may be susceptible to wind uplift.  
No obvious stability system is evident.**

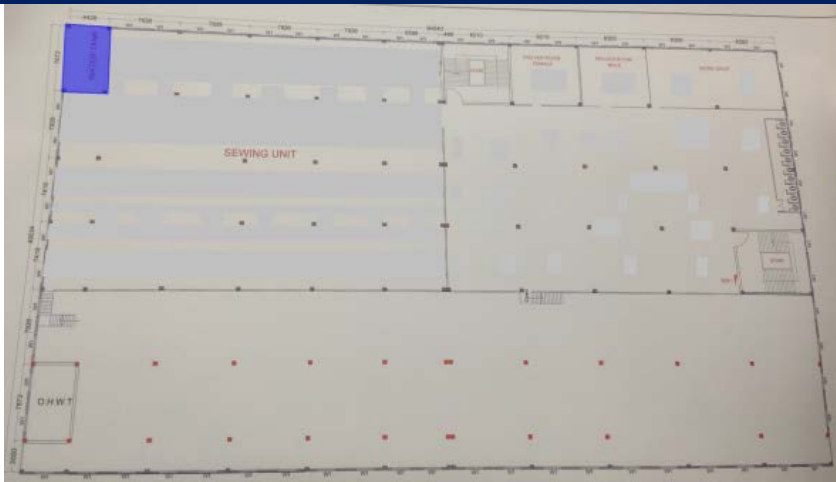
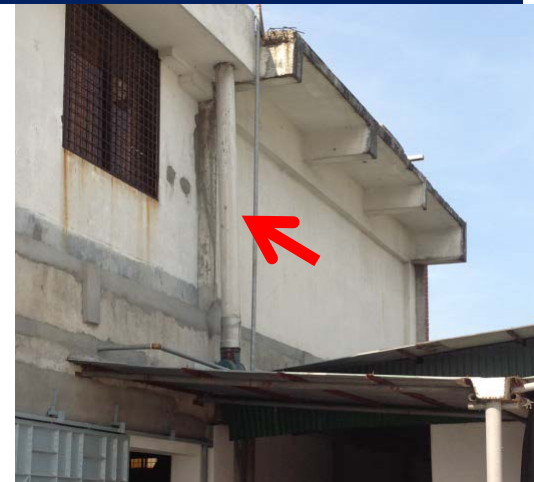
**Support arrangement for water tank at the south – west corner of factory is unclear**

**Water tank on the 3<sup>rd</sup> floor with four circular steel stub columns not shown on the structural design drawings – support arrangement unclear. Tank being decommissioned.**

- Water tank to be decommissioned and a replacement tank provided in a location to be agreed with the Building Engineer
