# AR Jeans Producer Ltd.

Pukurpar, Kathgora, Zirabo, Ashulia

20<sup>th</sup> March 2018

# Observations

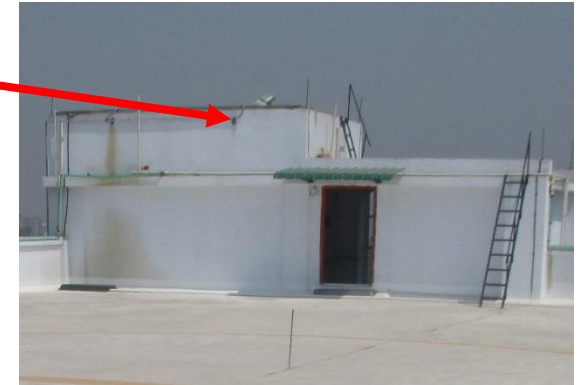
Roof layout plan

Cursory calculations indicate that few Columns under toilet area & water tank would appear to be stressed in excess of normal design limits, assuming minimum concrete strength. Building Engineer to review design, loads and columns stresses. Also, prepared load plan need to be revised based on floor, column and foundation capacity.

| Item No. | Observation | Recommended Action Plan | Recommended Timeline |
|---|---|---|---|
| 4 | (Building-1)<br>Column and Footing to be stressed above normal design limits | Produce and actively manage a loading plan for all floor plates within the factory, giving consideration to floor, column and foundation capacity. | 6-weeks |

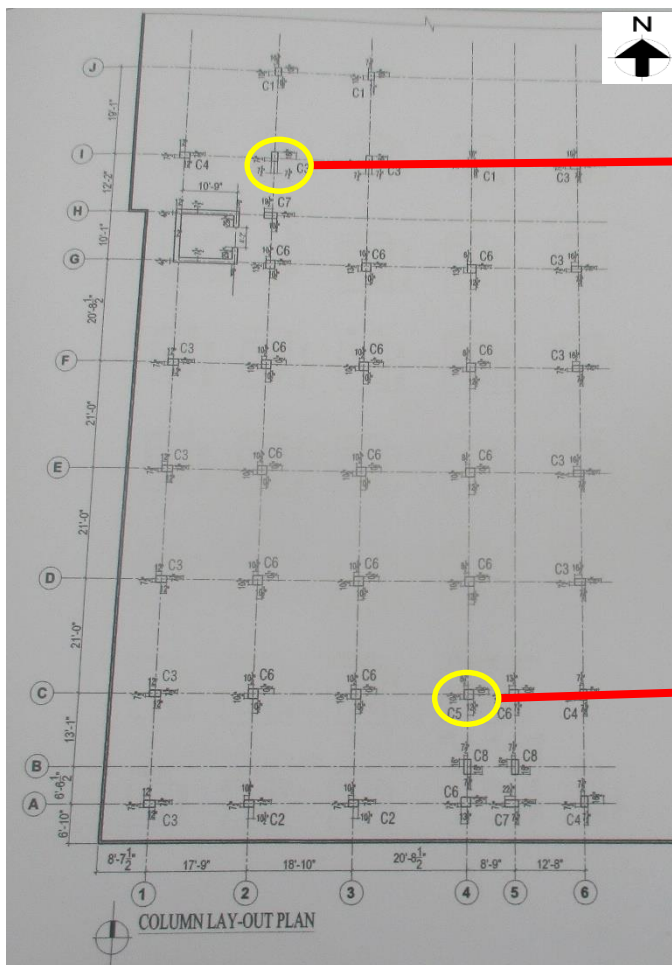
Number of rebar for C-5 column does not match with column schedule. 16 nos. of rebar are found by ferro scan whereas 20 nos. of rebars are shown in column schedule. On grid I-2, C-3 type column is shown in layout but that column size is similar to C-1 type column.

| Item No. | Observation | Recommended Action Plan | Recommended Timeline |
|---|---|---|---|
| 14 | (Building-2)<br>Discrepancies between provided drawings and on site condition | Building Engineer to survey as-built structure and prepare accurate as-built survey information for the building. | 6-weeks |
