Wucho Fashion Ltd.

AFSAR UDDIN SHEIKH COMPLEX, HAZI LIAKAT, JAMGARA

3rd May 2018

Observations

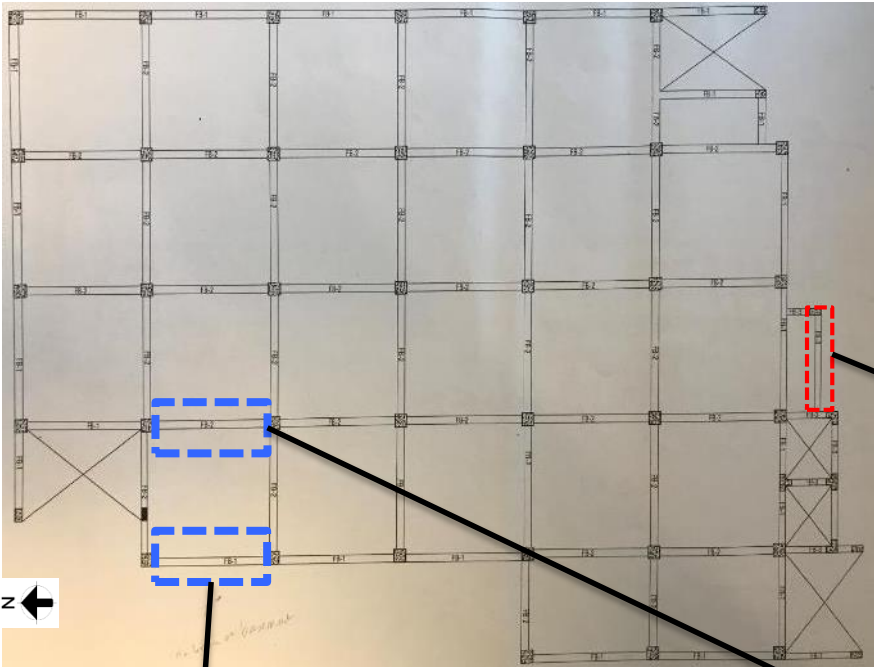
Beam-column layout in provided drawing

The marked beam was absent on 1st floor under south side toilet zone but the beam was shown in beam layout.

The marked beams were absent in basement floor on ramp area but the beam was shown in drawing.

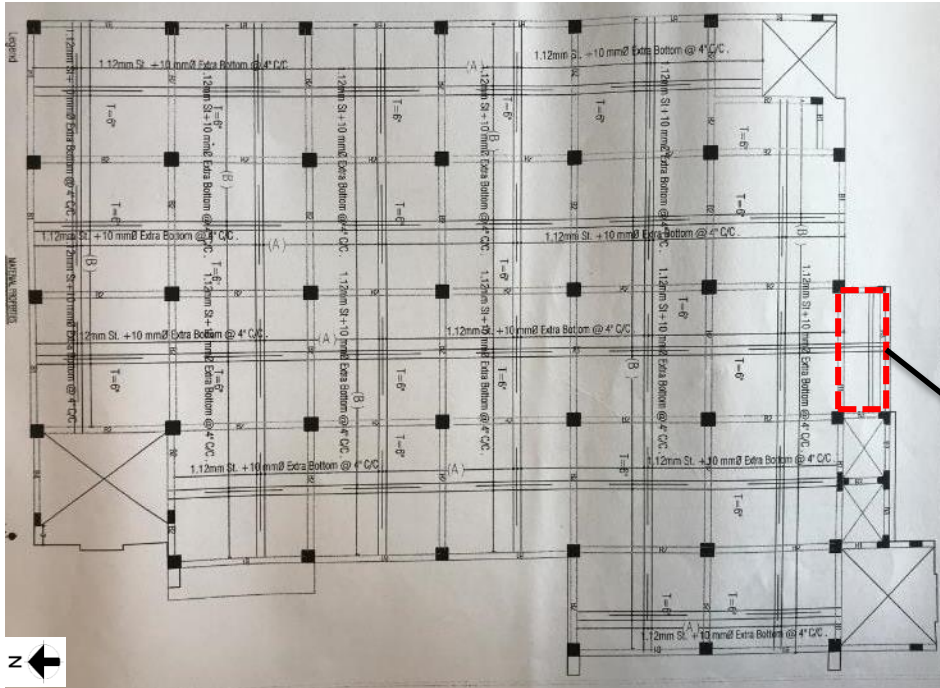
Slab layout in provided drawing.

No slab was found under the toilet zone on 1st floor. Whereas, the slab was shown in slab detail drawing
