# AB Apparels Ltd

225, Singair Road, Hemayetpur, Savar, Bangladesh.

9<sup>th</sup> November, 2016

# Observations

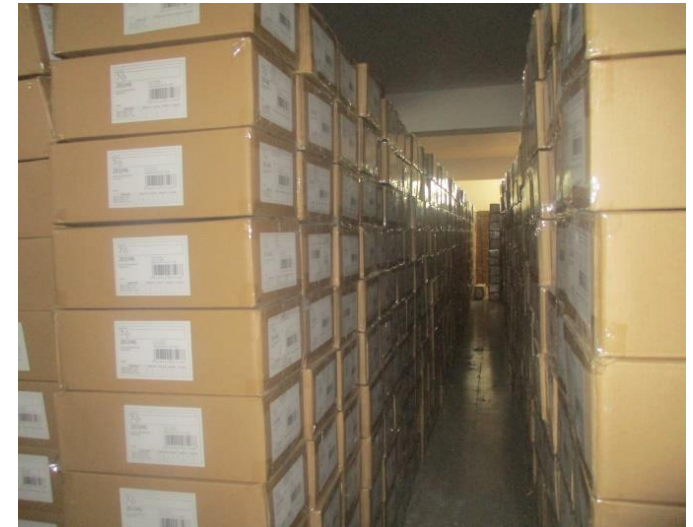
Build up found on the highlighted area of 2<sup>nd</sup> Floor. High Stack of finished goods have been observed.

Based on analysis by considering live loads according to load plan and build up loads, highlighted column stresses are found below normal design limit.

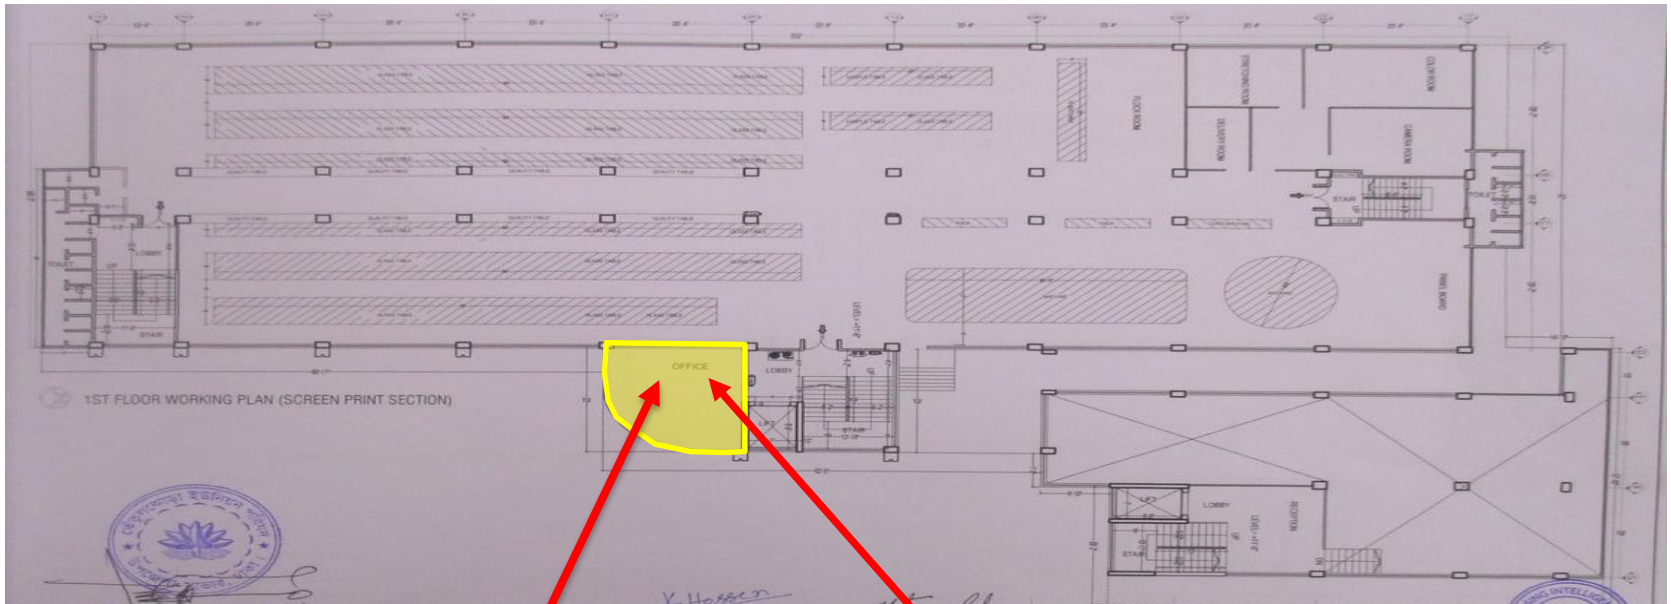
High Stack of Fabric Roll has been observed on 1<sup>st</sup> Floor.
