Vertex Innovative Apparels Ltd. (10524)

H.B. Intimates (11786)

Forkan Tower, 360/A, Bitak Bazar, Sagorika, Pahartoli Thana, Chittagong

15.MARCH.2014

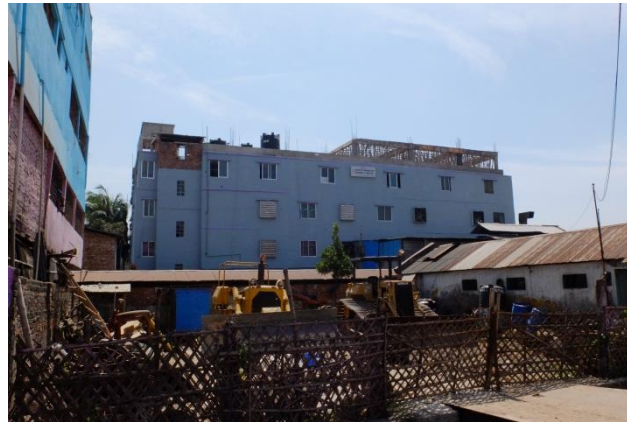
Identified Priority 1 Concerns

Low Column Safety Factors

Priority 1 Concern

Column load run-downs indicate lower than desirable column safety factors.

- Do not continue construction past the 5th floor slab level. It is recommended that the 5th floor slab be used as the roof level.
