# Purbachal Apparel Ltd.

South Panjora, Ward#05, Nagori, Gazipur  
(23.888930N, 90.502231E)  
10<sup>th</sup> June 2018

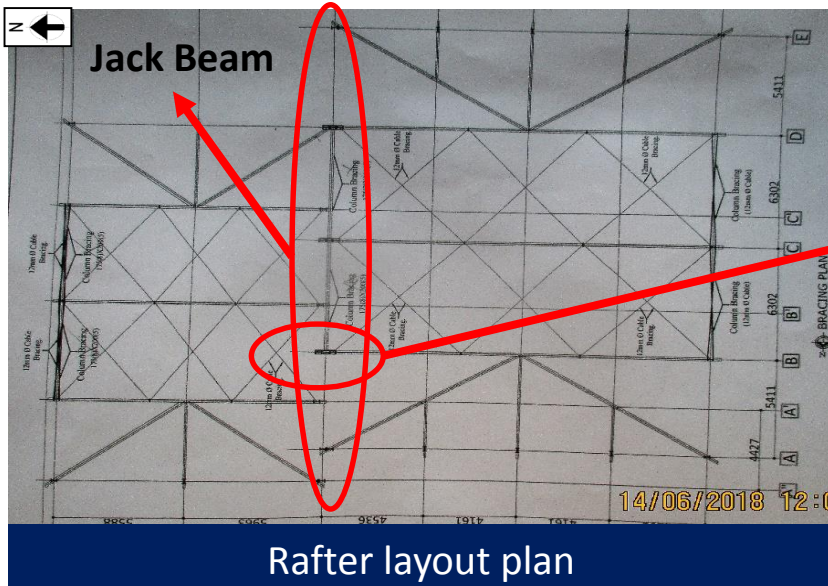
Rafter layout plan

From the layout plan and visual inspection it was observed that the lateral stability of the structure partly depends on the jack beam as some of the rafter are resting on it. Apparently no obvious lateral load resisting system on north-south direction due to insufficient of lateral load transfer media. Factory engineer is require to verify the lateral stability of the structure against the horizontal and vertical loads.

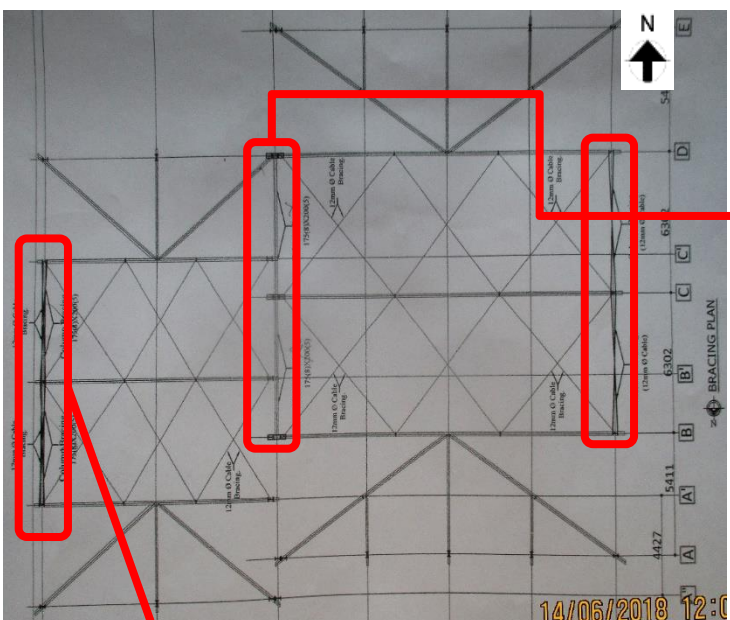
As-built drawing Bracing Layout

The location of column to column vertical bracing didn't match with provided bracing layout drawings. Factory is require to install the bracings as per bracing layout drawings.

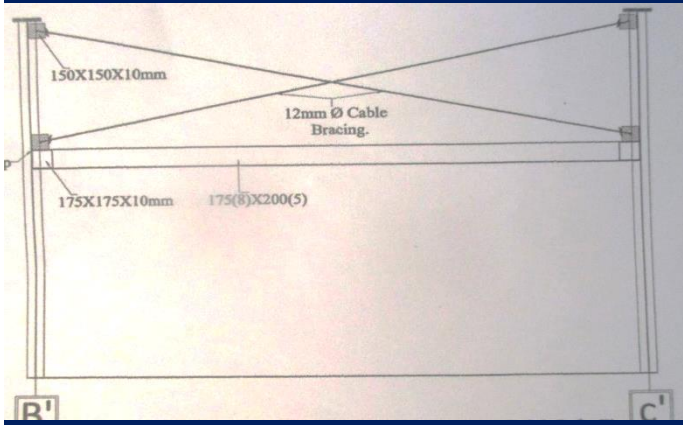
Vertical bracing with compression strut in as-built drawing

Only cable bracing was found in grid 1B-1C & 1C-1D but no compression strut was observed.

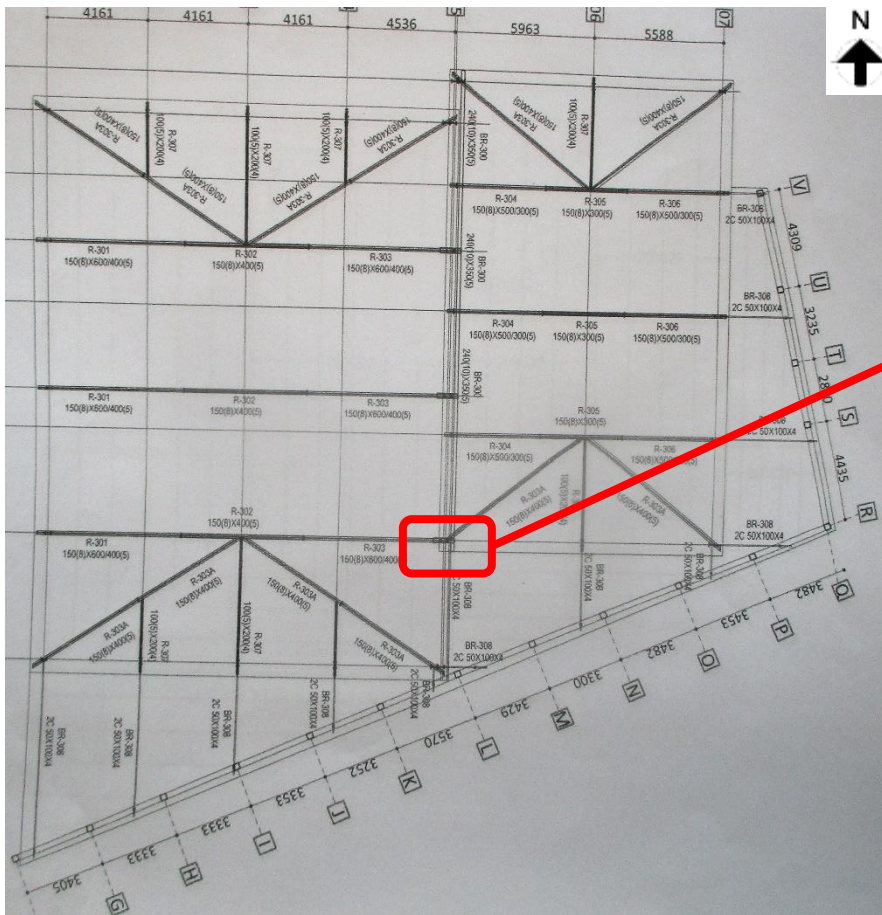
Rafter Layout in as-built drawing

The size of Jack beam at grid B-5 was found F200mm (10mm) X W300mm(5mm) which was supposed to be F240mm (10mm) X W350mm(5mm) as per provided as-built structural drawing.
