Versatile Textiles Limited (New Buildings)

89/2 Chaydana, Degerchala Road, National University

4th June 2018

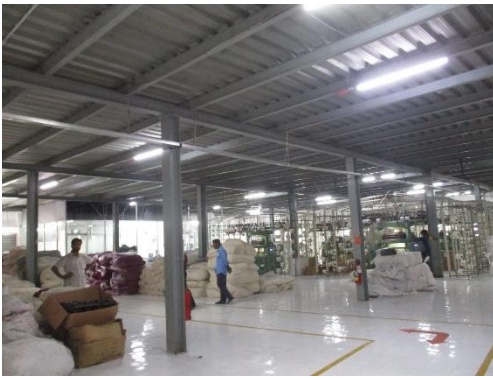
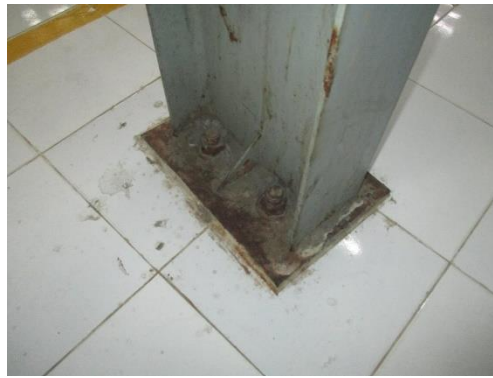
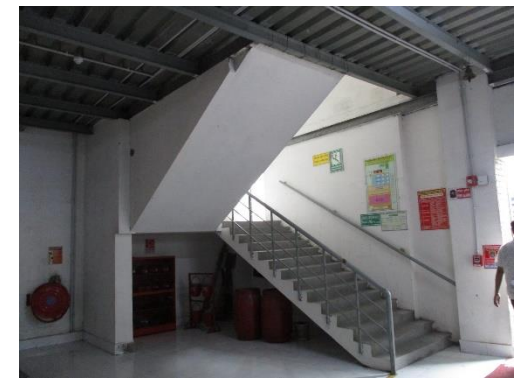
Steel column layout

As-built drawing to be updated

As per drawings, the steel columns are shown in every grid location. But the foundation layout shown only for the periphery and central columns. Also, there is no detail for RC floor slab and stairs.

Discrepancies observed in the sectional dimension of SC-2 columns and rafter at ridge. Building engineer is required to update the as-built drawing and design documents.
