Trouser World (Pvt.) Ltd.(New Building)

378/1, Kunia, National University, Joydebpur, Gazipur
(23.926324N, 90.387200E)
7th June 2018

Observations

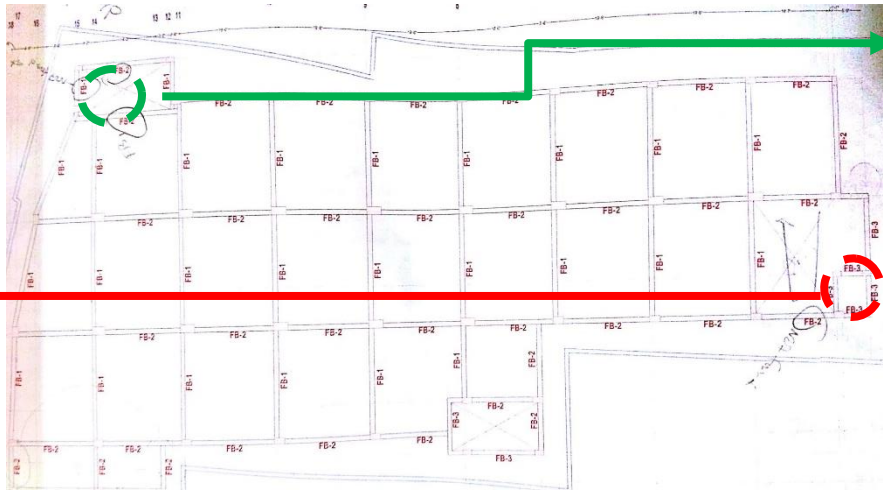
During inspection, stair beam was found missing in the south side and east side stair.

Stair beam was not found as per beam layout plan. Stair beam was found missing in the in the south side and east side stair. One beam was found missing for each stair. Update of as-built drawing is required. Stair stability is required to be assessed.

Item No.	Observation	Recommended Action Plan	Recommended Timeline
1	Inaccurate as- built drawings	Building Engineer to survey as-constructed building and update drawings as required.	6-weeks
2	Inaccurate as- built drawings	Stability check for the stair is required.	6-weeks
3	Inaccurate as- built drawings	Implement remedial works suggested by the building engineer.	6-months
4	Load plan to be produced	Produce and actively manage a loading plan for all floor plates within the factory giving consideration to slab, beam, column and foundation capacity.	6-weeks
5	Load plan to be produced	Continue to implement load plan.	6-months
6	Falling Hazard in the roof floor	Factory is required to install safety guard for falling hazard.	Immediate - Now
7	Probable Vehicle Impact for Ground Floor Columns	Install safety guard to protect the columns from vehicular impact	Immediate - Now
8	Lack of as-built documents for generator shed	Building Engineer to check the structure and update as-built drawings	6-weeks
