**Moonlux Knit Garments Ltd. #10694**  
**West Knit Wear Ltd. #9892**  
**West Fashion Ltd #11020**  
**Moonlux Composite Knit Garments Ltd. #11699**

7504-7505 Waxbill Plaza, Sumilpara, Siddirgonj, Narayanganj

16.April.2014

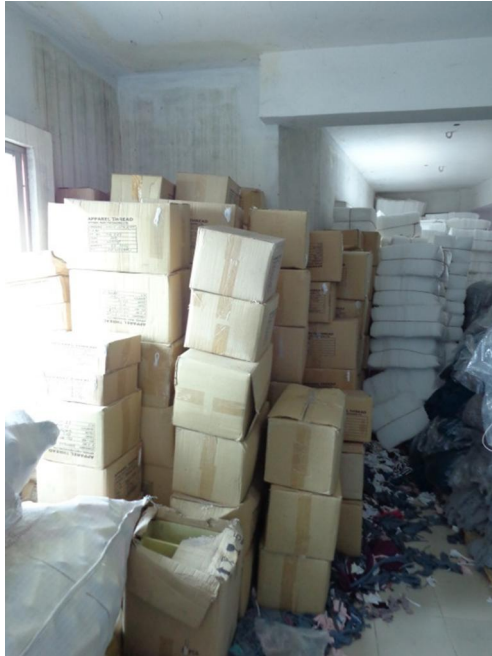
## 1<sup>st</sup> Priority 2 Concern

During our visit, we have found that the floors used for excessive storage. For example, on the 3<sup>rd</sup> floor of the front building, we found a cantilevered section loaded at 6 kPa. The factory and floor manager were advised to lower the height of the storage by half in that area.

We also noticed that some construction material stored at the roof. Loading of the roof has to be limited to a minimum.

This concern is applicable for both buildings

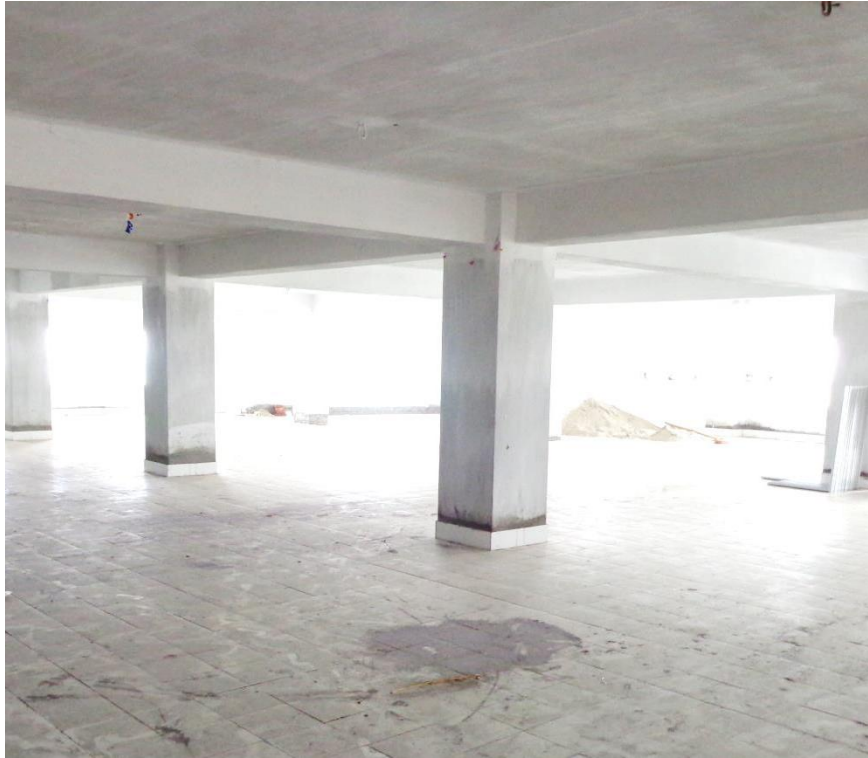
The overall stability of both buildings is probably provided by a moment frame which requires special detailing at the beam to column connections. Such details were not available in the construction drawings.

Brick walls infills cannot be considered in the lateral load resisting system as they are not restrained.

We have one main concern with regards to the surveyed system. The first one is the fact that both buildings are connected at the main staircase. This can alter load distribution and create load concentration at the staircase, which could fail and prevent emergency egress.
