# Space Sweater Ltd. (Jogitala)

Shi-145/1, Jogitola, Joydebpur, Gazipur  
(23.973670N, 90.405423E)  
2<sup>nd</sup> July 2018

# Observations

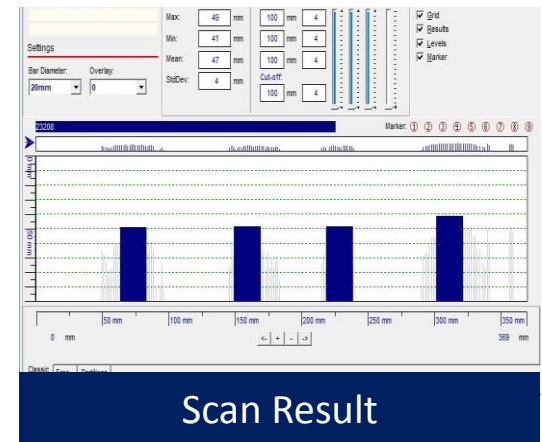
C-1 type column

Number of rebar for C-1 column does not match with column schedule. 12 nos. of rebar were found by ferro scan whereas 16 nos. of rebars are shown in column schedule.

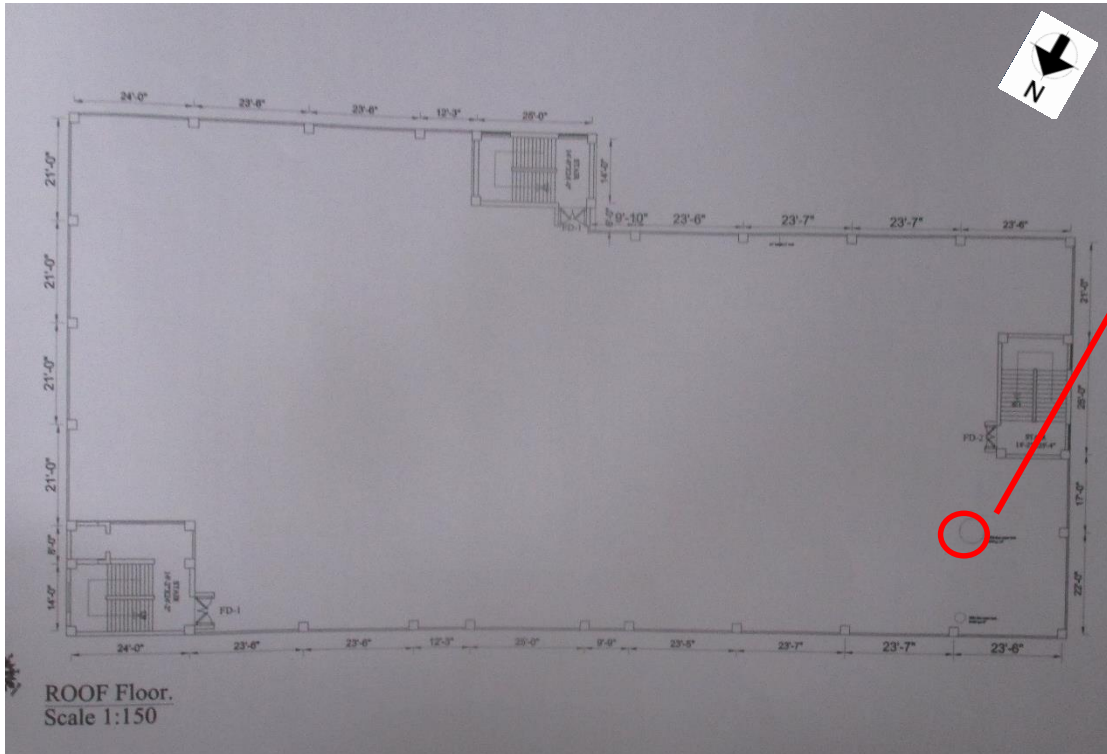
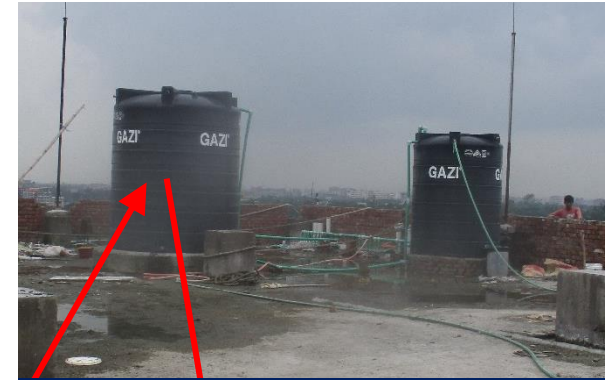
Roof Plan

Over head plastic water tank having 10,000 & 5000 liters capacity was found at west side of roof
