# Rio Fashion Wear Ltd

Industrial Plot No.3, Milk Vita Road, Section 7, Mirpur, Dhaka  
(23.81596N, 90.3625E)

2 November 2013

# Site Observations

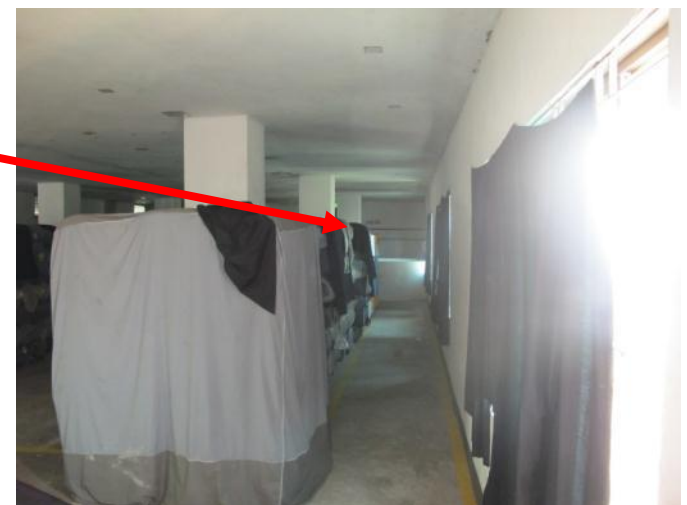
## Heavily loaded bonded warehouse

**Rolls of denim stacked 2m high over areas of 1.5m x 3m**

**Loading in this area needs to be reduced See below**

| Item No. | Observation | Recommended Action Plan | Recommended Timeline |
|---|---|---|---|
| 9 | Heavy loading in fabric store on 8th floor has resulted in overloading of the slab and cracking to the soffit of the 7th floor | Reduce loading on 8th floor. Assuming 1.5m x 1.5m area limit height of rolls of fabric to 1.5m height . Ensure 1m clear pathway around 4 sides of every 1.5m x 1.5m pallet. Remove all loading in bay directly over crack. | Immediate - Now |

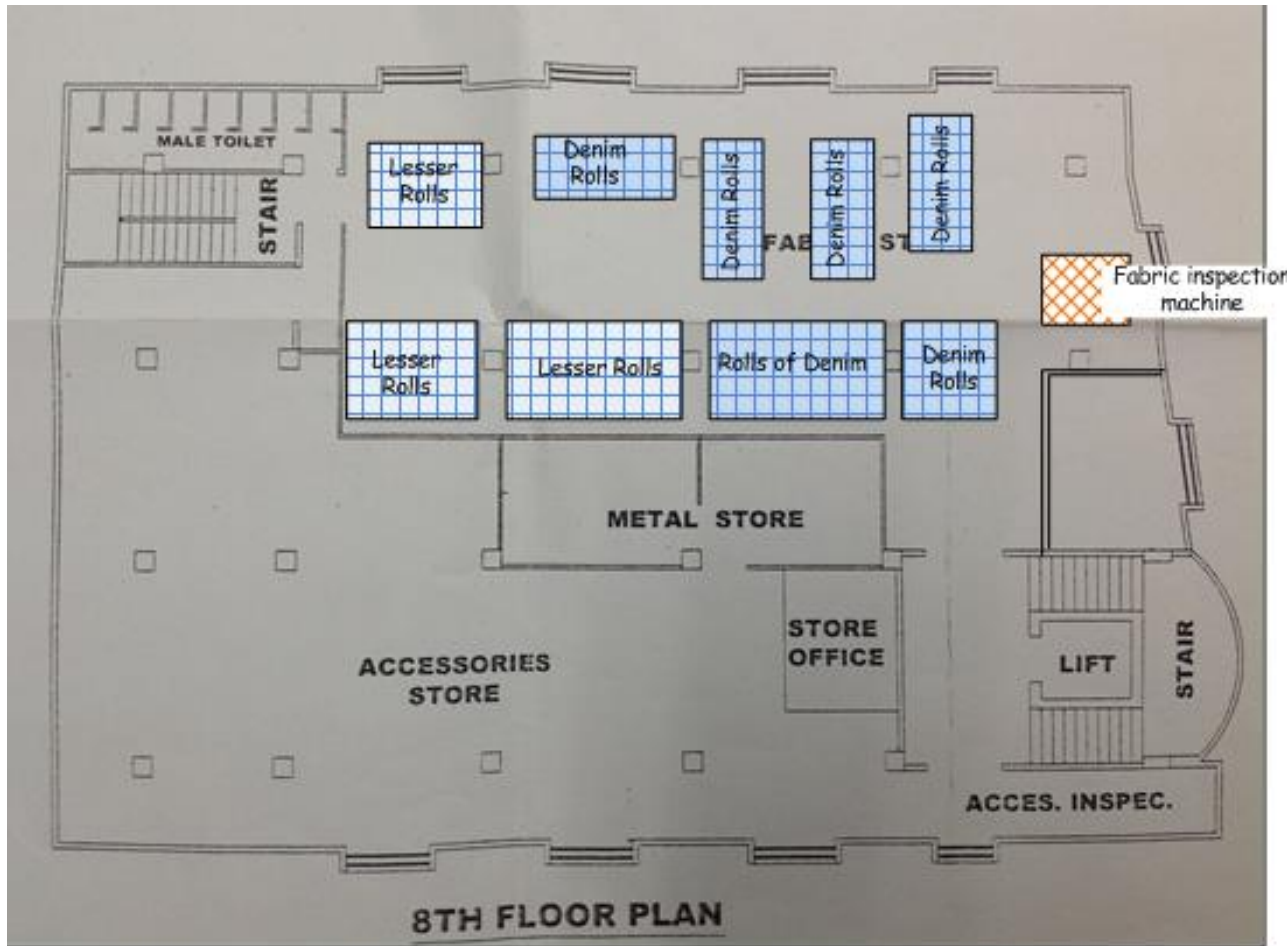
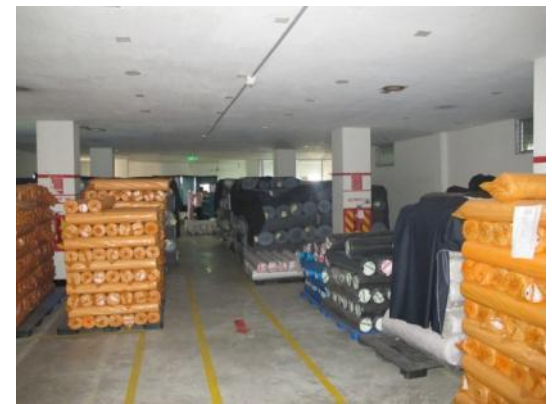
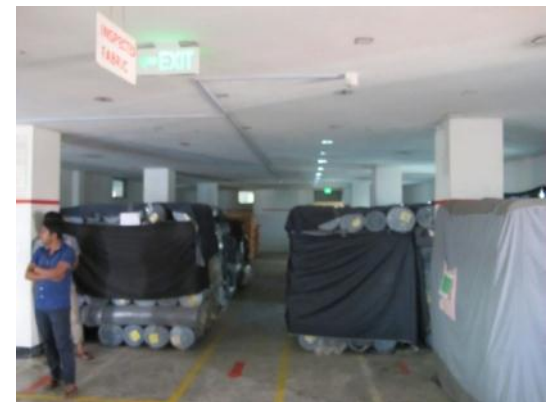
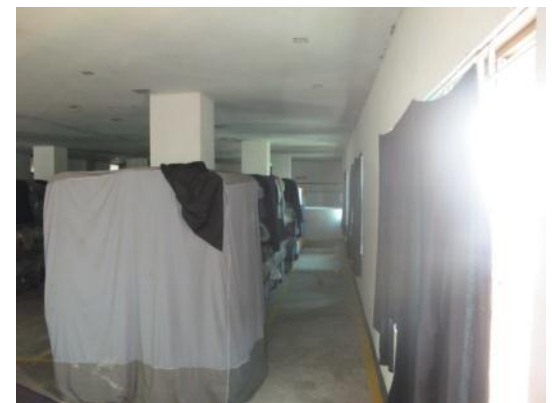
**Heavily loaded bonded warehouse**

**Multiple hairline cracks in underside of 8<sup>th</sup> floor slab**

**Crack opened up with hammer revealed voids in concrete**

| Item No. | Observation | Recommended Action Plan | Recommended Timeline |
|---|---|---|---|
| 10 | Heavy loading in fabric store on 8th floor has resulted in overloading of the slab and cracking to the soffit of the 7th floor | Qualified Engineer to assess slab, confirming reinforcement diameter, condition and cover depth). Check for voids in slab under storage area using Non-Destructive Testing apparatus. | 6-weeks |
| 11 | Heavy loading in fabric store on 8th floor has resulted in overloading of the slab and cracking to the soffit of the 7th floor | If voiding is not extensive in situ repair may be feasible with imposed loads on 8th floor limited to a quantified design capacity. If voiding is extensive slab will need to be propped and strengthening options developed. | 6-weeks |

**Remove all items from the column bay directly over cracked area. No imposed load permitted until slab is assessed and repaired**

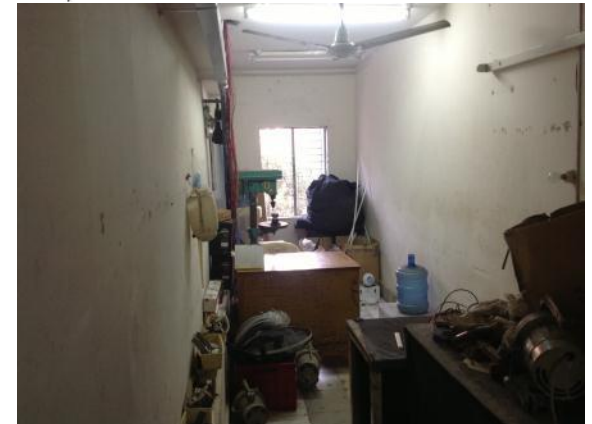
**Deflections of cantilevered slab at perimeter walls**

**Crack in floor tiles due to deflection of slab edge**

**35mm deflection at tip of cantilever (edge of slab at wall is 35mm lower than slab at column position)**
